Arkansas Union

University of Arkansas-Fayetteville

Programming and Concept Design Final Report

February 05, 2010

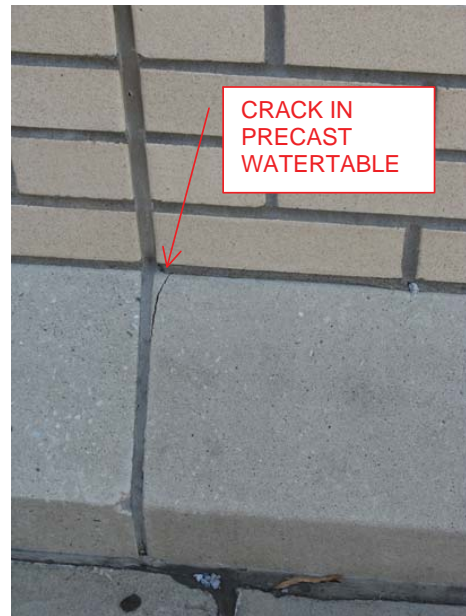
Photo 005

CRACK IN
PRECAST
WATERTABLE

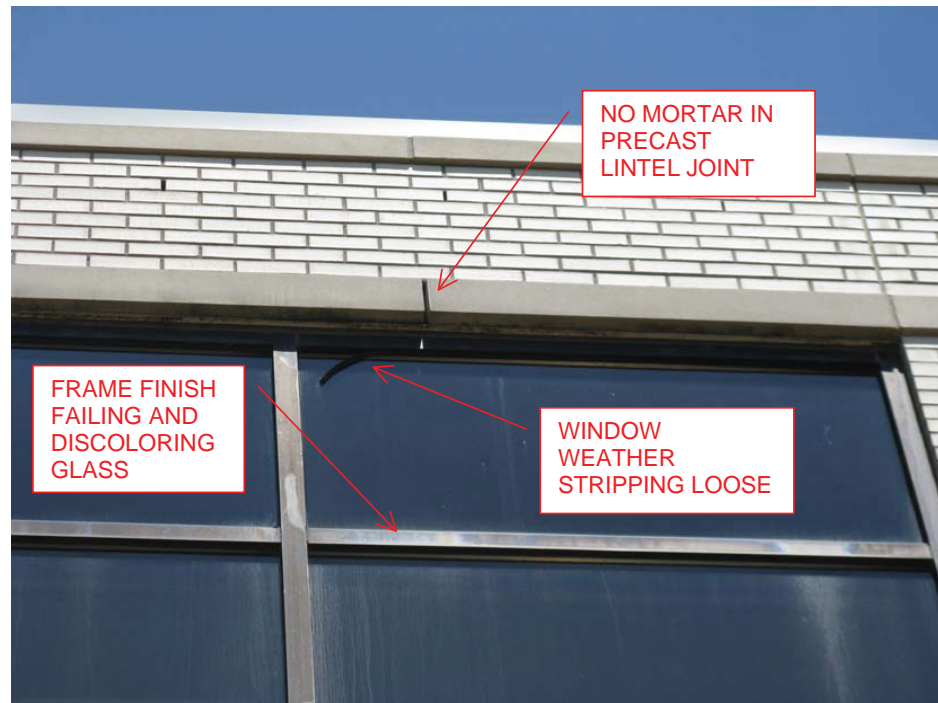
Photo 006

NO MORTAR IN
PRECAST
LINTEL JOINT

FRAME FINISH
FAILING AND
DISCOLORING
GLASS

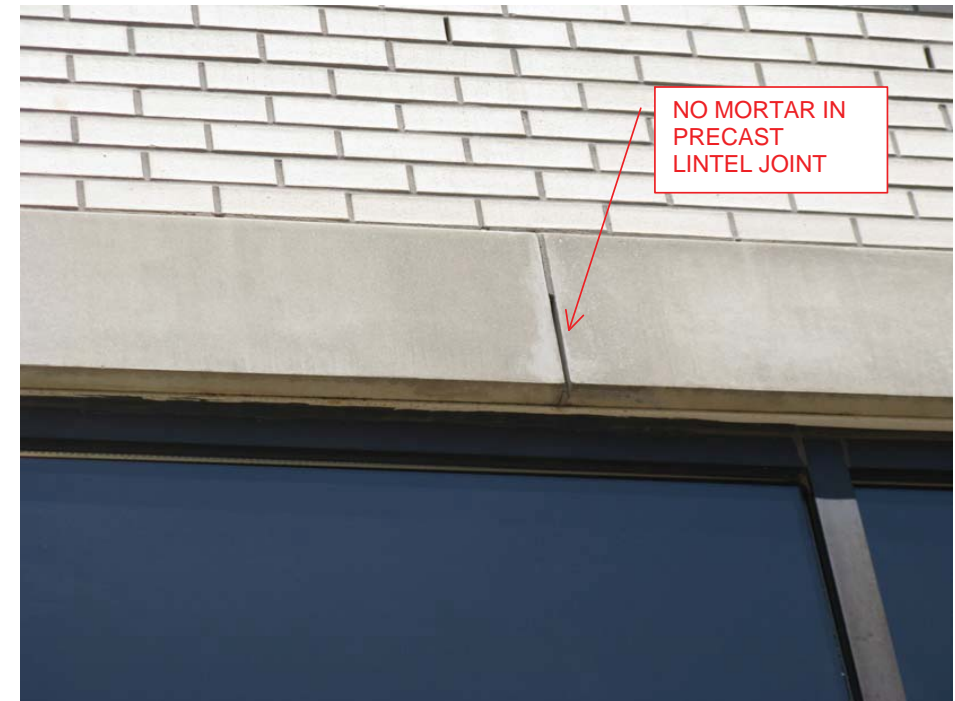
Photo 007

NO MORTAR IN
PRECAST
LINTEL JOINT

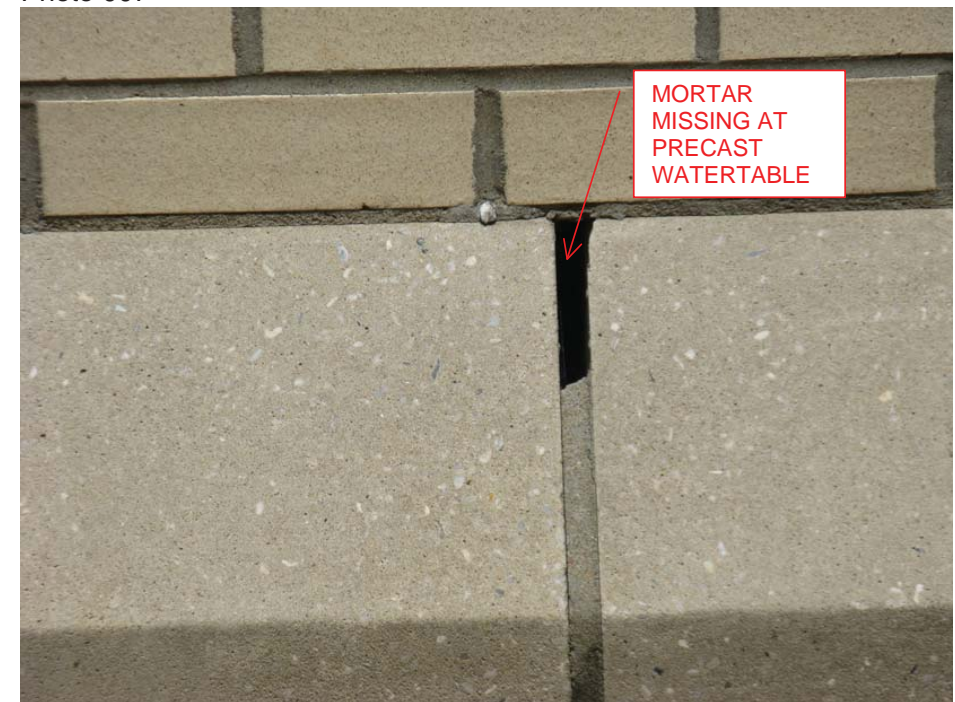
Photo 008

MORTAR
MISSING AT
PRECAST
WATERTABLE

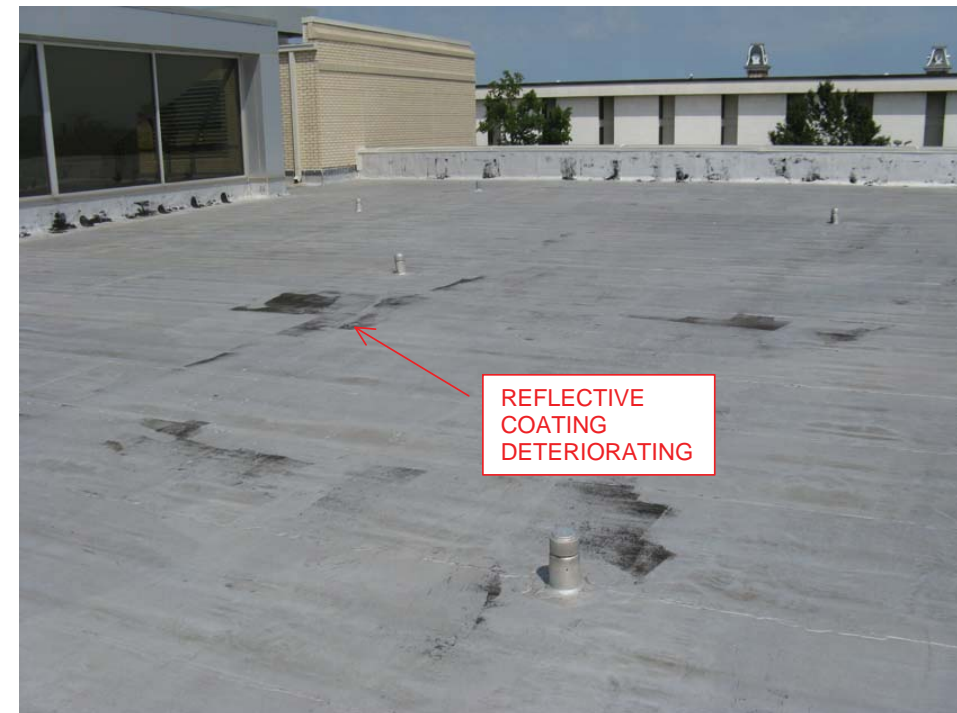
Photo 045

- a. Roofs over the buildings seem in good condition. The reflective coating has deteriorated and should be touched up. (Photo 045 & 046)

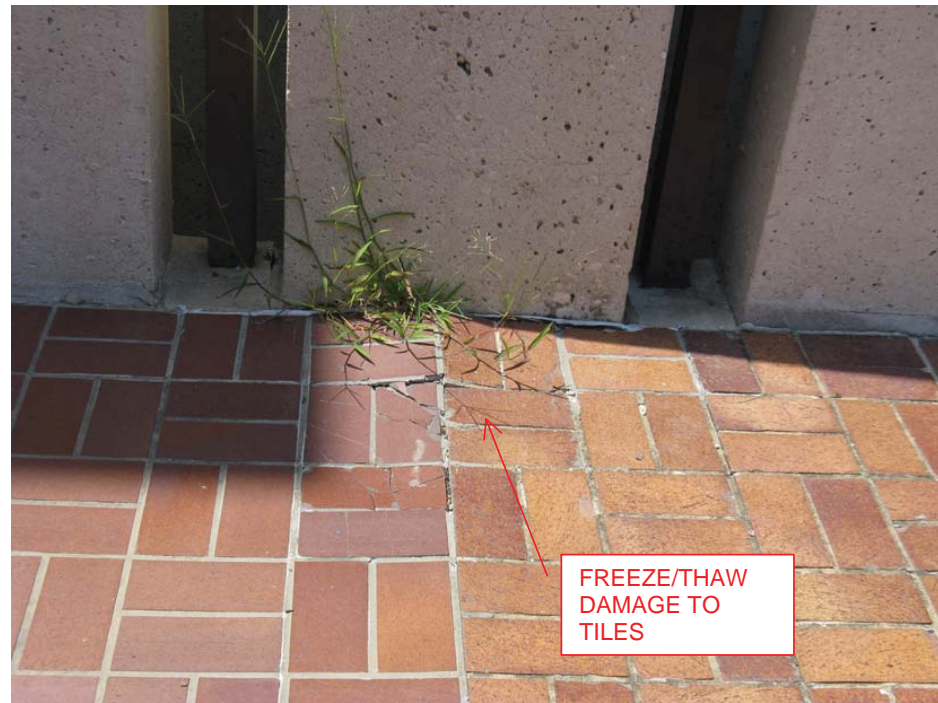
Photo 061

- a. Quarry tile plazas on top of the bridge to the north and south of connecting link are deteriorating. Freezing and thawing has popped up some tiles. (Photo 061). There seems to be inadequate slope to drainage. (Photo 062 & 063) Inadequate water proofing mainly at plaza edges seems to be allowing water to migrate though plaza and form mineral deposits on the concrete structure below. (Photo 064)
- b. Traffic has cause some damage to concrete bridge joists. (Photo 065)
- c. Traffic has caused damage to conduit under bridge that needs repaired. (Photo 066)
- d. Moisture present under plaza deck slabs in some locations indicating possible leakage of membrane above. (Photo 067 & 068)
- e. Guardrail tops at plazas in bad repair. (Photo 069 & 070)
- f. Concrete retaining wall east of drive has staining that could be cleaned and some cracking that should be monitored. (Photo 071 & 072)

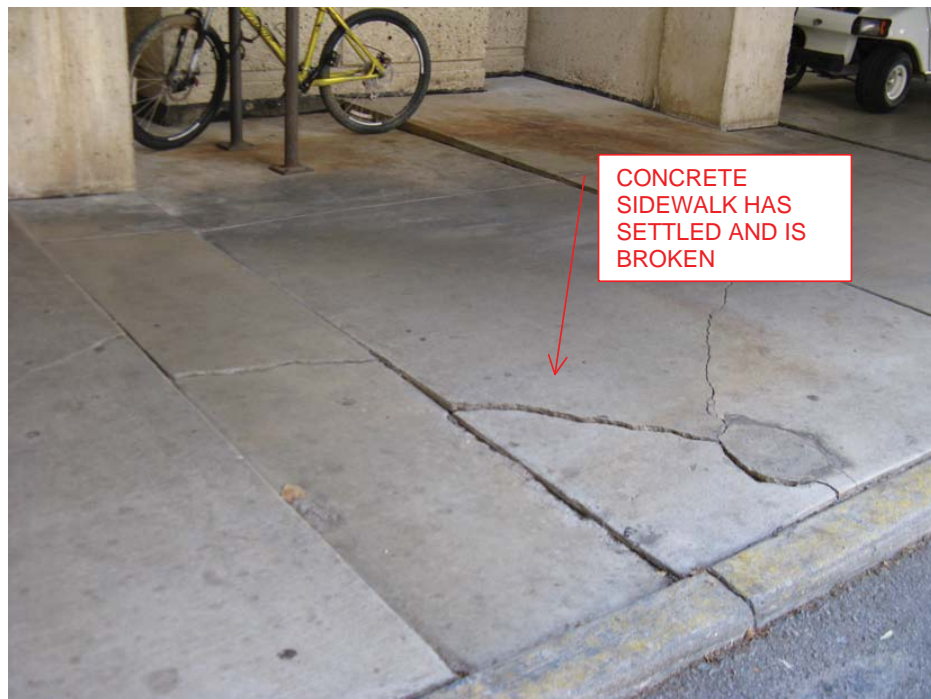
Photo 073

- a. Sidewalks along east side of building at level under bridge have settled several inches. This has caused breakage in the concrete. (Photo 073) It has also cause a place for water ponding along north end of sidewalk. (Photo 074 & 075)
- b. Earth along north side of south wing of building has settled exposing top of footing. This side of building should be regarded. (Photo 076)

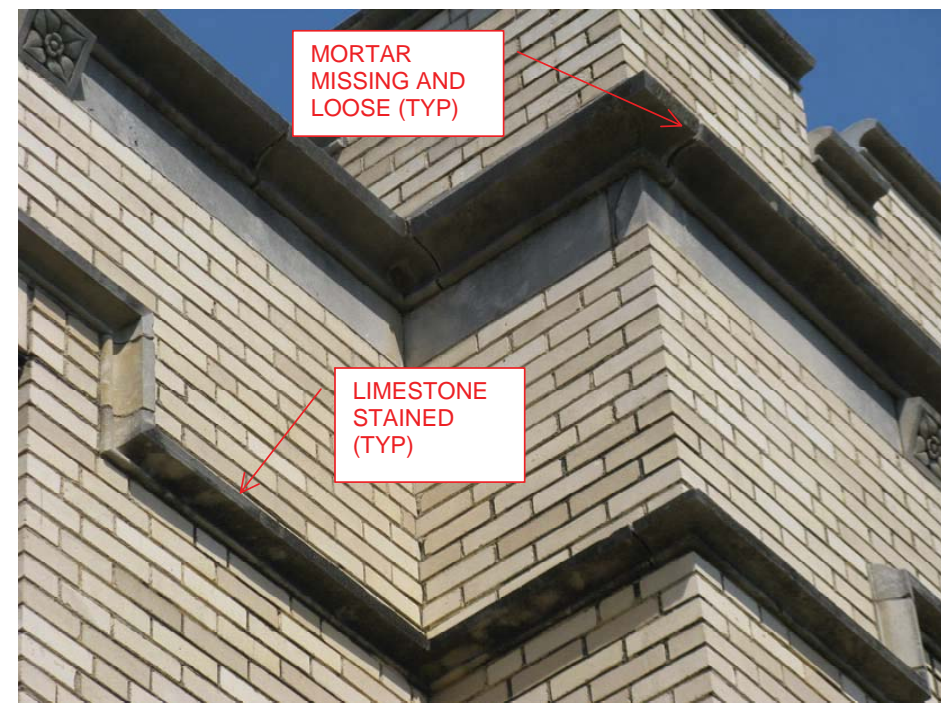
Photo 007

MORTAR
MISSING AND
LOOSE (TYP)

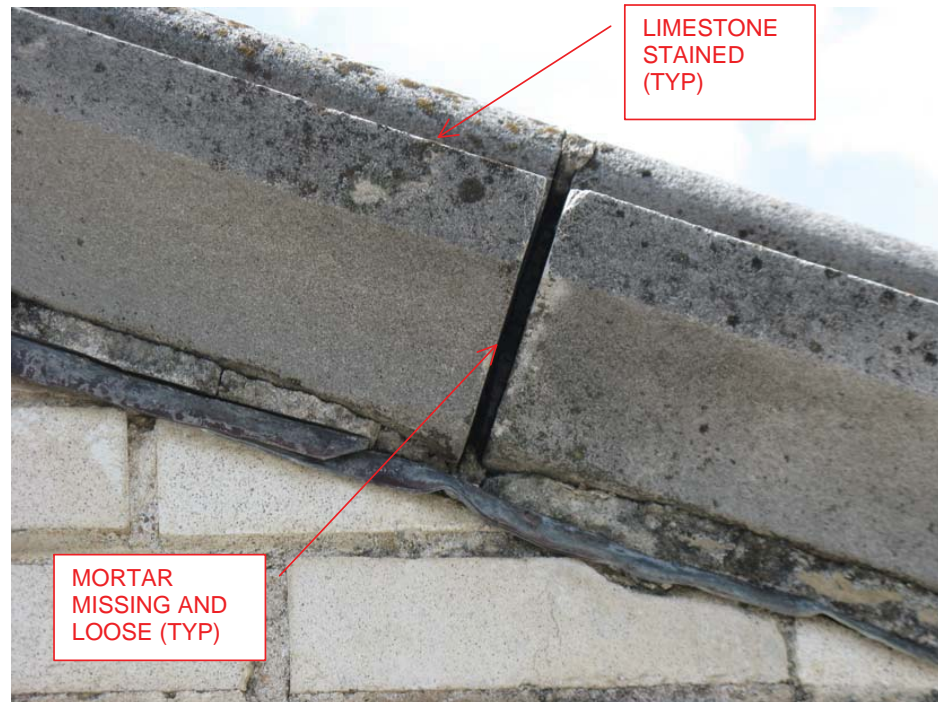
Photo 006

LIMESTONE
STAINED
(TYP)

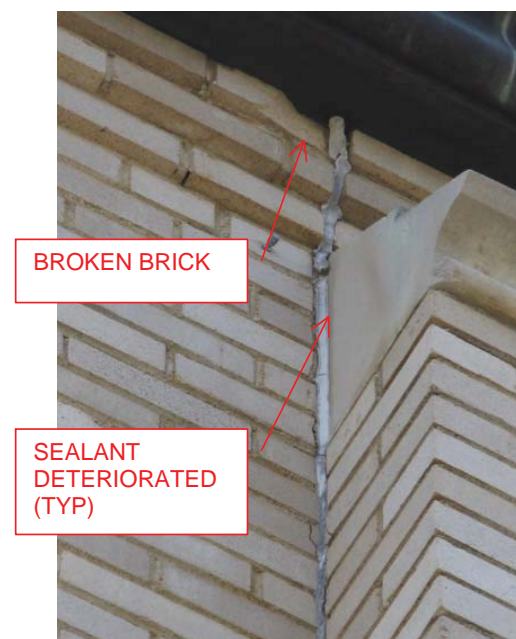
Photo 008

BROKEN BRICK

- a. Some spalling and brick breakage at stepped out brick cornice. These should be replaced with matching brick. (photo 008)
- b. At lower section of building on the west end of the building is a significant diagonal crack that extends through the depth of the wall. Reason for crack as determined by structural engineer should be corrected and wall should be taken down as necessary and relaid. (photo 018 & 019)

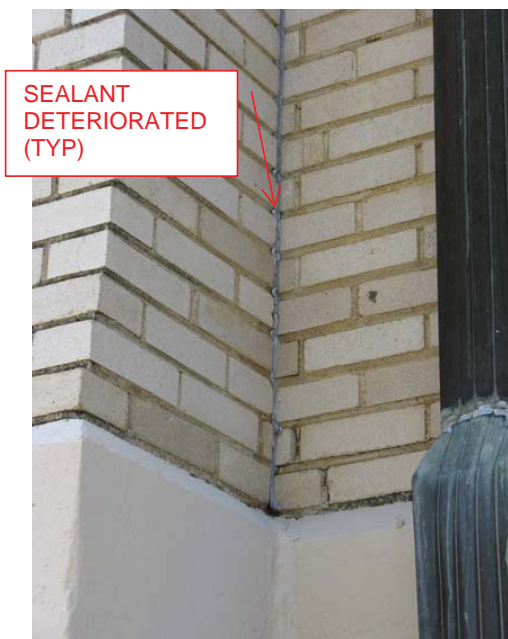
Photo 009

SEALANT
DETERIORATED
(TYP)

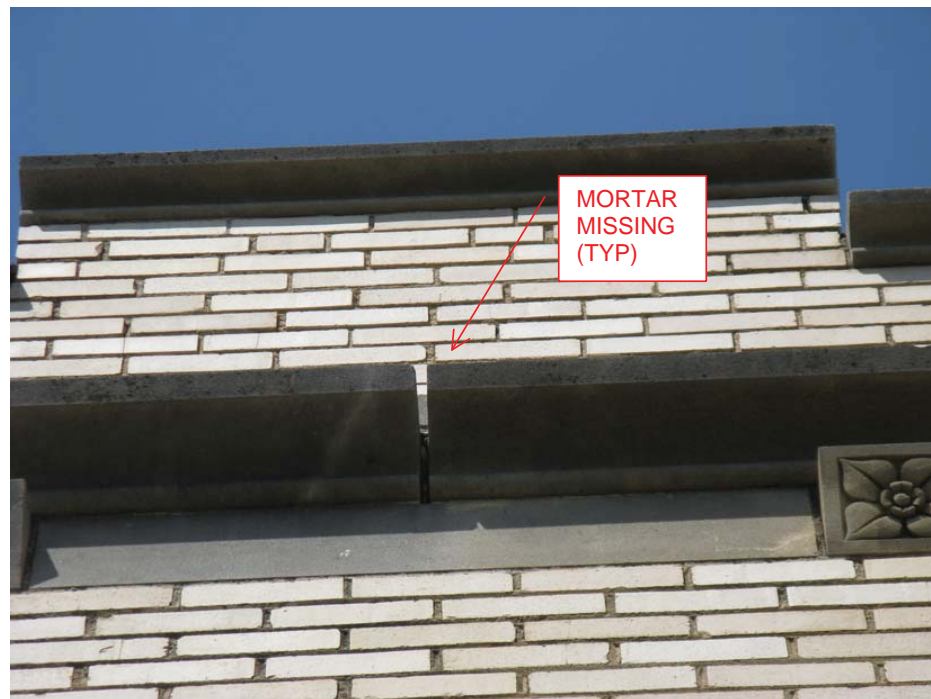
Photo 013

- a. Limestone accents and cornices missing mortar. Should be repointed. (photo 013 & 014)
- b. Steel lintels at ticket booth are rusting and need to be refinished. (photo 015)
- c. Decorative copper cornice at thicket booth is loose. Needs to be reattached. (photo 015)
- d. Staining on brick below decorative louvers in gable. Should be removed in general overall cleaning of brick. (photo 016)
- e. There are a few spalled face bricks above low roof that should be replaced with matching brick. (photo 017)

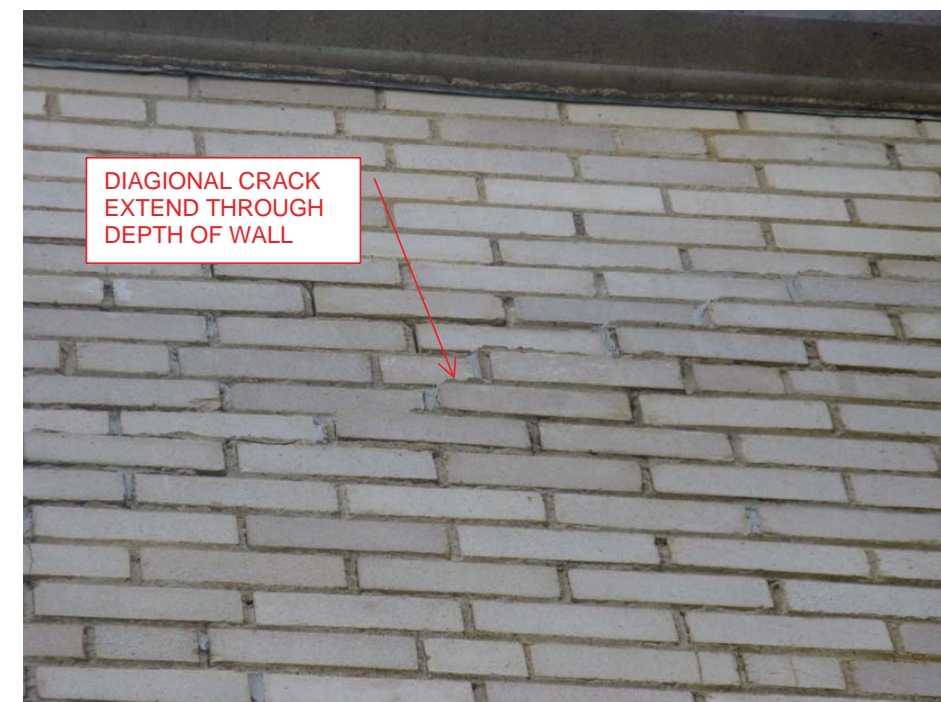
Photo 020

- a. Diagonal cracking continues at lower section of building, both ends of building. See previous corrective suggestion (photo 020 & 021)
- b. Open joint at brick pilaster needs filled. (photo 022)
- c. While copper downspouts are generally in good overall condition, some joints have been sloppily repaired with contrasting sealant. These should be cleaned and repaired in more sympathetic manner. (photo 023)
- d. Wood canopies over doors and door frames have deteriorated. Some wood trim needs replaced and entire canopy repainted. (photo 024 & 025)

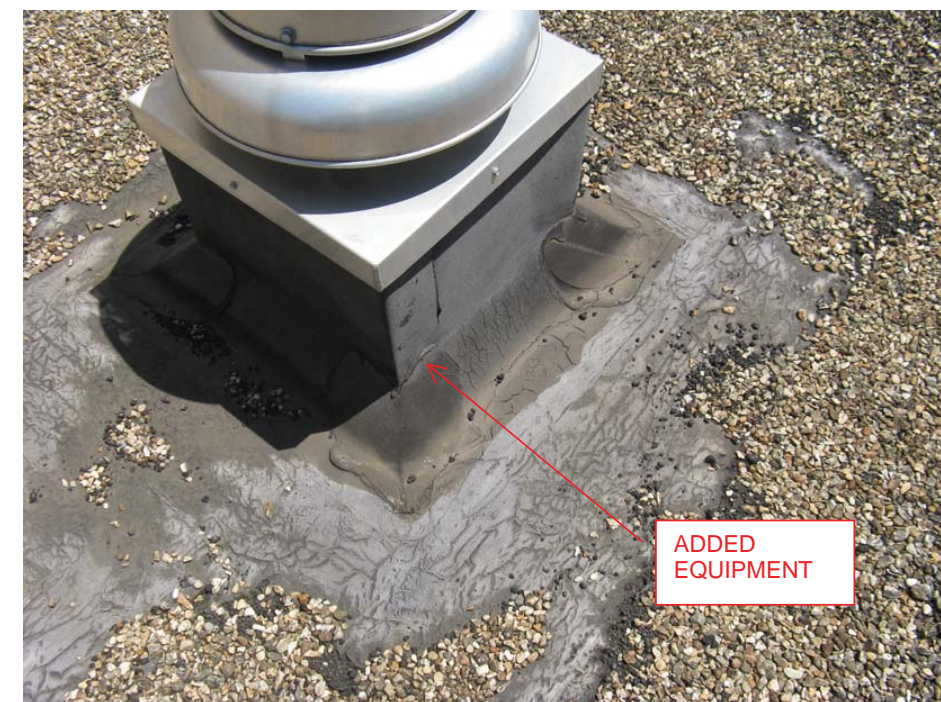
Photo 044

- a. Roof seems to be a built-up type roof with pea gravel that has been patched for installation of new equipment. (photo 044) Roof shows generally to be sound but showing age. (photo 045 & 046)
- b. Flashing around vent penetration damaged. (photo 047)

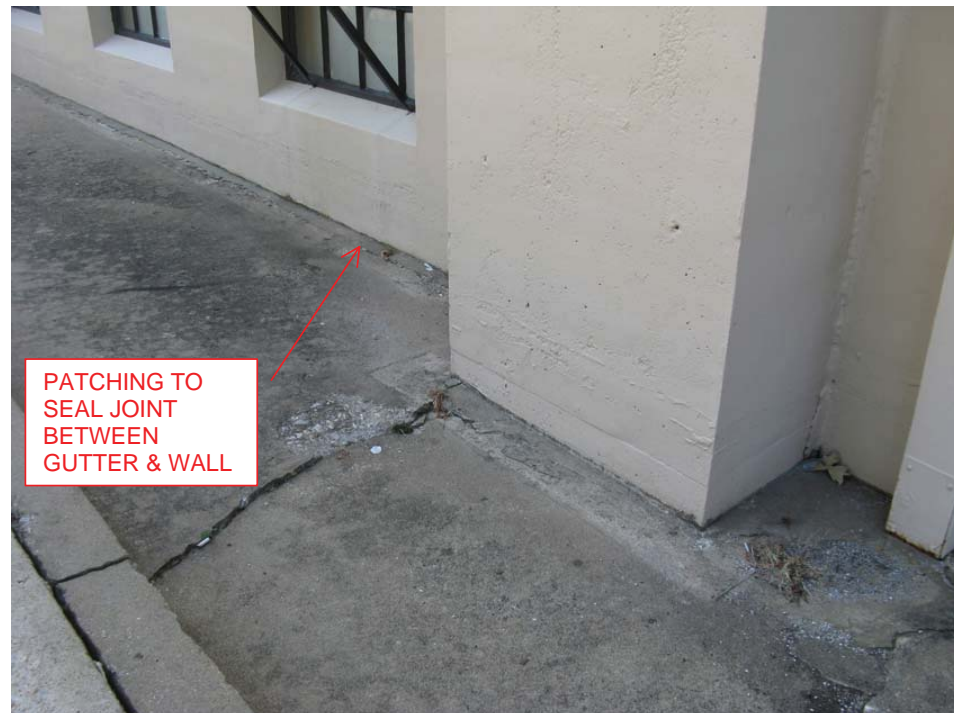
Photo 049

- a. There is no indication on the original drawings or in site observations that the concrete walls retaining earth above the basement level have waterproofing. There is some indication that there may have been some water problems along the north side of the building by attempts to seal the joint between the concrete gutter and the building. (photo 049)

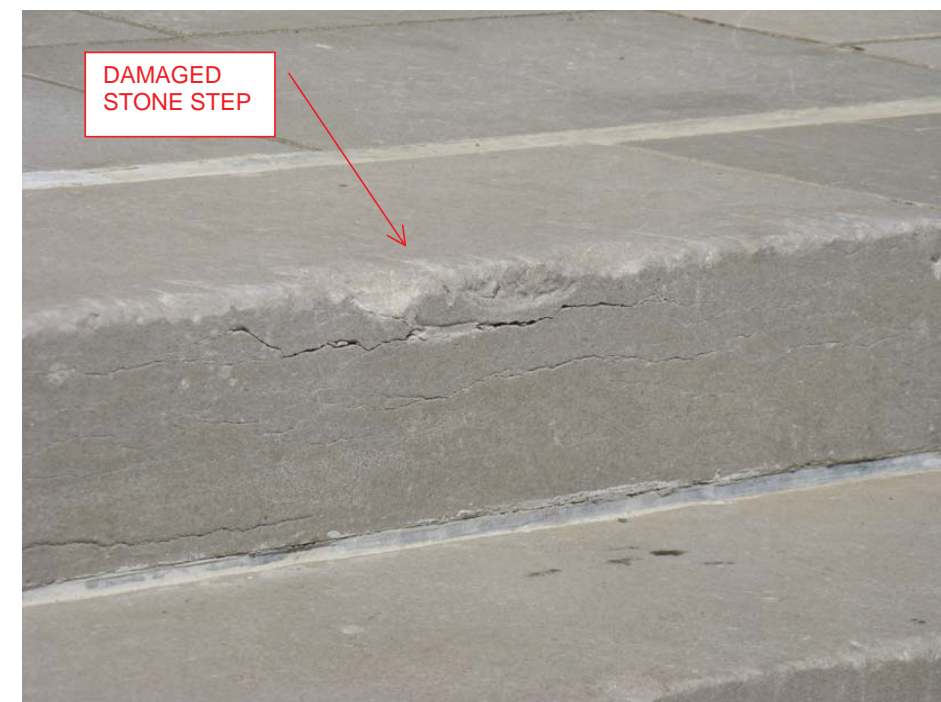
Photo 050

- a. Several of the stone steps have been damaged. Attempts to patch some have been made. Movement has occurred in some. (Photo 050 & 051)
- b. Stones in the ashlar terrace have moved over time and the mortar has deteriorated. (Photo 052)
- c. Concrete sidewalk in front of step platform at entry is broken and uneven. (Photo 053)
- d. A concrete ramp provides wheel chair accessibility to main front entry. (Photo 054)

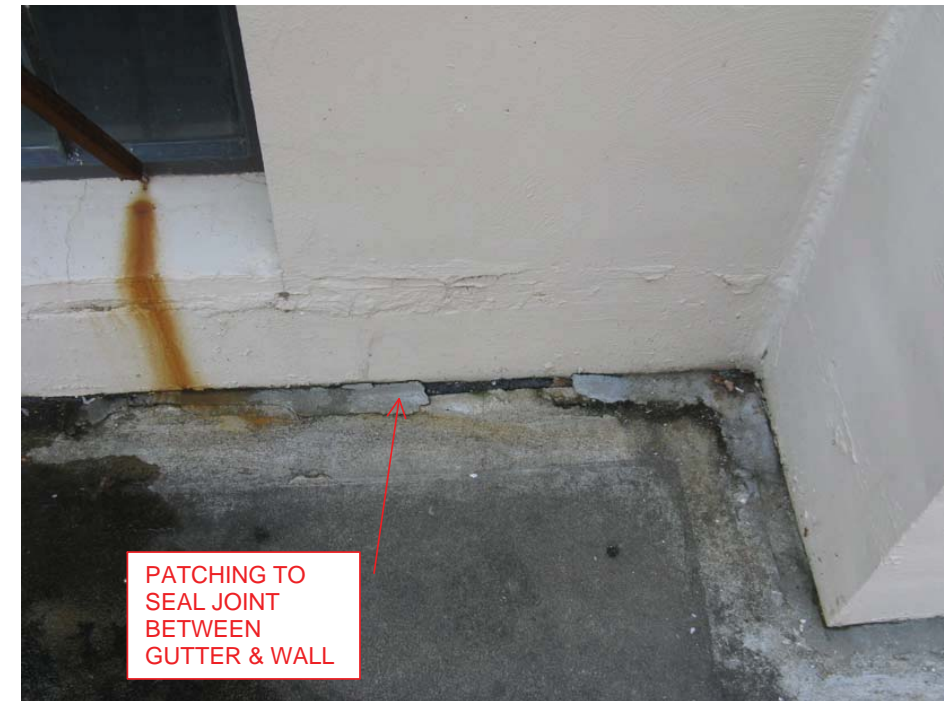
- a. Sidewalk along north side of the building has settled. (Photo 055)
- b. Steps should be replaced with wheelchair accessible access if possible from front of building to side. (photo 056)
- c. Joint between concrete gutter and face of building has been patched in what looks like an attempt to prevent water from coming into building. (Photo 057)

PATCHING TO
SEAL JOINT
BETWEEN
GUTTER & WALL
