FINE ARTS BUILDING (FNAR) Restoration / Renovations Study

August 2017

APPENDIX Rigging and Fly System Inspection Report

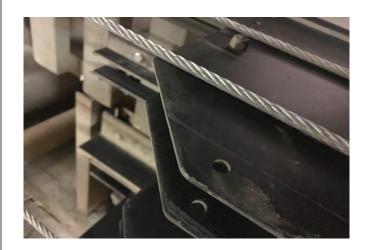
Picture above shows where cable is rubbing against the cheek of the loft block.

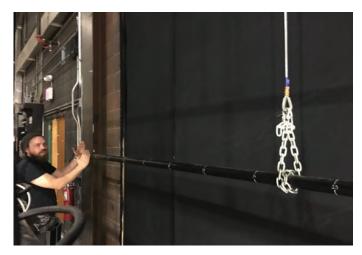
Picture above shows batten extending 8' bevond last termination.

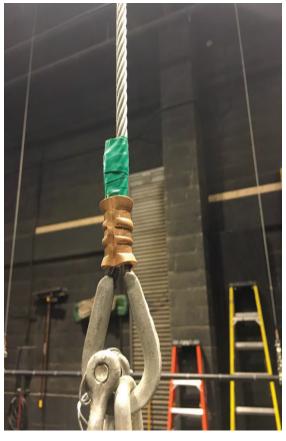
This image shows an improper termination on a copper sleeve

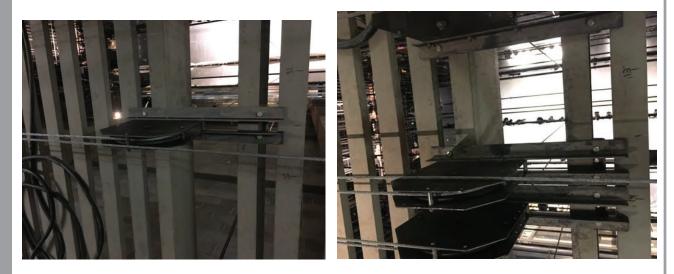
The images above show cables rubbing on loft blocks.

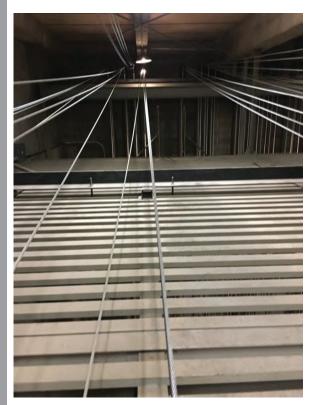
The image above shows unacceptable fleet angles coming off the headblock to the loft block.

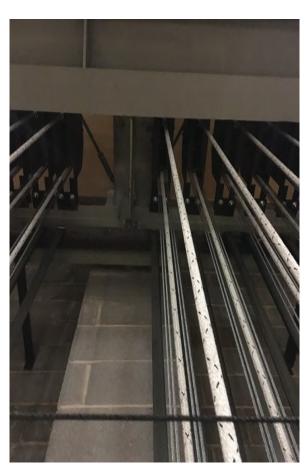
The image above shows the head steel. No Stop Rail in place. This allows the arbor to contact the steel.

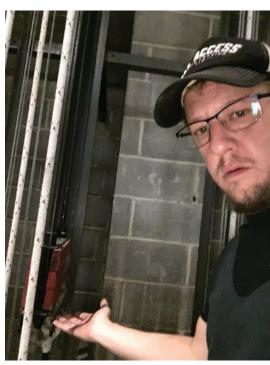
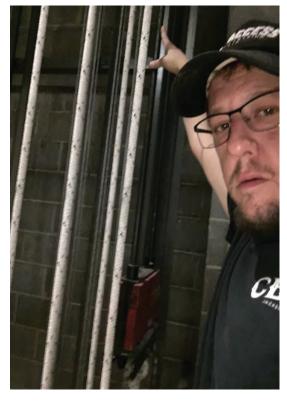
The image above and below show an arbor on the loading bridge. The weights are unusually high, and if counterweight needs to be added, the loader would soon be loading overhead.

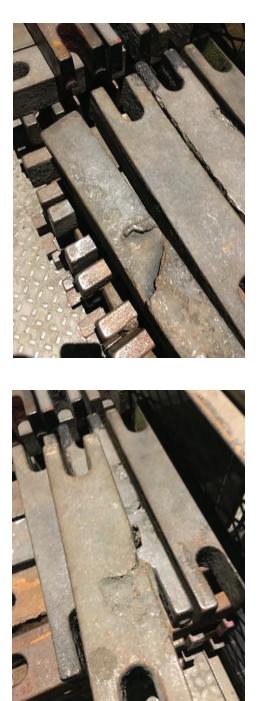
The images above show Cast counterweights. The weights are noticeably deformed.

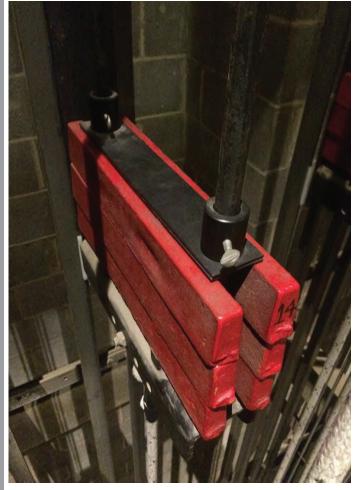
The image above shows an arbor without appropriate number of spacers. This picture is true throughout system.

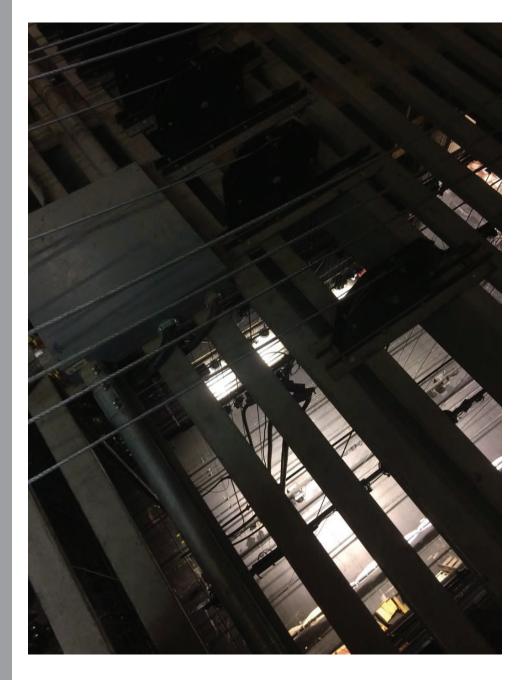
The image above shows where cable is contacting other steel in the grid. Sag bars should be used to prevent this from happening.
