UNIVERSITY OF
ARKANSAS

Engineering Research Center (ENRC)

Roof Replacement Plan

UNIVERSITY OF ARKANSAS ENGINEERING RESEARCH CENTER (ENRC) ROOF REPLACEMENT PLAN

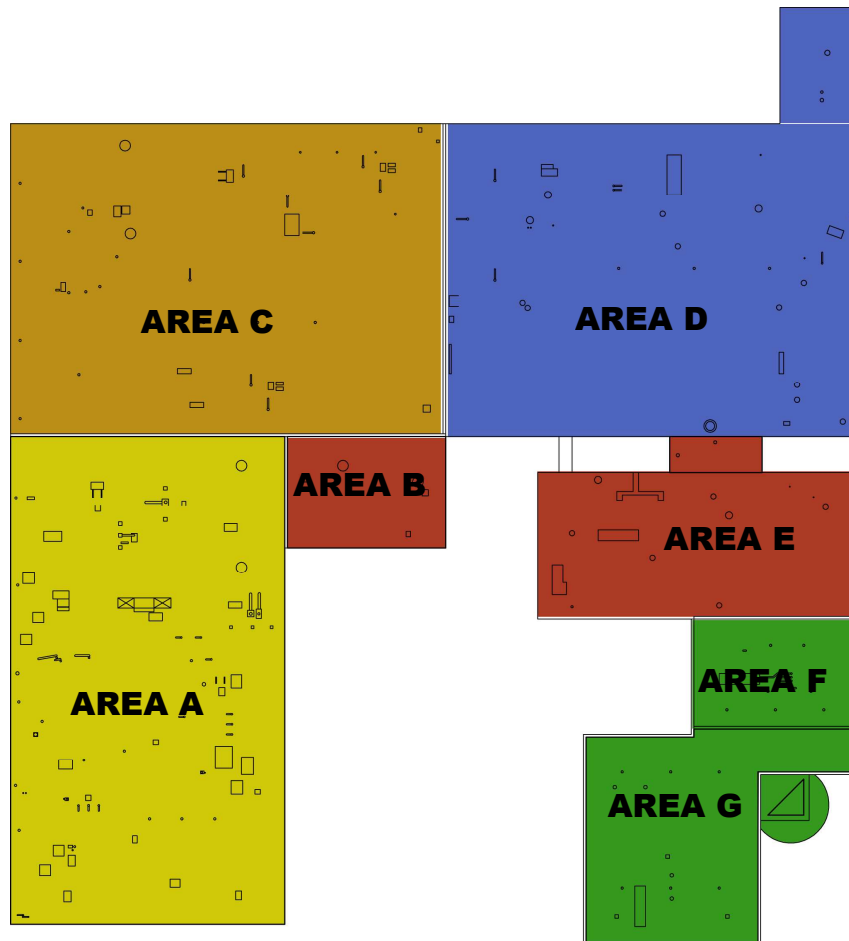
Engineering Research Center (ENRC) Roof Plan
Not To Scale

Area known or believed to include wet insulation

PHASE III: \$ 603,128
(Includes 10% Contingency and 9% JOC Fee)

PHASE II: \$ 607,940
(Includes 10% Contingency and 9% JOC Fee)

PHASE I: \$ 639,361
(Includes 10% Contingency and 9% JOC Fee)

PHASE IV: \$ 699,881
(Includes 10% Contingency and 9% JOC Fee)

PHASE V: \$ 588,888
(Includes 10% Contingency and 9% JOC Fee)

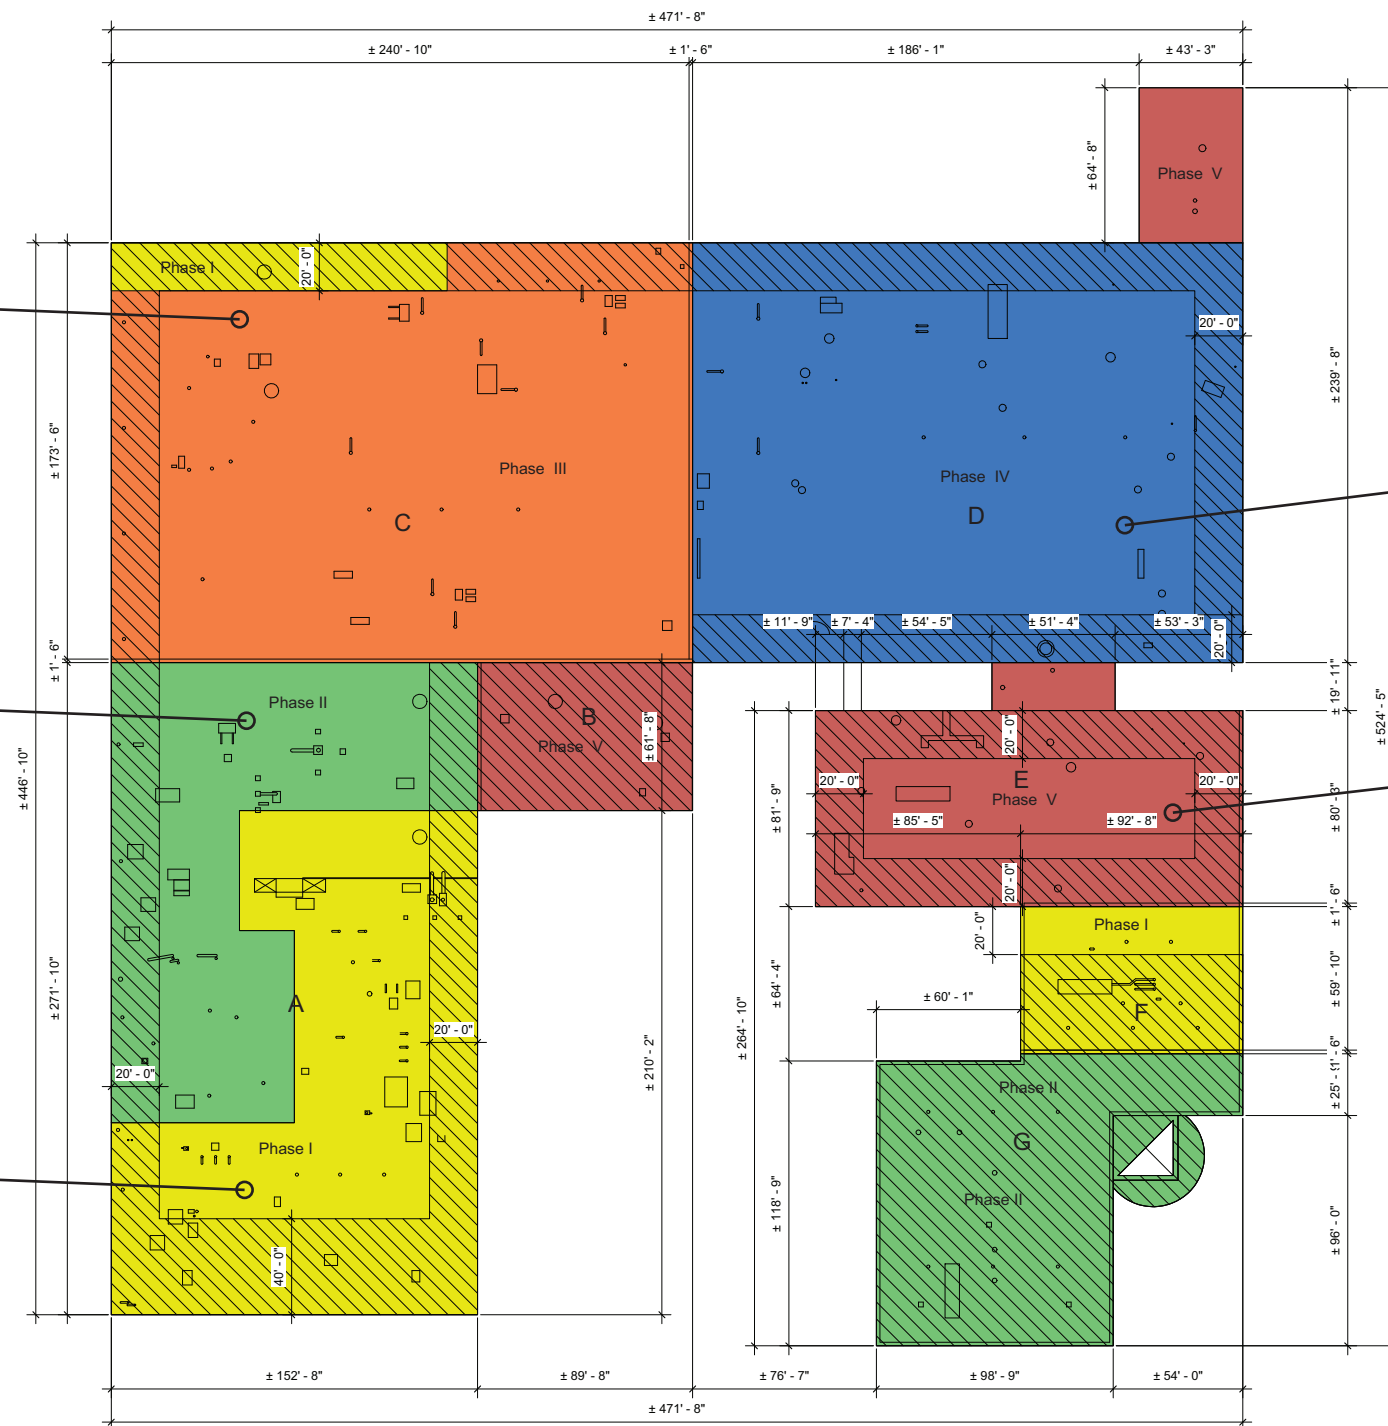
5F ROOF REPLACEMENT - PHASING PLAN
1" = 40'-0"

TOTAL SQUARE FOOTAGE = 165,839 SF

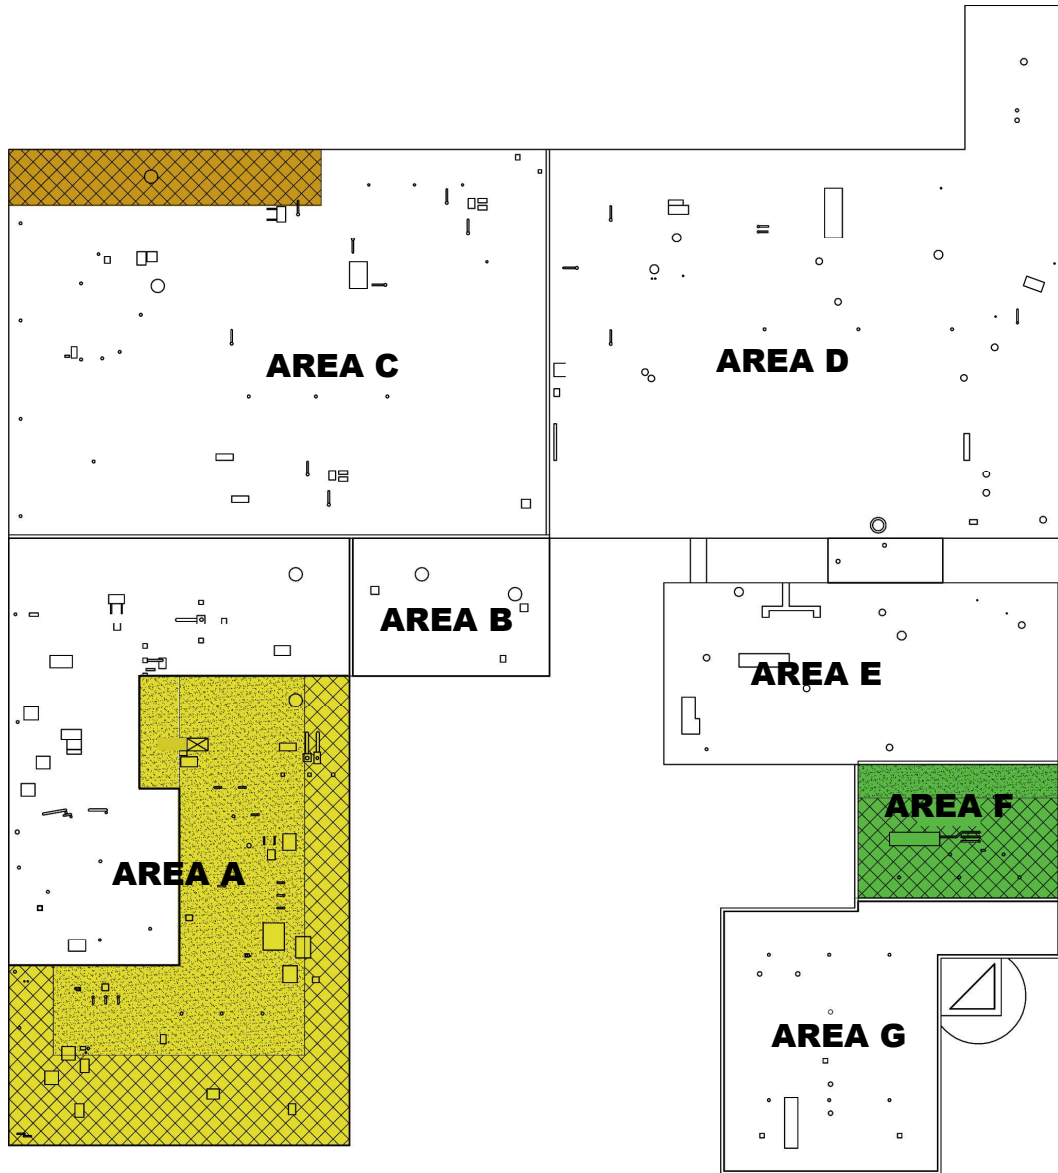
Engineering Research Center (ENRC) Roof Plan
PHASE I
Not To Scale

1. HATCHED AREA (10,309 SF): REMOVE EXISTING OUTER (2ND ROOF) MODIFIED BITUMEN ROOF MEMBRANE AND FIBER PROTECTION BOARD AND INSPECT FOR WATER INTRUSION; WHERE FOUND REMOVE EXISTING INNER (1ST) MODIFIED BITUMEN ROOF AND POLYISOCYANURATE INSULATION DOWN TO METAL DECK. AREA ASSUMED TO HAVE WATER INTRUSION BASED ON ROOF CORE SAMPLING.

2. SHADED AREA (11,838 SF): REMOVE EXISTING OUTER (2ND ROOF) MODIFIED BITUMEN ROOF MEMBRANE AND FIBER PROTECTION BOARD AND INSPECT FOR WATER INTRUSION; CONSULT ARCHITECT WHERE FOUND. AREA ASSUMED TO BE DRY BASED ON ROOF CORE SAMPLING. **12,738 x \$12/SF = \$152,856**

1. HATCHED AREA (3,500 SF): REMOVE EXISTING OUTER (2ND ROOF) MODIFIED BITUMEN ROOF MEMBRANE AND FIBER PROTECTION BOARD AND INSPECT FOR WATER INTRUSION; WHERE FOUND REMOVE EXISTING INNER (1ST) MODIFIED BITUMEN ROOF AND POLYISOCYANURATE INSULATION DOWN TO METAL DECK. AREA ASSUMED TO HAVE WATER INTRUSION BASED ON ROOF CORE SAMPLING.

1. HATCHED AREA (5,362 SF): REMOVE EXISTING OUTER (2ND ROOF) MODIFIED BITUMEN ROOF MEMBRANE AND FIBER PROTECTION BOARD AND INSPECT FOR WATER INTRUSION; WHERE FOUND REMOVE EXISTING INNER (1ST) MODIFIED BITUMEN ROOF AND POLYISOCYANURATE INSULATION DOWN TO METAL DECK. AREA ASSUMED TO HAVE WATER INTRUSION BASED ON ROOF CORE SAMPLING.

2. SHADED AREA (1,345 SF): REMOVE EXISTING OUTER (2ND ROOF) MODIFIED BITUMEN ROOF MEMBRANE AND FIBER PROTECTION BOARD AND INSPECT FOR WATER INTRUSION; CONSULT ARCHITECT WHERE FOUND. AREA ASSUMED TO BE DRY BASED ON ROOF CORE SAMPLING. **1,345 x \$12/SF = \$16,140**

PROVIDE NEW TAPERED POLYISOCYANRATE ROOF INSULATION AND FLEECEBACK TPO ROOF MEMBRANE. MEMBRANE TO MEET VERY SEVERE HAIL (VSH) FM GLOBAL APPROVALS. **10,309 x \$19/SF = \$195,871**

PROVIDE NEW PROTECTION BOARD AND FLEECEBACK TPO ROOF MEMBRANE. MEMBRANE TO MEET VERY SEVERE HAIL (VSH) FM GLOBAL APPROVALS.

PROVIDE NEW TAPERED POLYISOCYANRATE ROOF INSULATION AND FLEECEBACK TPO ROOF MEMBRANE. MEMBRANE TO MEET VERY SEVERE HAIL (VSH) FM GLOBAL APPROVALS. **3,500 x \$19/SF = \$66,500**

PROVIDE NEW TAPERED POLYISOCYANRATE ROOF INSULATION AND FLEECEBACK TPO ROOF MEMBRANE. MEMBRANE TO MEET VERY SEVERE HAIL (VSH) FM GLOBAL APPROVALS. **5,362 x \$19/SF = \$101,878**

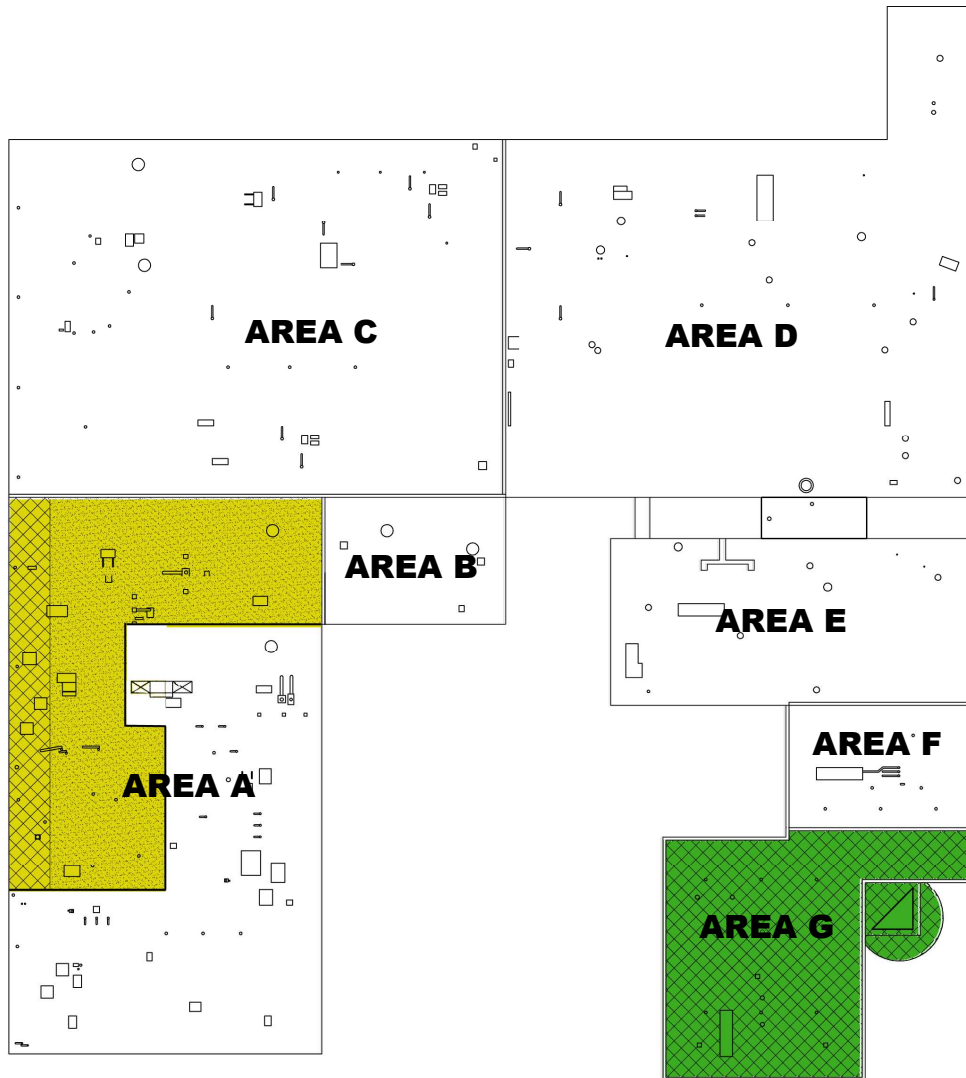
Engineering Research Center (ENRC) Roof Plan
PHASE II
Not To Scale

1. HATCHED AREA (3,836 SF): REMOVE EXISTING OUTER (2ND ROOF) MODIFIED BITUMEN ROOF MEMBRANE AND FIBER PROTECTION BOARD AND INSPECT FOR WATER INTRUSION; WHERE FOUND REMOVE EXISTING INNER (1ST) MODIFIED BITUMEN ROOF AND POLYISOCYANURATE INSULATION DOWN TO METAL DECK. AREA ASSUMED TO HAVE WATER INTRUSION BASED ON ROOF CORE SAMPLING.

2. SHADED AREA (15,513 SF): REMOVE EXISTING OUTER (2ND ROOF) MODIFIED BITUMEN ROOF MEMBRANE AND FIBER PROTECTION BOARD AND INSPECT FOR WATER INTRUSION; CONSULT ARCHITECT WHERE FOUND. AREA ASSUMED TO BE DRY BASED ON ROOF CORE SAMPLING. **14,613 x \$12/SF = \$175,356**

1. HATCHED AREA (13,621 SF): REMOVE EXISTING OUTER (2ND ROOF) MODIFIED BITUMEN ROOF MEMBRANE AND FIBER PROTECTION BOARD AND INSPECT FOR WATER INTRUSION; WHERE FOUND REMOVE EXISTING INNER (1ST) MODIFIED BITUMEN ROOF AND POLYISOCYANURATE INSULATION DOWN TO METAL DECK. AREA ASSUMED TO HAVE WATER INTRUSION BASED ON ROOF CORE SAMPLING.

PROVIDE NEW TAPERED POLYISOCYANRATE ROOF INSULATION AND FLEECEBACK TPO ROOF MEMBRANE. MEMBRANE TO MEET VERY SEVERE HAIL (VSH) FM GLOBAL APPROVALS. **3,836 x \$19/SF = \$72,884**

PROVIDE NEW PROTECTION BOARD AND FLEECEBACK TPO ROOF MEMBRANE. MEMBRANE TO MEET VERY SEVERE HAIL (VSH) FM GLOBAL APPROVALS.

PROVIDE NEW POLYISOCYANRATE ROOF INSULATION AND FLEECEBACK TPO ROOF MEMBRANE. MEMBRANE TO MEET VERY SEVERE HAIL (VSH) FM GLOBAL APPROVALS. **13,621 x \$19/SF = \$258,799**

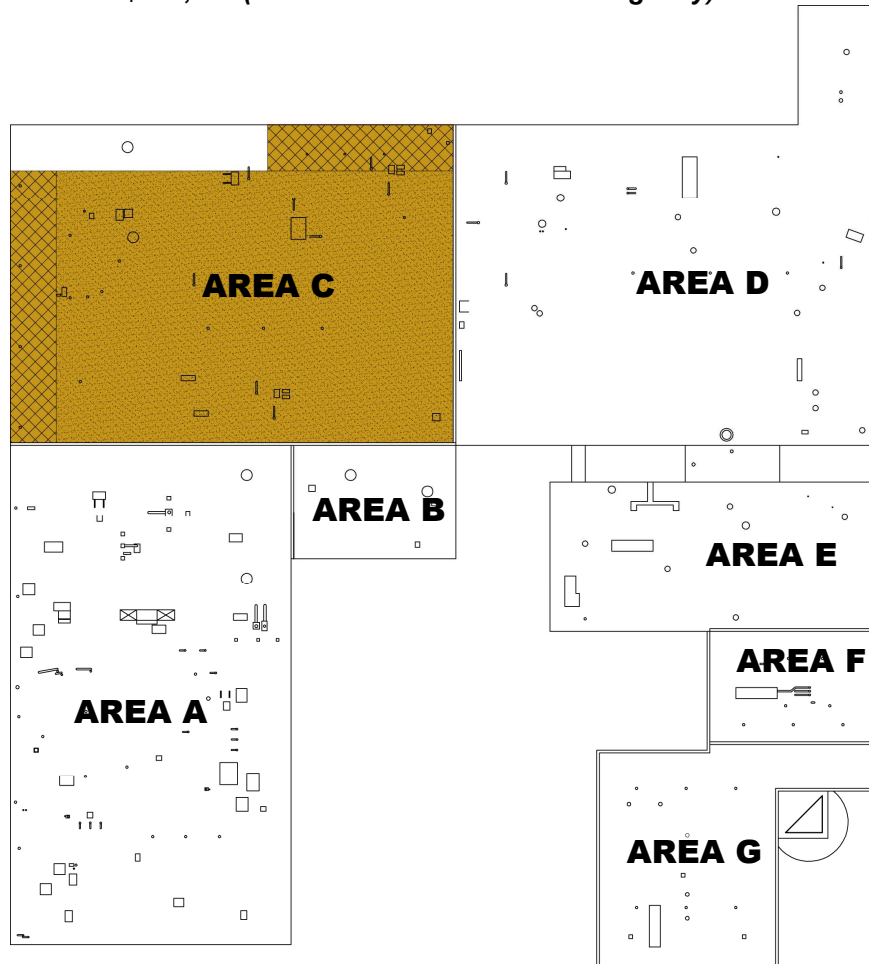
**Engineering Research Center (ENRC) Roof Plan
PHASE III
Not To Scale**

3. HATCHED AREA (6,233 SF): REMOVE EXISTING OUTER (2ND ROOF) MODIFIED BITUMEN ROOF MEMBRANE AND FIBER PROTECTION BOARD AND INSPECT FOR WATER INTRUSION; WHERE FOUND REMOVE EXISTING INNER (1ST) MODIFIED BITUMEN ROOF AND POLYISOCYANURATE INSULATION DOWN TO METAL DECK. AREA ASSUMED TO HAVE WATER INTRUSION BASED ON ROOF CORE SAMPLING.

4. SHADED AREA (32,050 SF): REMOVE EXISTING OUTER (2ND ROOF) MODIFIED BITUMEN ROOF MEMBRANE AND FIBER PROTECTION BOARD AND INSPECT FOR WATER INTRUSION; CONSULT ARCHITECT WHERE FOUND. AREA ASSUMED TO BE DRY BASED ON ROOF CORE SAMPLING. **32,050 x \$12/SF = \$384,600**

PROVIDE NEW TAPERED POLYISOCYANURATE ROOF INSULATION AND FLEECEBACK TPO ROOF MEMBRANE. MEMBRANE TO MEET VERY SEVERE HAIL (VSH) FM GLOBAL APPROVALS. **6,233 x \$19/SF = \$118,427**

PROVIDE NEW PROTECTION BOARD AND FLEECEBACK TPO ROOF MEMBRANE. MEMBRANE TO MEET VERY SEVERE HAIL (VSH) FM GLOBAL APPROVALS.

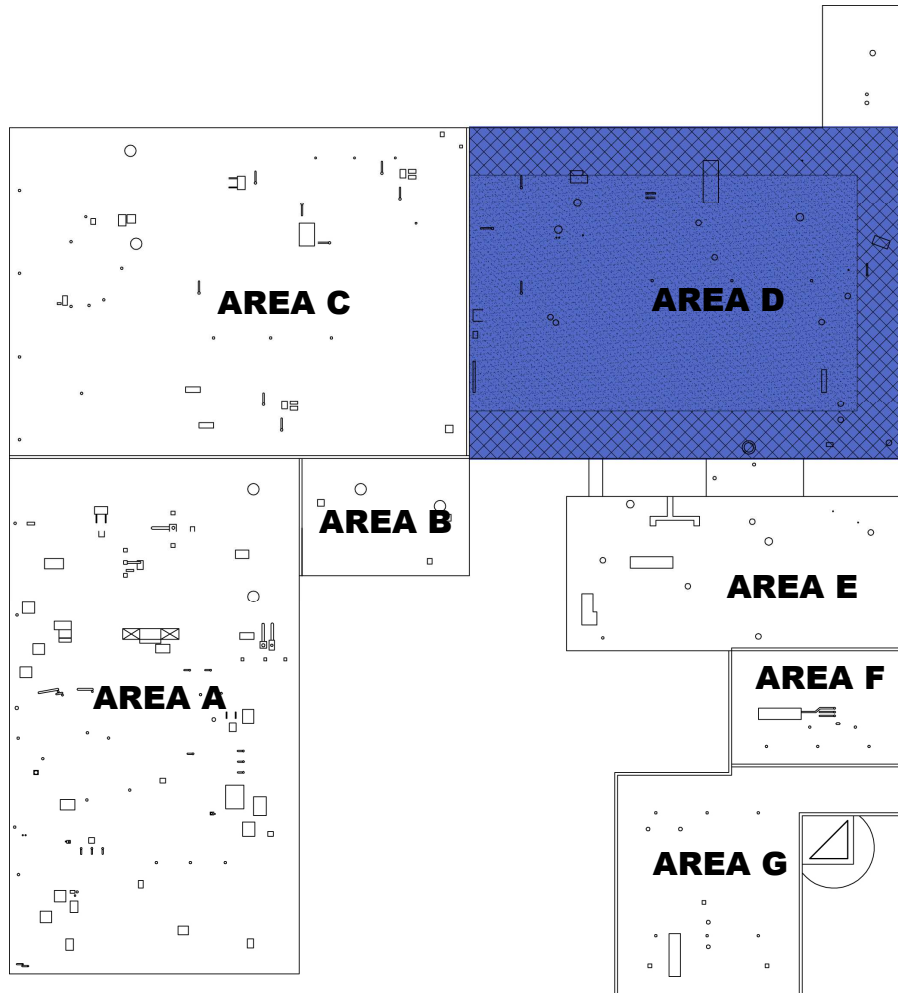
5. HATCHED AREA (14,591 SF): REMOVE EXISTING OUTER (2ND ROOF) MODIFIED BITUMEN ROOF MEMBRANE AND FIBER PROTECTION BOARD AND INSPECT FOR WATER INTRUSION; WHERE FOUND REMOVE EXISTING INNER (1ST) MODIFIED BITUMEN ROOF AND POLYISOCYANURATE INSULATION DOWN TO METAL DECK. AREA ASSUMED TO HAVE WATER INTRUSION BASED ON ROOF CORE SAMPLING.

6. SHADED AREA (25,541 SF): REMOVE EXISTING OUTER (2ND ROOF) MODIFIED BITUMEN ROOF MEMBRANE AND FIBER PROTECTION BOARD AND INSPECT FOR WATER INTRUSION; CONSULT ARCHITECT WHERE FOUND. AREA ASSUMED TO BE DRY BASED ON ROOF CORE SAMPLING. **25,541 x \$12/SF = \$306,492**

PROVIDE NEW TAPERED POLYISOCYANURATE ROOF INSULATION AND FLEECEBACK TPO ROOF MEMBRANE. MEMBRANE TO MEET VERY SEVERE HAIL (VSH) FM GLOBAL APPROVALS. **14,591 x \$19/SF = \$277,229**

PROVIDE NEW PROTECTION BOARD AND FLEECEBACK TPO ROOF MEMBRANE. MEMBRANE TO MEET VERY SEVERE HAIL (VSH) FM GLOBAL APPROVALS.

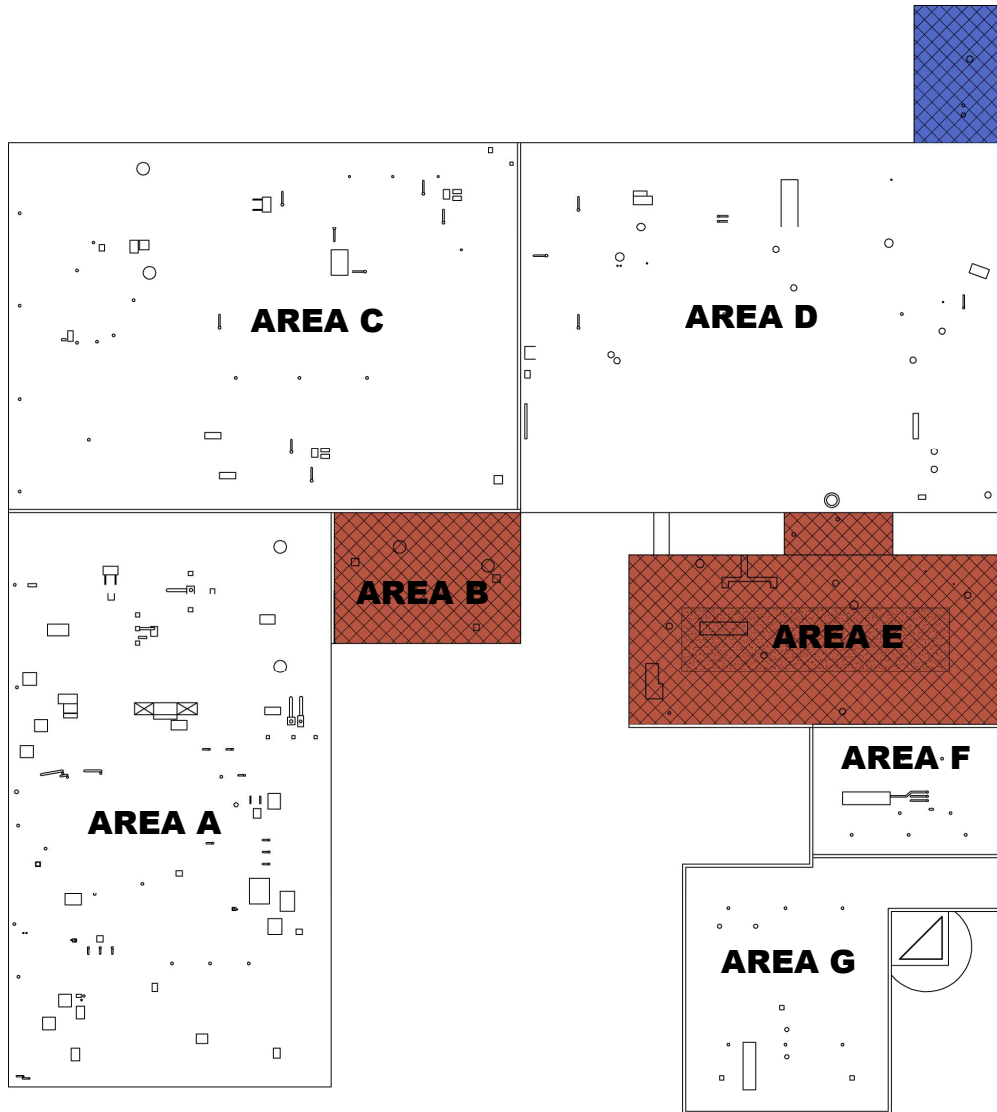
Engineering Research Center (ENRC) Roof Plan
PHASE V
Not To Scale

1. HATCHED AREA (5,436 SF): REMOVE EXISTING OUTER (2ND ROOF) MODIFIED BITUMEN ROOF MEMBRANE AND FIBER PROTECTION BOARD AND INSPECT FOR WATER INTRUSION; WHERE FOUND REMOVE EXISTING INNER (1ST) MODIFIED BITUMEN ROOF AND POLYISOCYANURATE INSULATION DOWN TO METAL DECK. AREA ASSUMED TO HAVE WATER INTRUSION BASED ON ROOF CORE SAMPLING.

2. HATCHED AREA (2,797 SF): REMOVE EXISTING OUTER (2ND ROOF) MODIFIED BITUMEN ROOF MEMBRANE AND FIBER PROTECTION BOARD AND INSPECT FOR WATER INTRUSION; WHERE FOUND REMOVE EXISTING INNER (1ST) MODIFIED BITUMEN ROOF AND POLYISOCYANURATE INSULATION DOWN TO METAL DECK. AREA ASSUMED TO HAVE WATER INTRUSION BASED ON ROOF CORE SAMPLING.

1. HATCHED AREA (15,198 SF): REMOVE EXISTING OUTER (2ND ROOF) MODIFIED BITUMEN ROOF MEMBRANE AND FIBER PROTECTION BOARD AND INSPECT FOR WATER INTRUSION; WHERE FOUND REMOVE EXISTING INNER (1ST) MODIFIED BITUMEN ROOF AND POLYISOCYANURATE INSULATION DOWN TO METAL DECK. AREA ASSUMED TO HAVE WATER INTRUSION BASED ON ROOF CORE SAMPLING.

2. SHADED AREA (3,830 SF): REMOVE EXISTING OUTER (2ND ROOF) MODIFIED BITUMEN ROOF MEMBRANE AND FIBER PROTECTION BOARD AND INSPECT FOR WATER INTRUSION; CONSULT ARCHITECT WHERE FOUND. AREA ASSUMED TO BE DRY BASED ON ROOF CORE SAMPLING.

PROVIDE NEW POLYISOCYANURATE ROOF INSULATION AND FLEECEBACK TPO ROOF MEMBRANE. MEMBRANE TO MEET VERY SEVERE HAIL (VSH) FM GLOBAL APPROVALS. **5,436 x \$19/SF = \$103,284**

PROVIDE NEW TAPERED POLYISOCYANURATE ROOF INSULATION AND FLEECEBACK TPO ROOF MEMBRANE. MEMBRANE TO MEET VERY SEVERE HAIL (VSH) FM GLOBAL APPROVALS. **2,797 x \$19/SF = \$53,143**

PROVIDE NEW POLYISOCYANURATE ROOF INSULATION AND FLEECEBACK TPO ROOF MEMBRANE. MEMBRANE TO MEET VERY SEVERE HAIL (VSH) FM GLOBAL APPROVALS. **15,198 x \$19/SF = \$288,762**

PROVIDE NEW POLYISOCYANURATE ROOF INSULATION AND FLEECEBACK TPO ROOF MEMBRANE. MEMBRANE TO MEET VERY SEVERE HAIL (VSH) FM GLOBAL APPROVALS. **3,830 x \$12/SF = \$45,960**

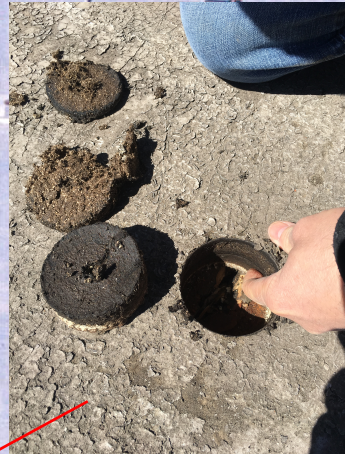
AREA A
SOUTH END AERIAL IMAGERY

● DRY
(COVER BOARD
CRUMBLED BUT NOT
WET PRESENTLY)

● WET
(WET BELOW TOP
MEMBRANE, DRY BELOW
1ST ROOF LAYER)

● WET
(WET BELOW TOP
MEMBRANE, WET BELOW
1ST ROOF LAYER)

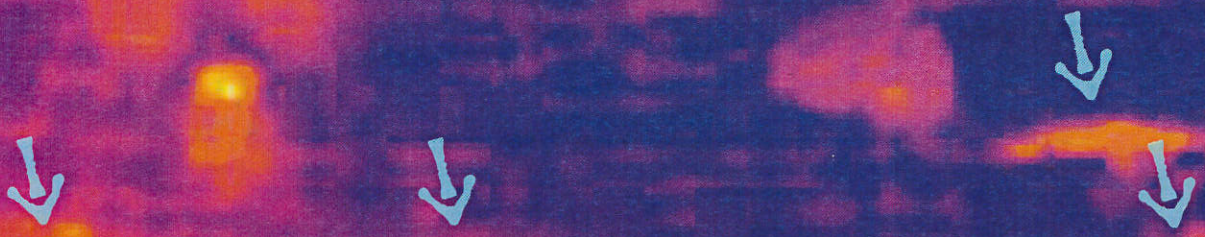
AREA A
SOUTH END THERMAL IMAGERY

ARROWS SHOW POTENTIAL
WET LOCATIONS

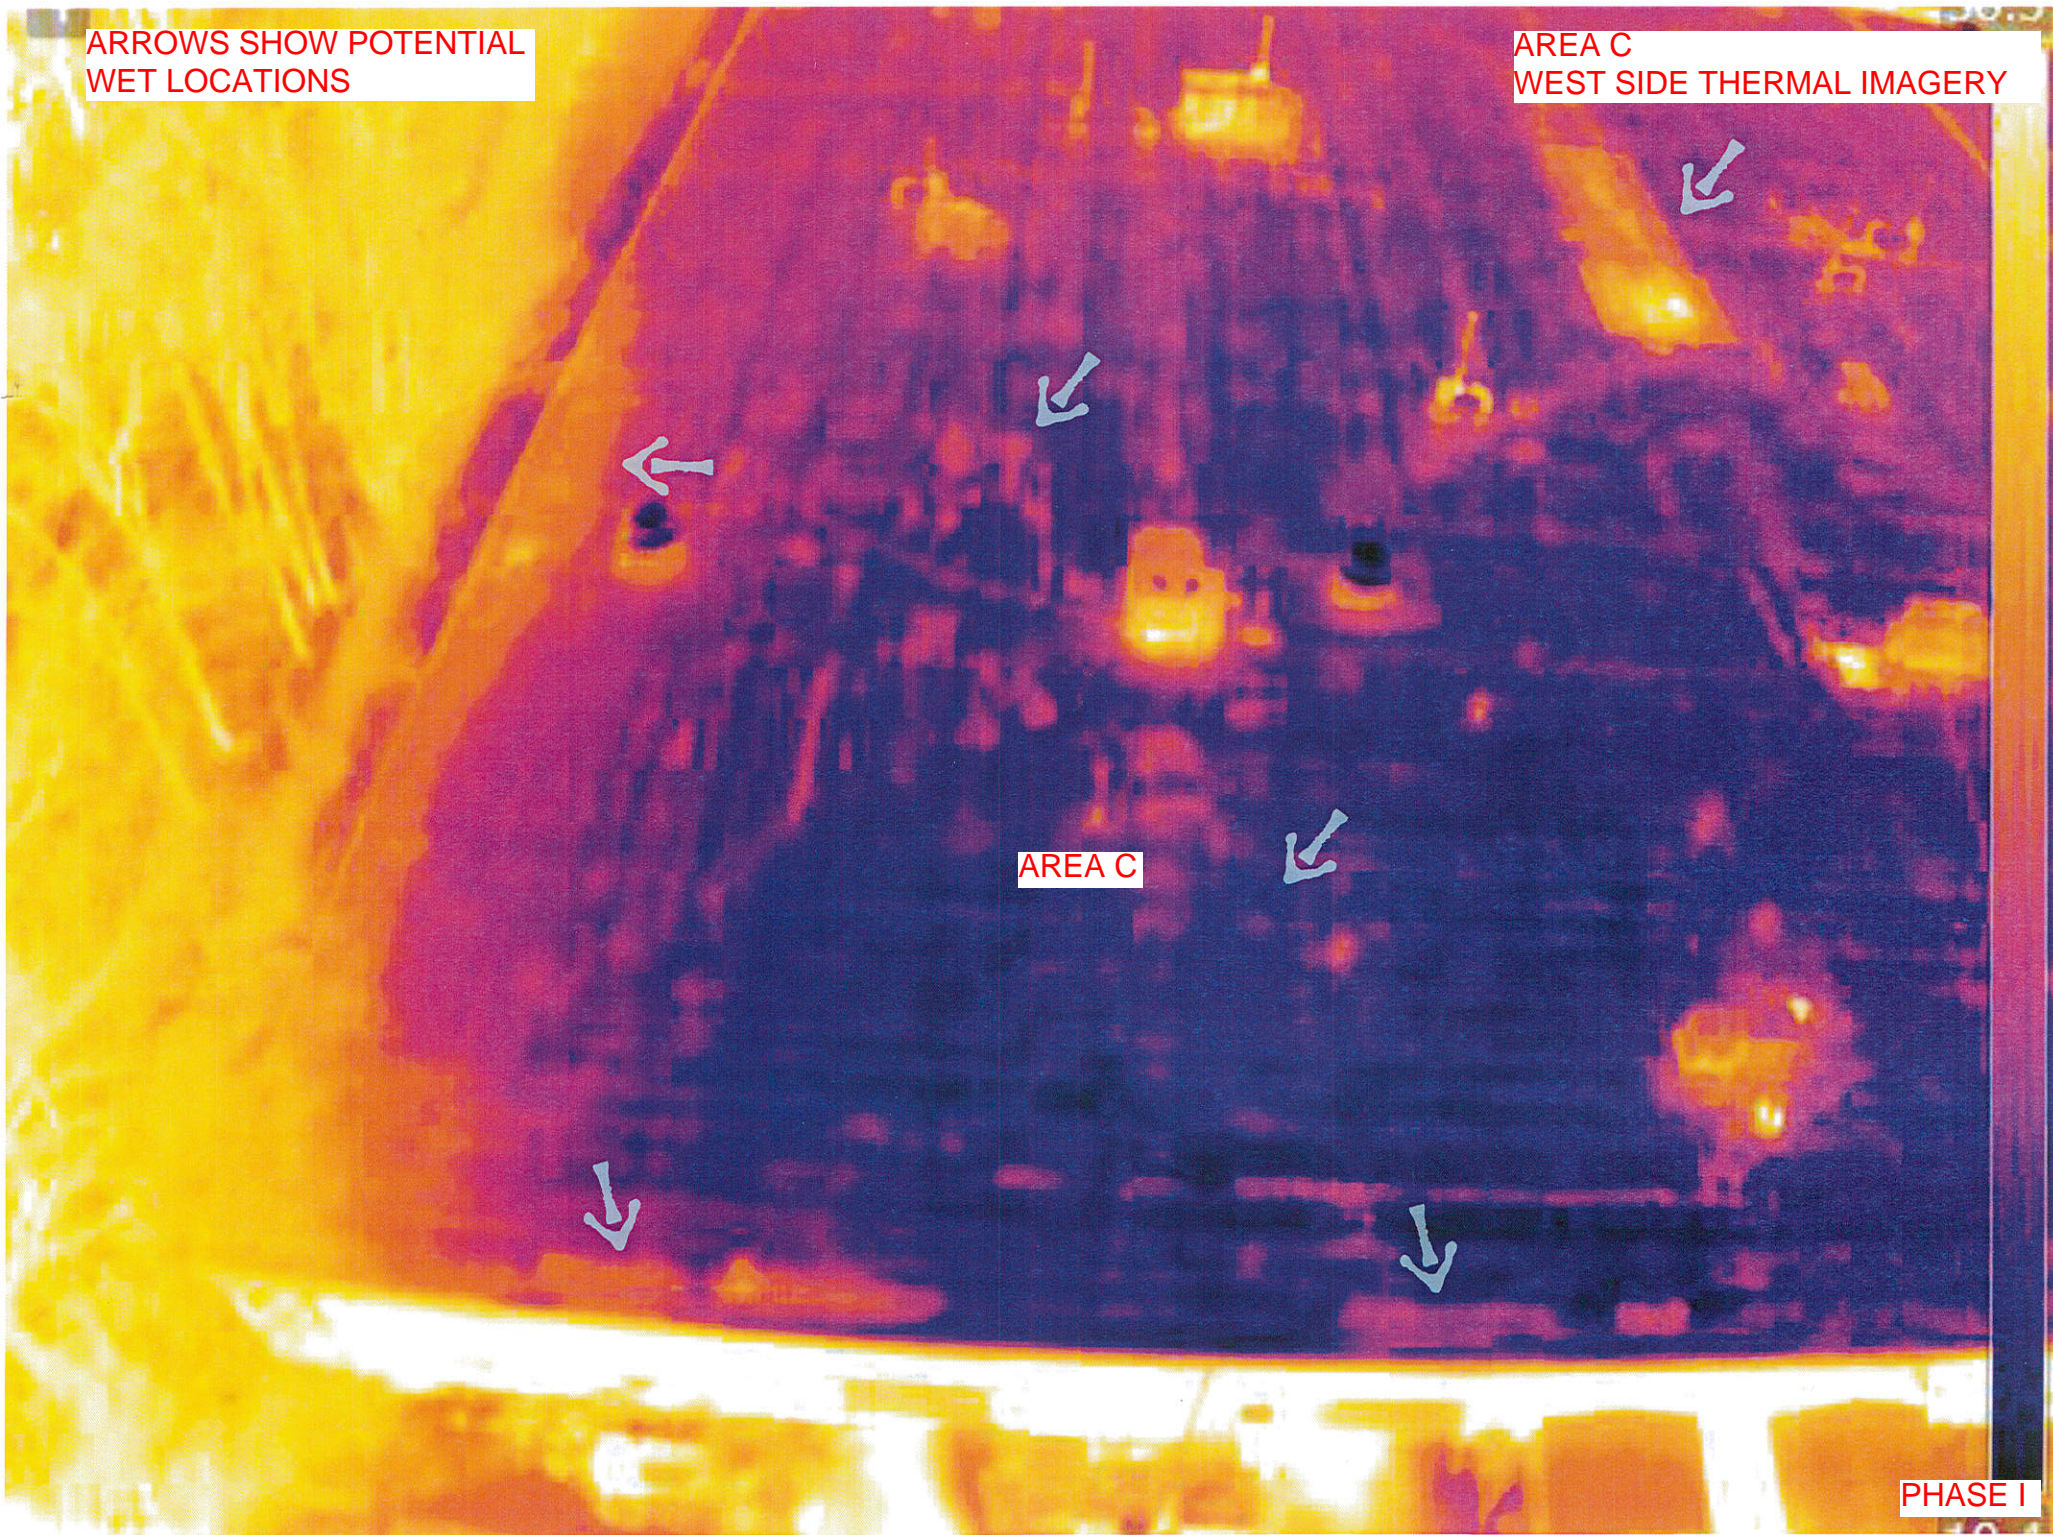
AREA C
WEST SIDE THERMAL IMAGERY

WET
(WET BELOW TOP MEMBRANE, DRY BELOW 1ST ROOF LAYER)

ARROWS SHOW POTENTIAL
WET LOCATIONS

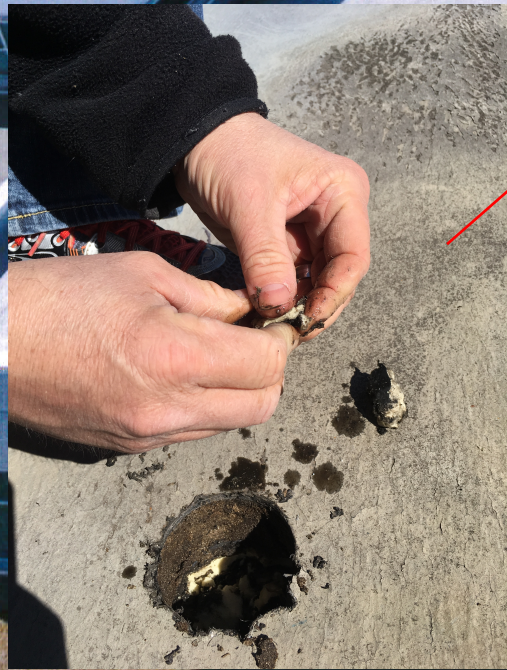
AREA F
WEST END AERIAL IMAGERY

(WET BELOW TOP
MEMBRANE, WET BELOW
1ST ROOF LAYER)

WET

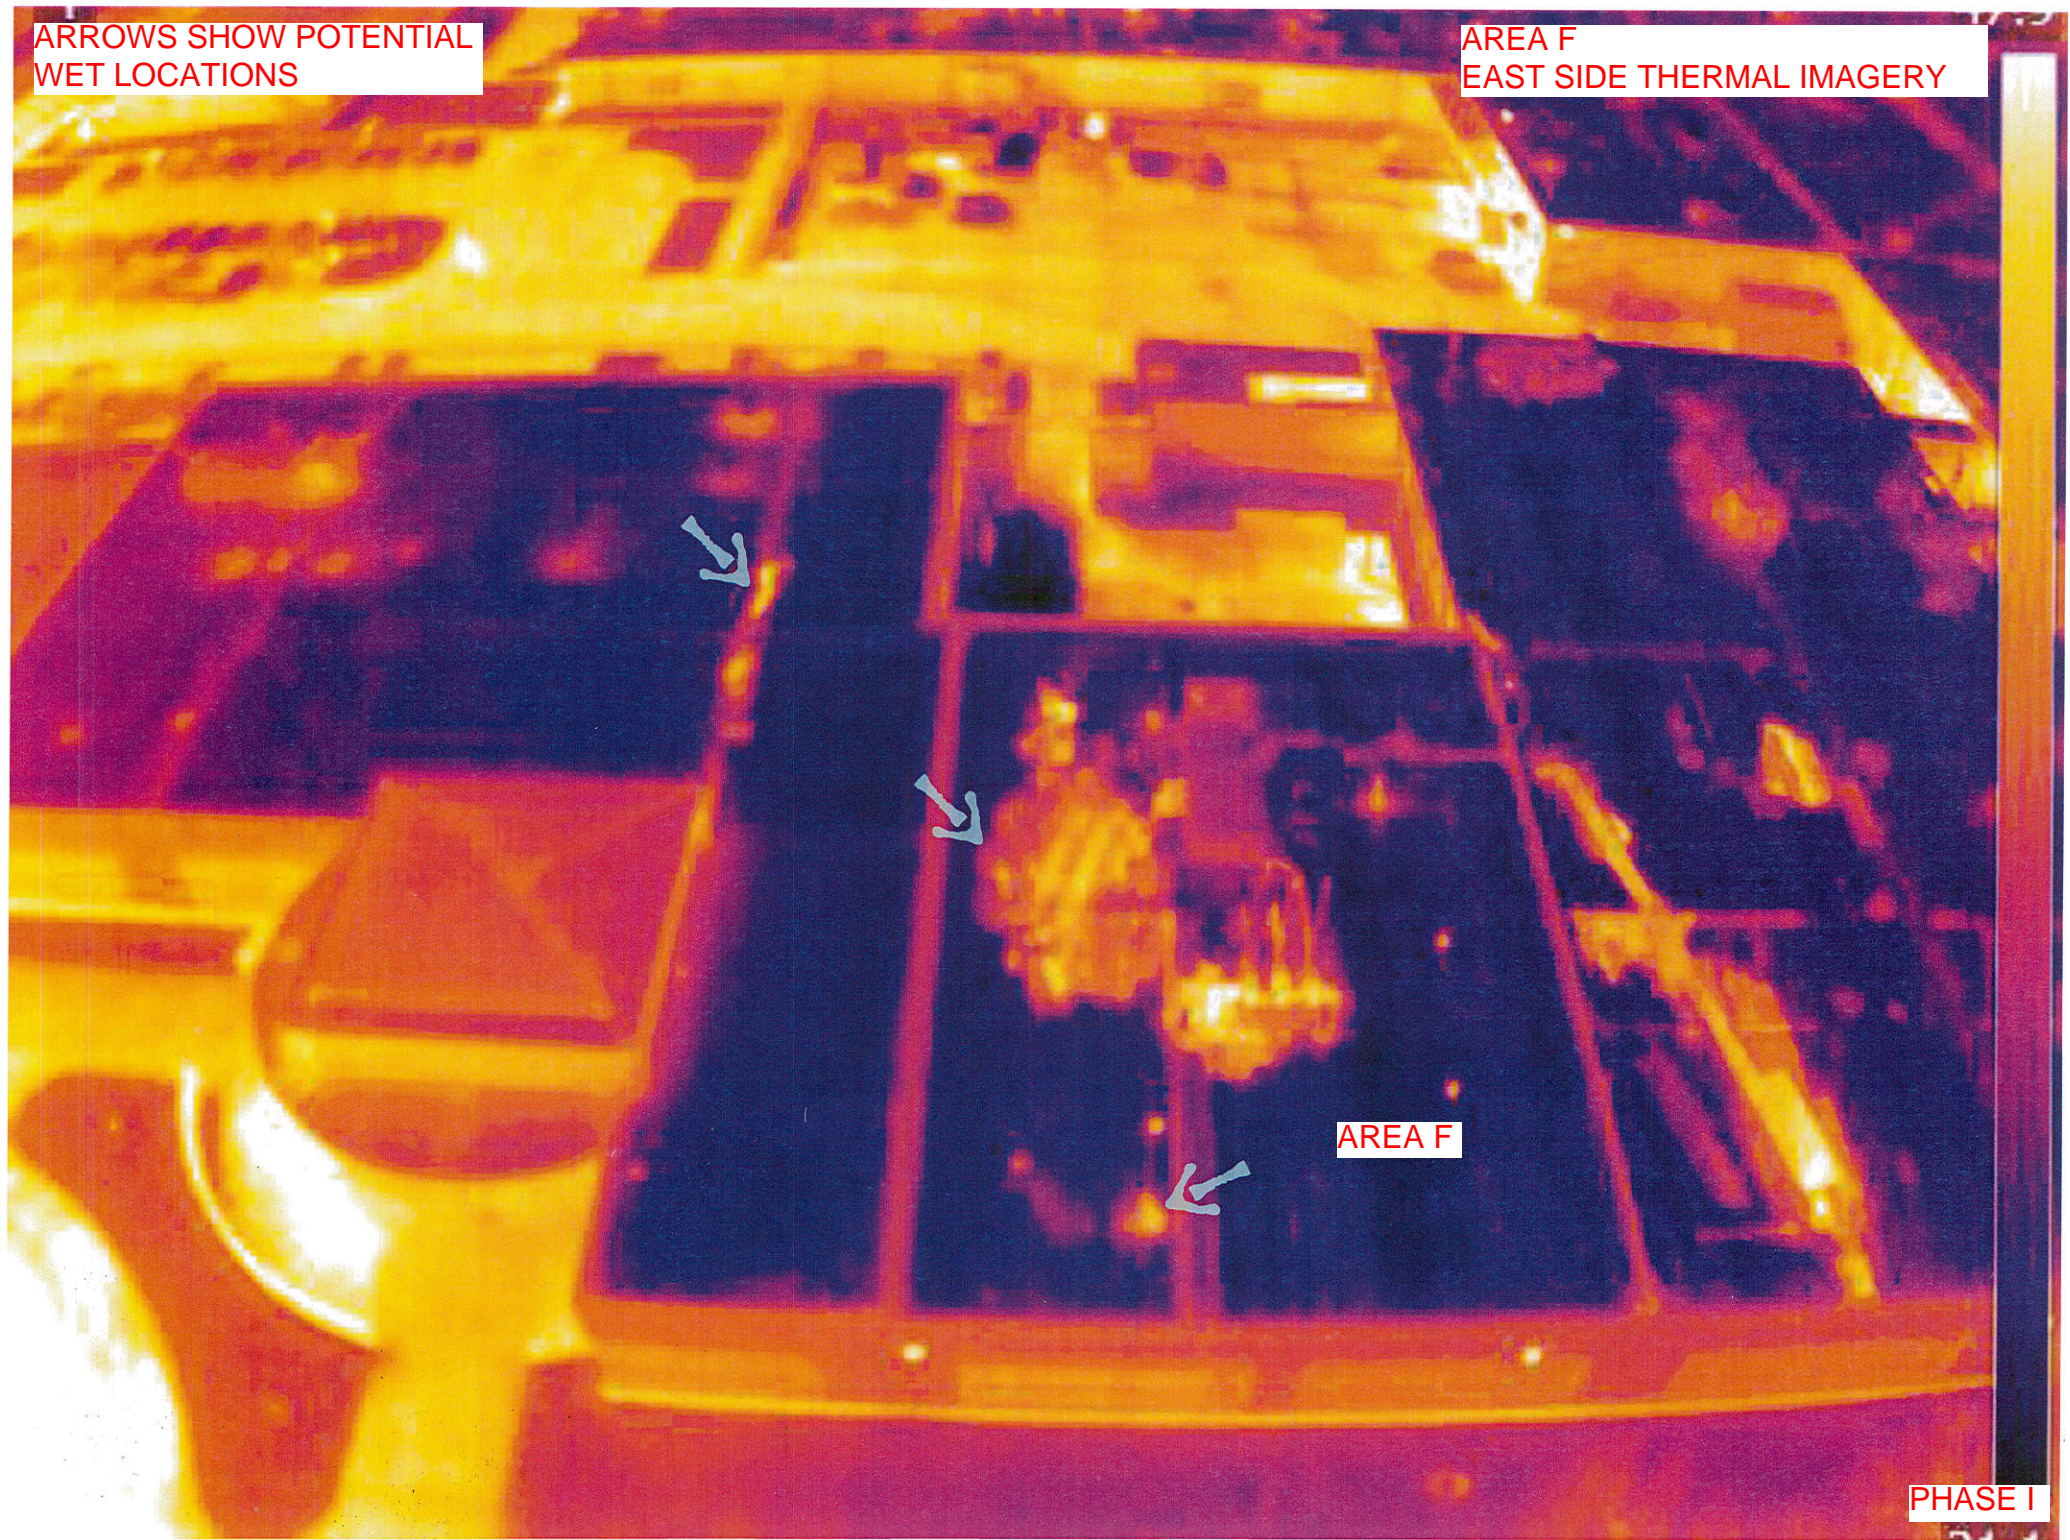
AREA F
EAST SIDE THERMAL IMAGERY

ARROWS SHOW POTENTIAL
WET LOCATIONS

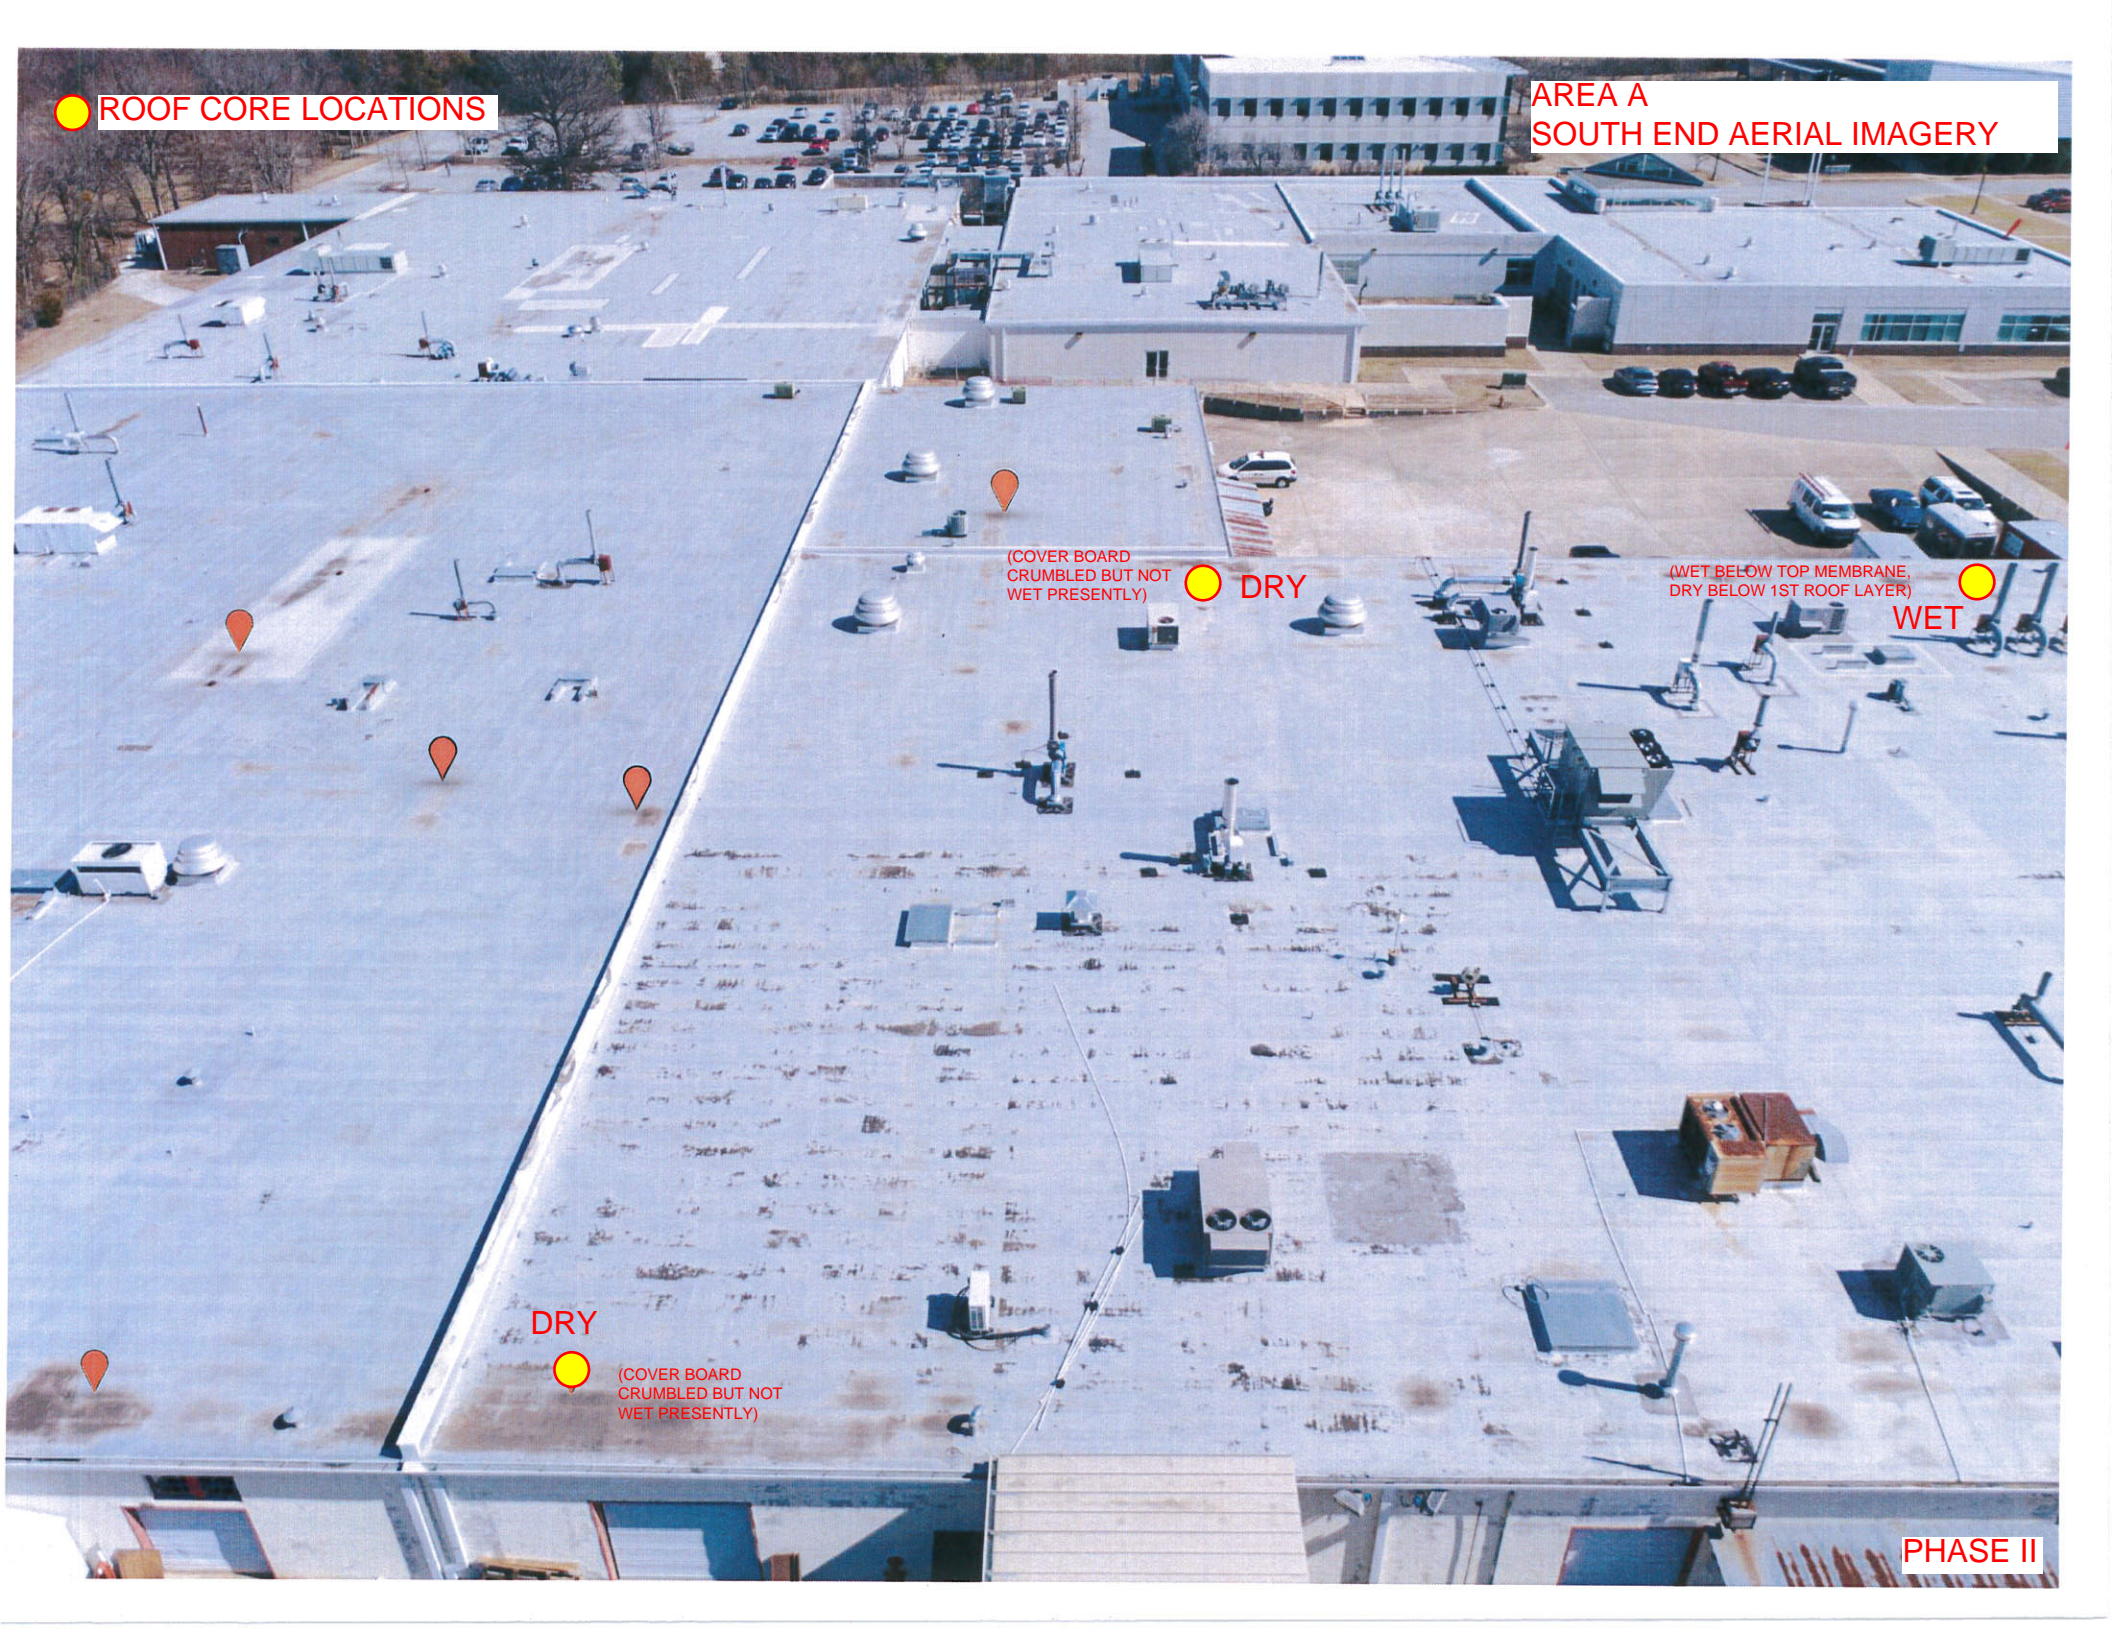
AREA A
SOUTH END AERIAL IMAGERY

(COVER BOARD
CRUMBLD BUT NOT
WET PRESENTLY)

● DRY

(WET BELOW TOP MEMBRANE,
DRY BELOW 1ST ROOF LAYER)

● WET
