UNIVERSITY OF
ARKANSAS

Engineering Research Center (ENRC)

Roof Replacement Plan

UNIVERSITY OF ARKANSAS ENGINEERING RESEARCH CENTER (ENRC) ROOF REPLACEMENT PLAN

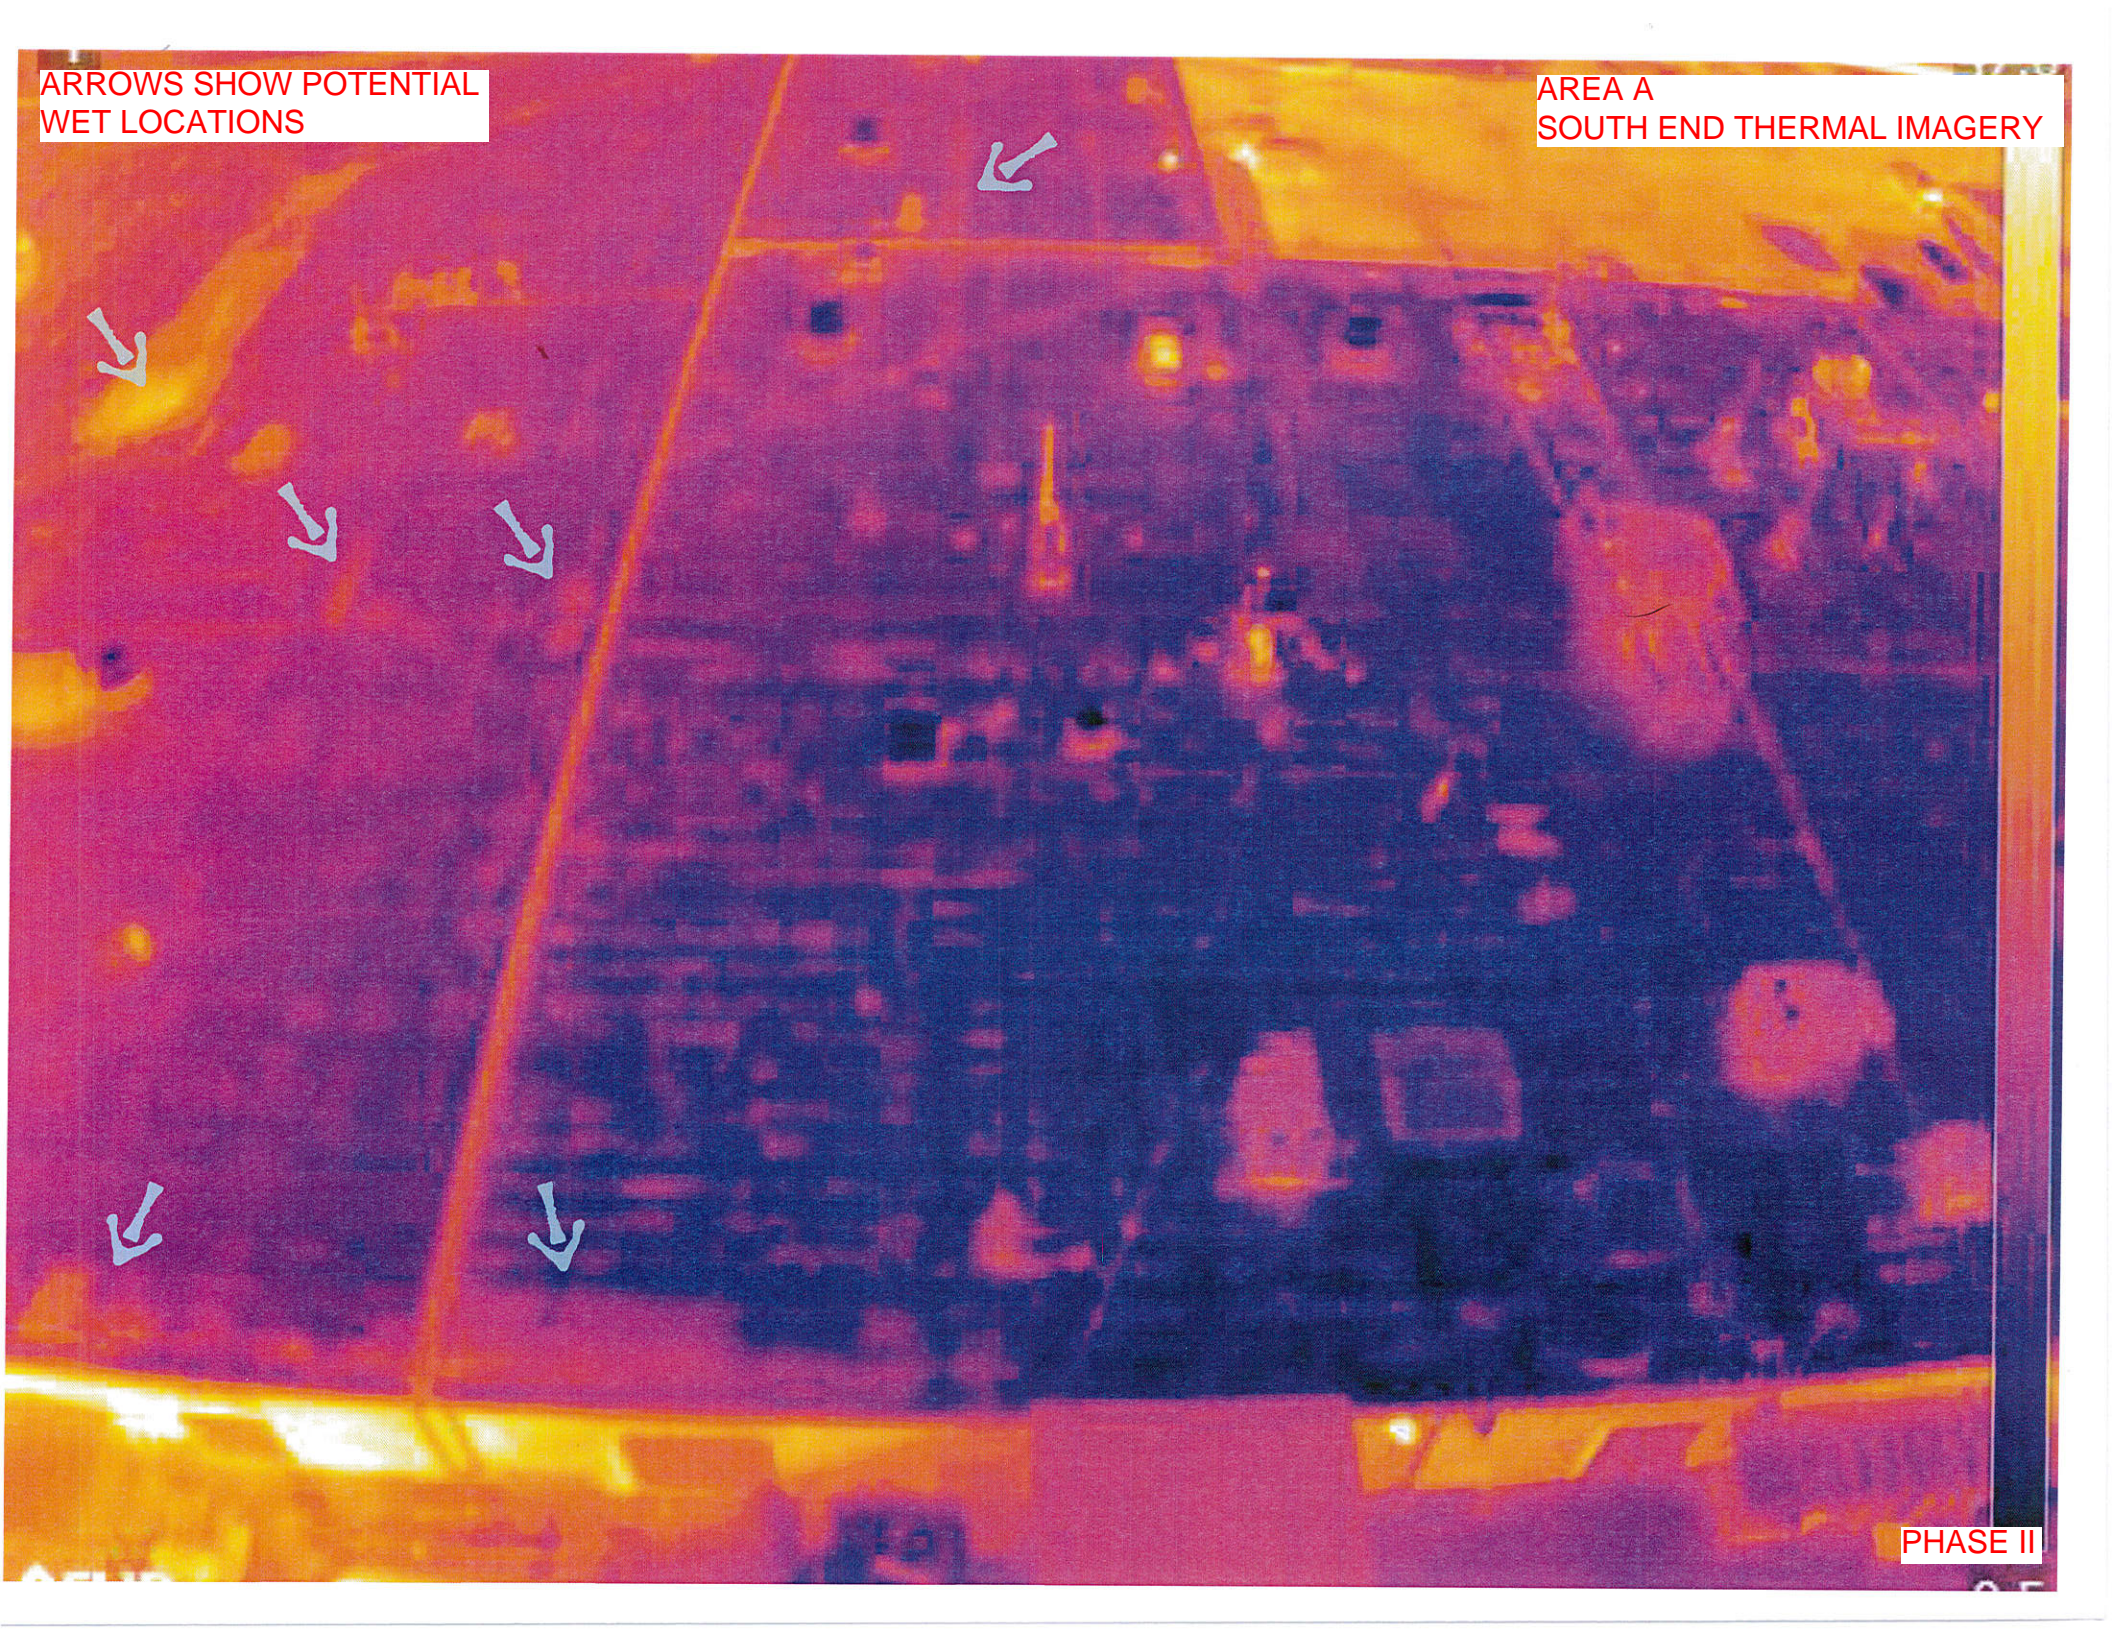
AREA A
SOUTH END THERMAL IMAGERY

ARROWS SHOW POTENTIAL
WET LOCATIONS

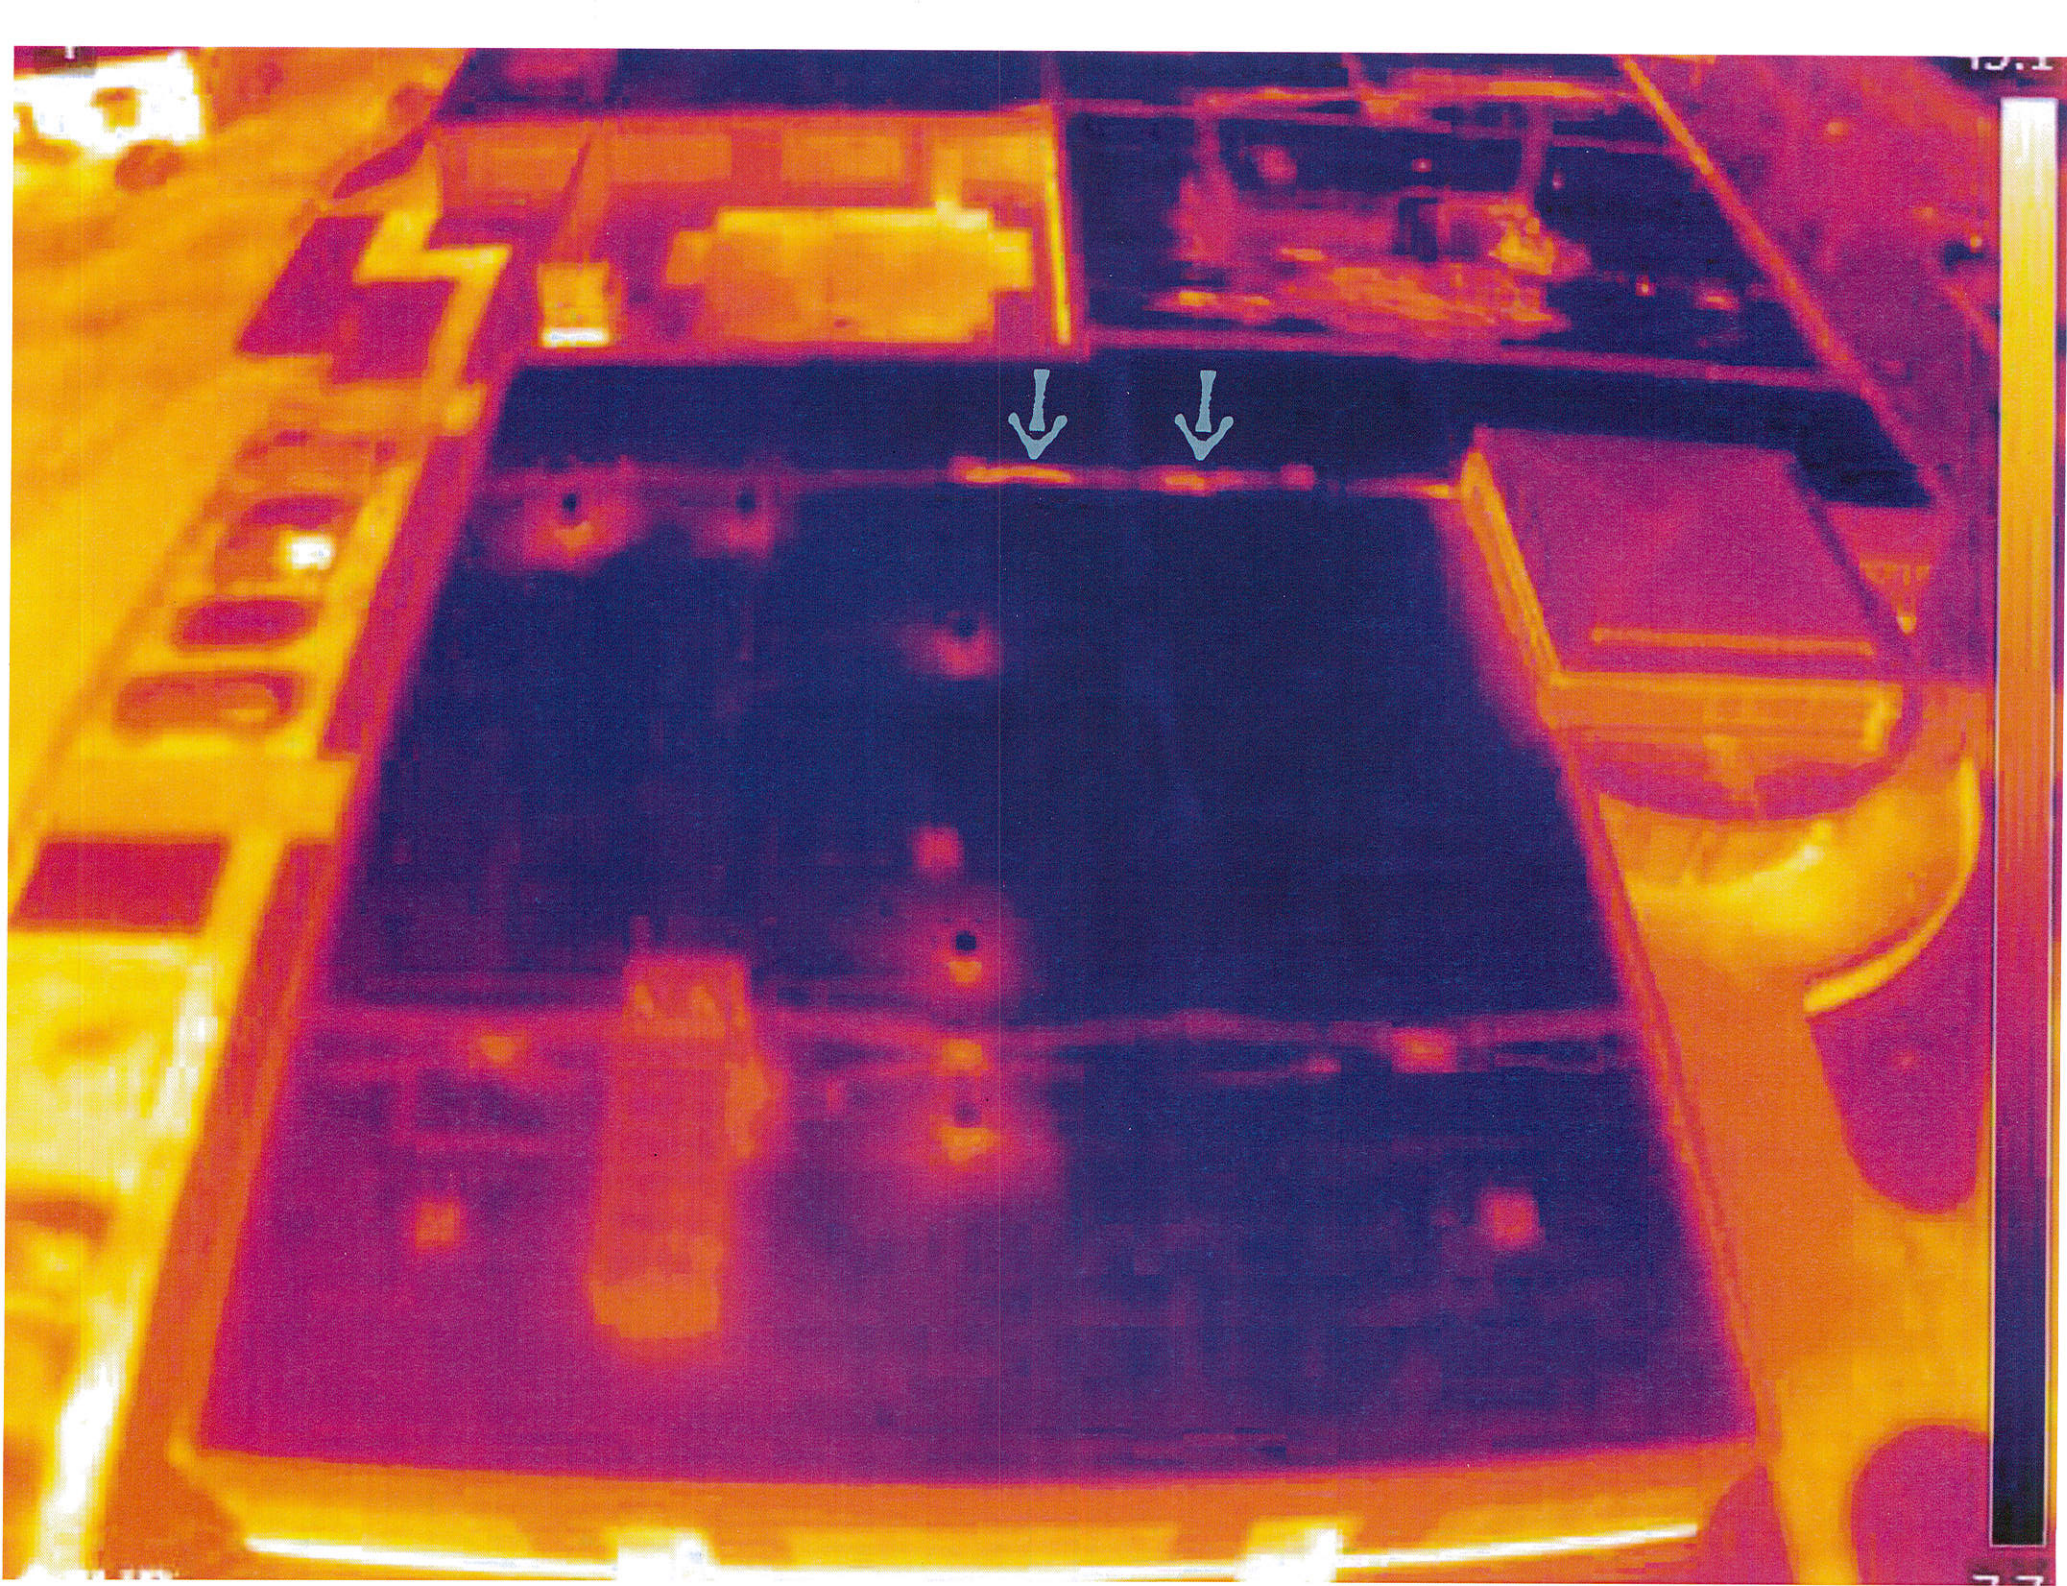
AREA G
SOUTH END AERIAL IMAGERY

AREA OF
SUSPECTED WATER
INFILTRATION

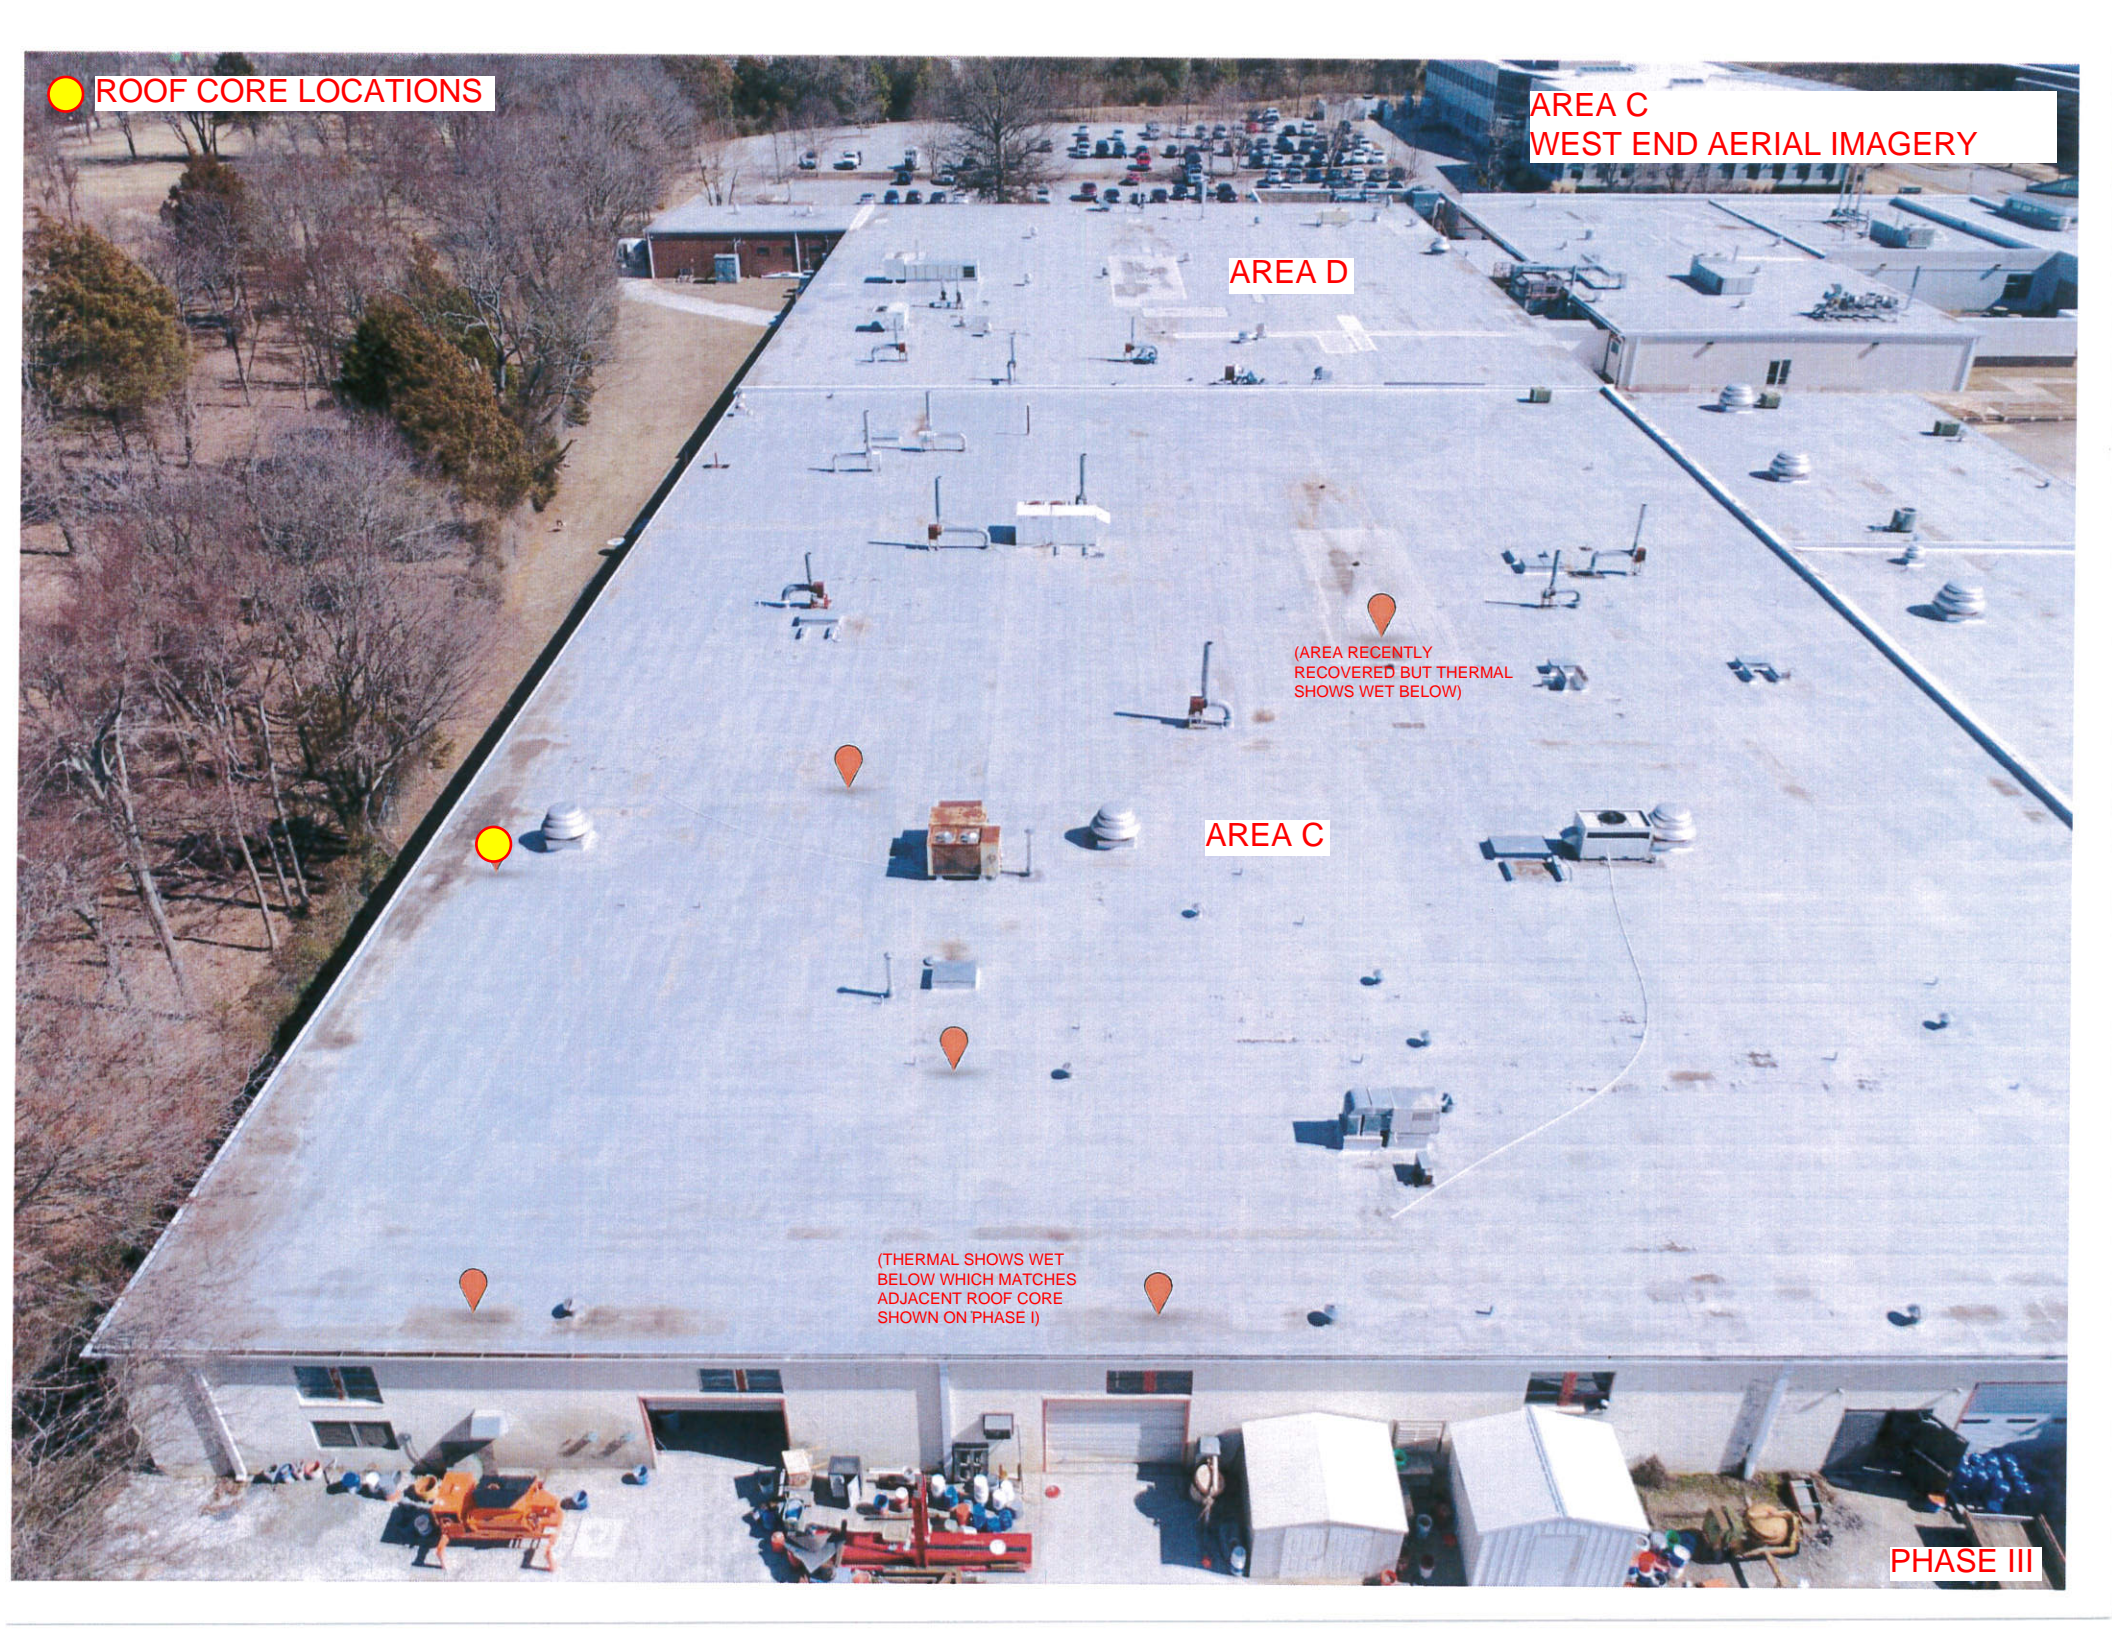
AREA C
WEST END AERIAL IMAGERY

(AREA RECENTLY
RECOVERED BUT THERMAL
SHOWS WET BELOW)

(THERMAL SHOWS WET
BELOW WHICH MATCHES
ADJACENT ROOF CORE
SHOWN ON PHASE I)

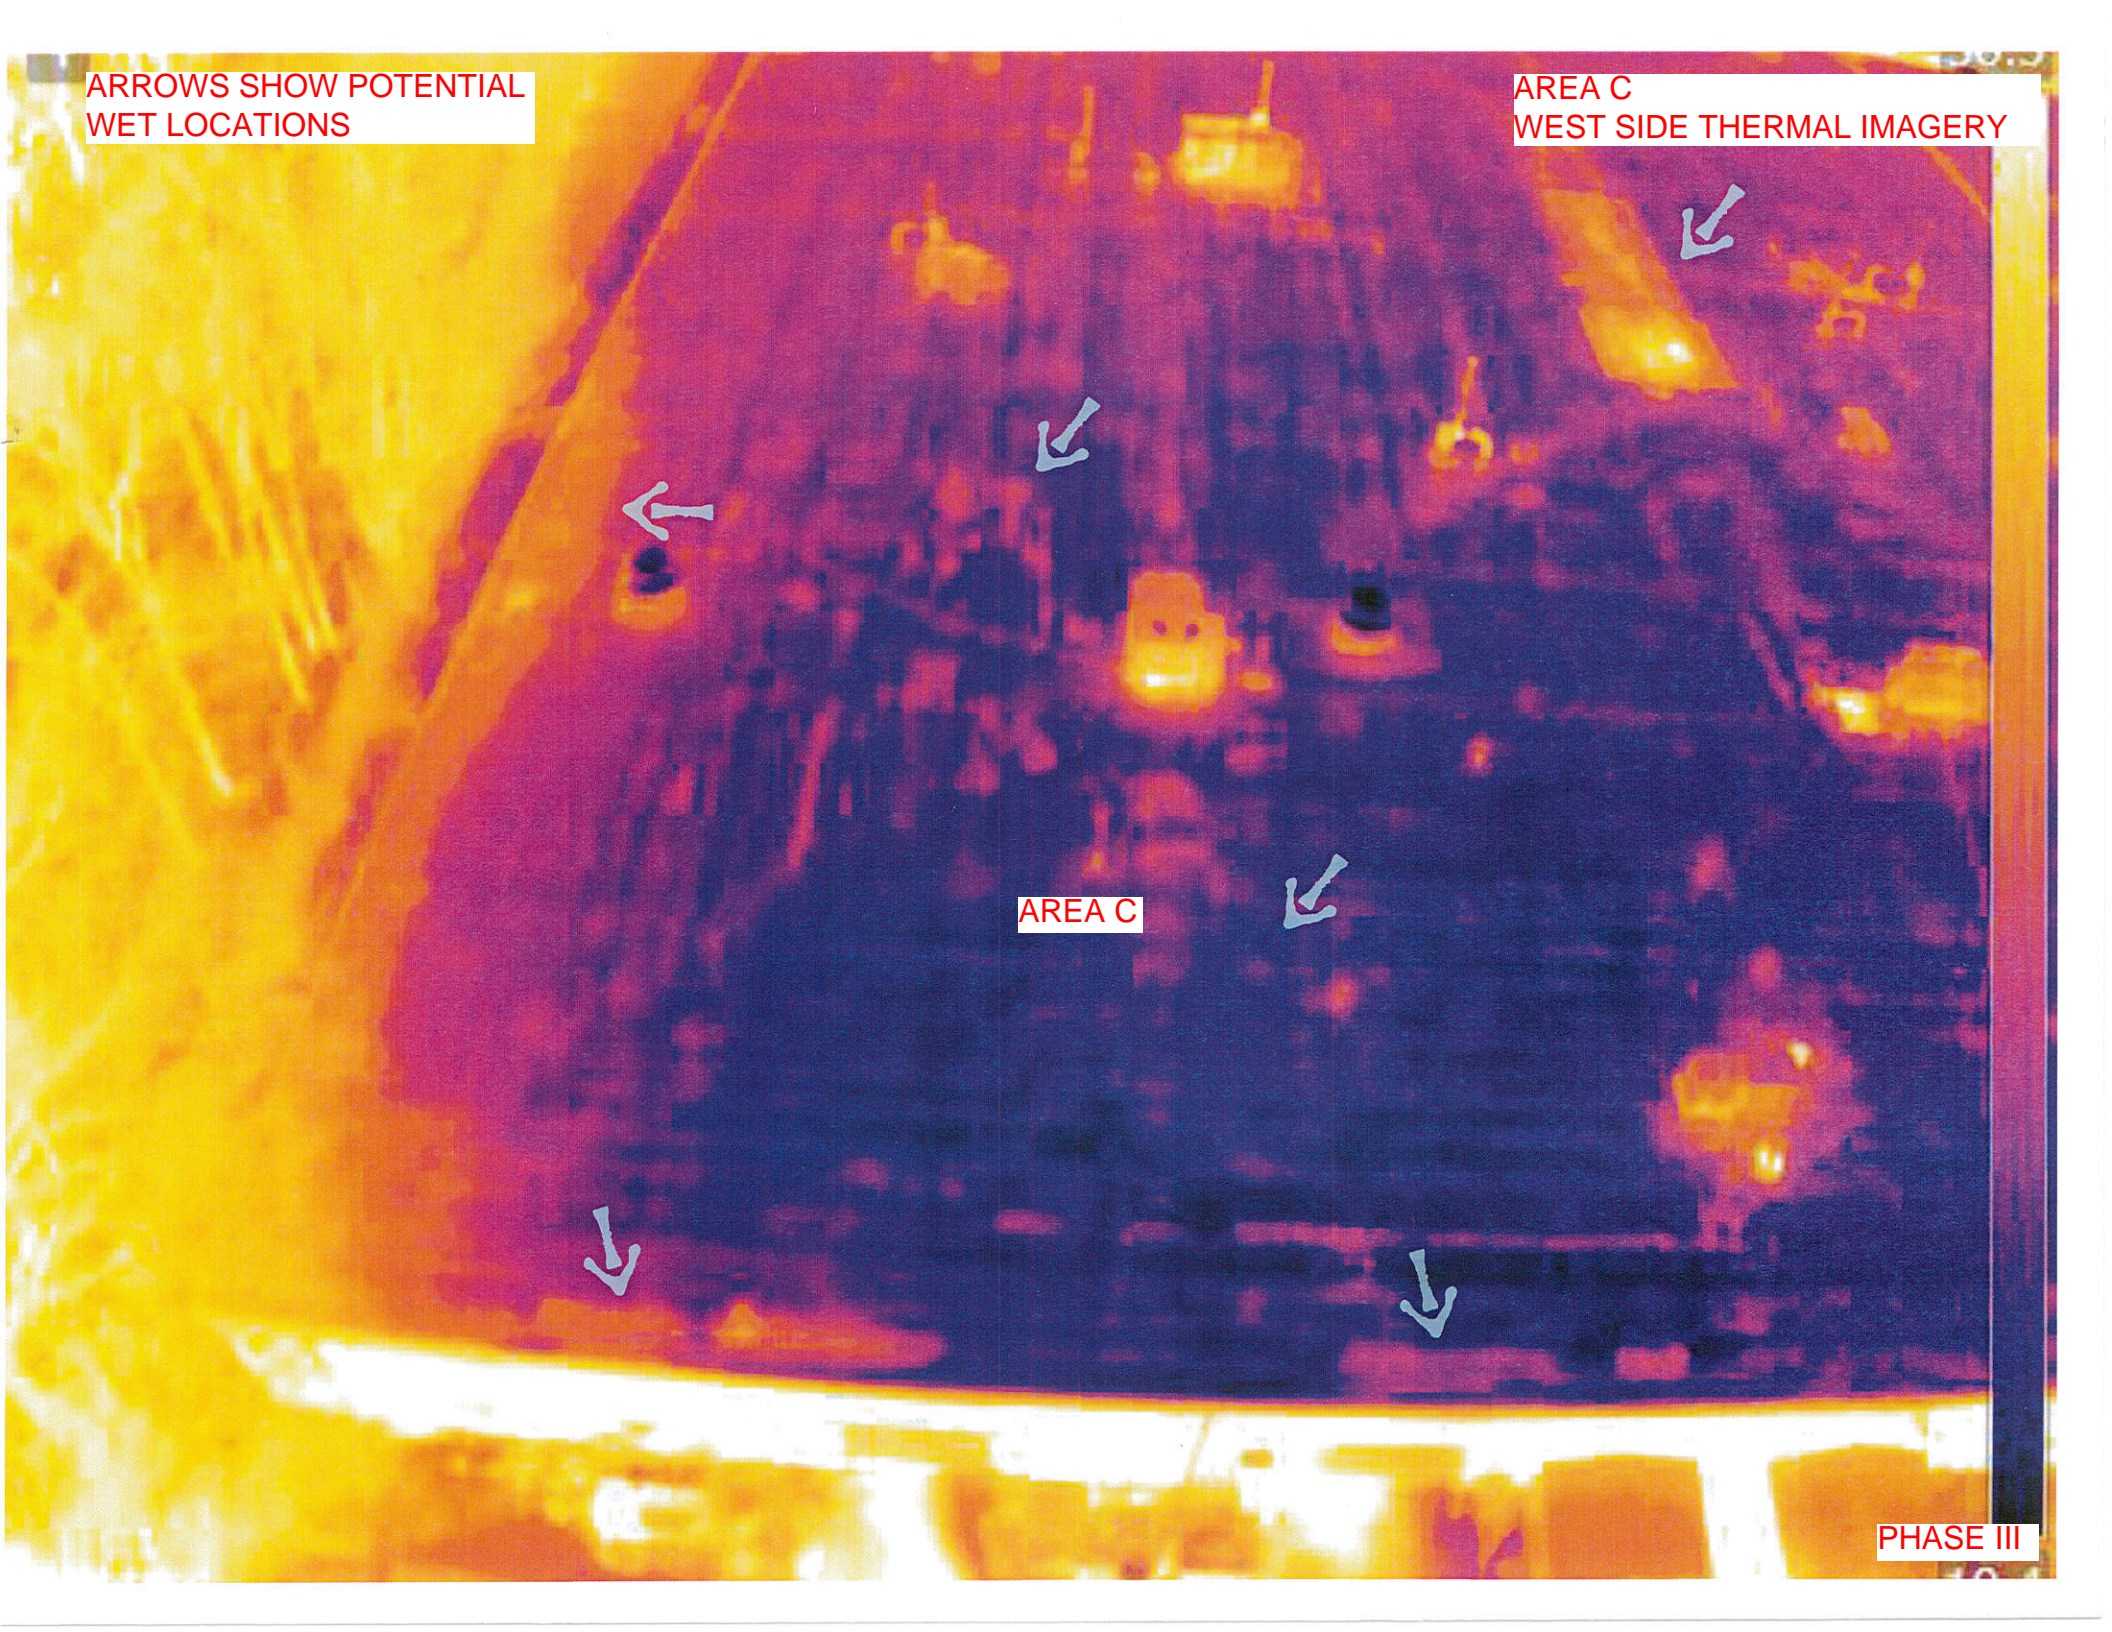
AREA C
WEST SIDE THERMAL IMAGERY

ARROWS SHOW POTENTIAL
WET LOCATIONS

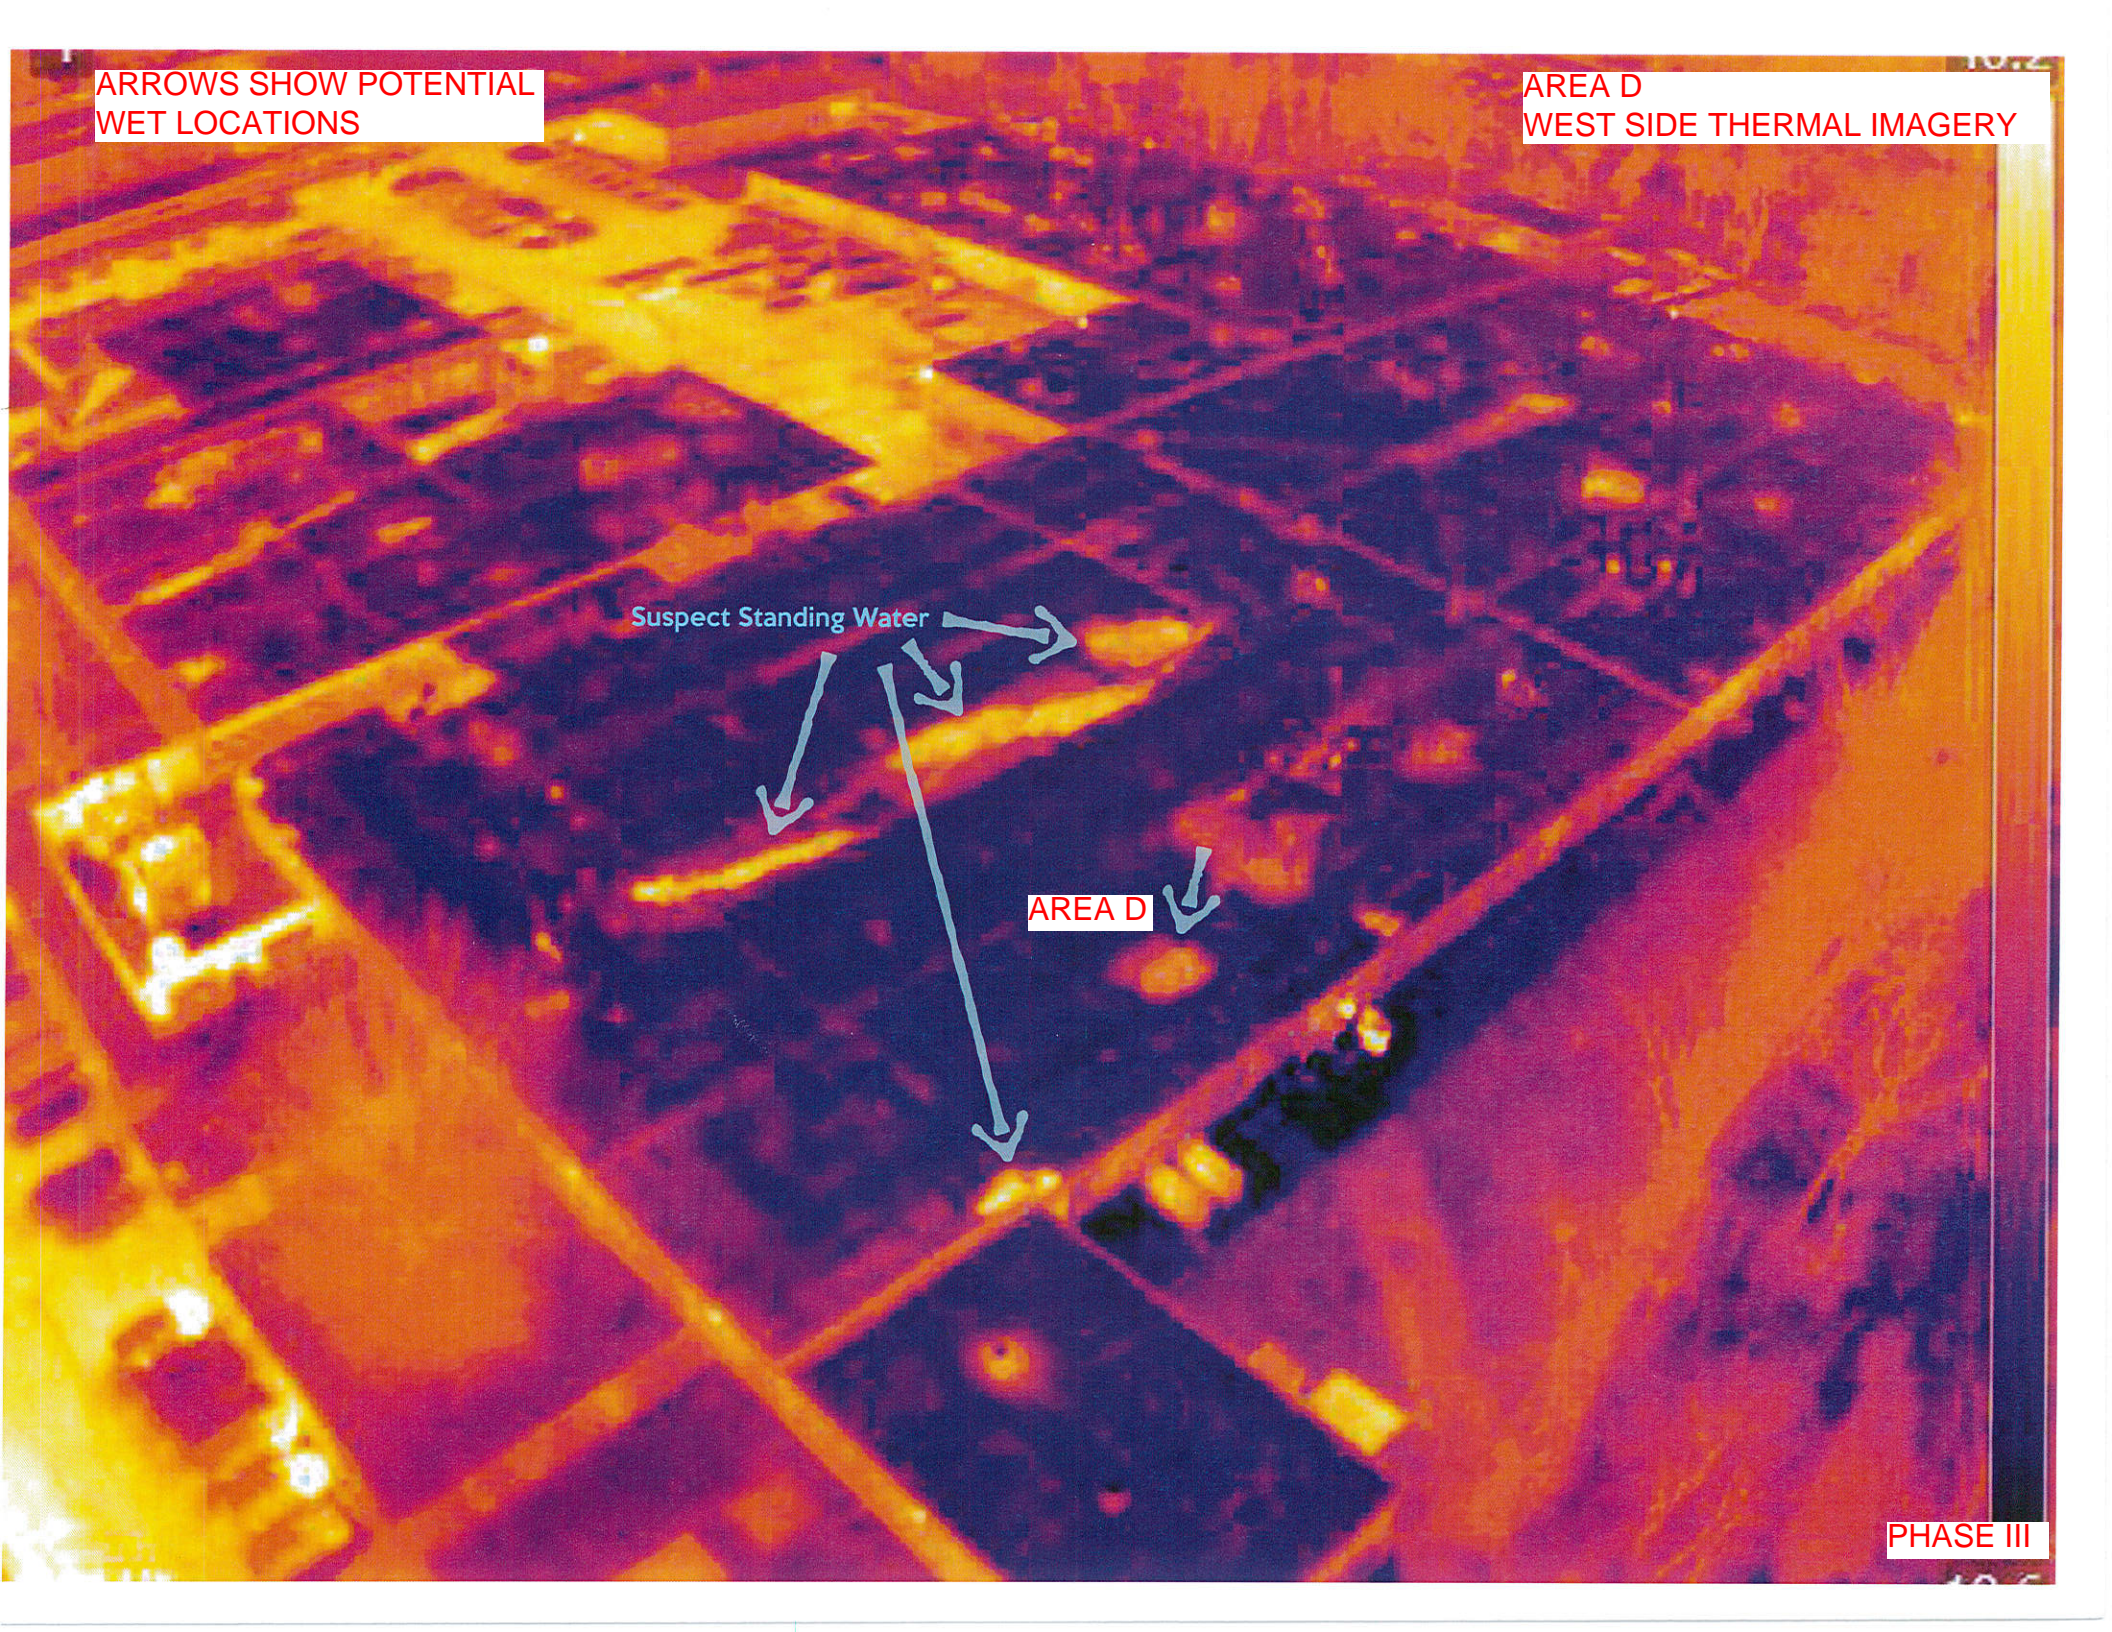
AREA D
WEST SIDE THERMAL IMAGERY

ARROWS SHOW POTENTIAL
WET LOCATIONS

Suspect Standing Water

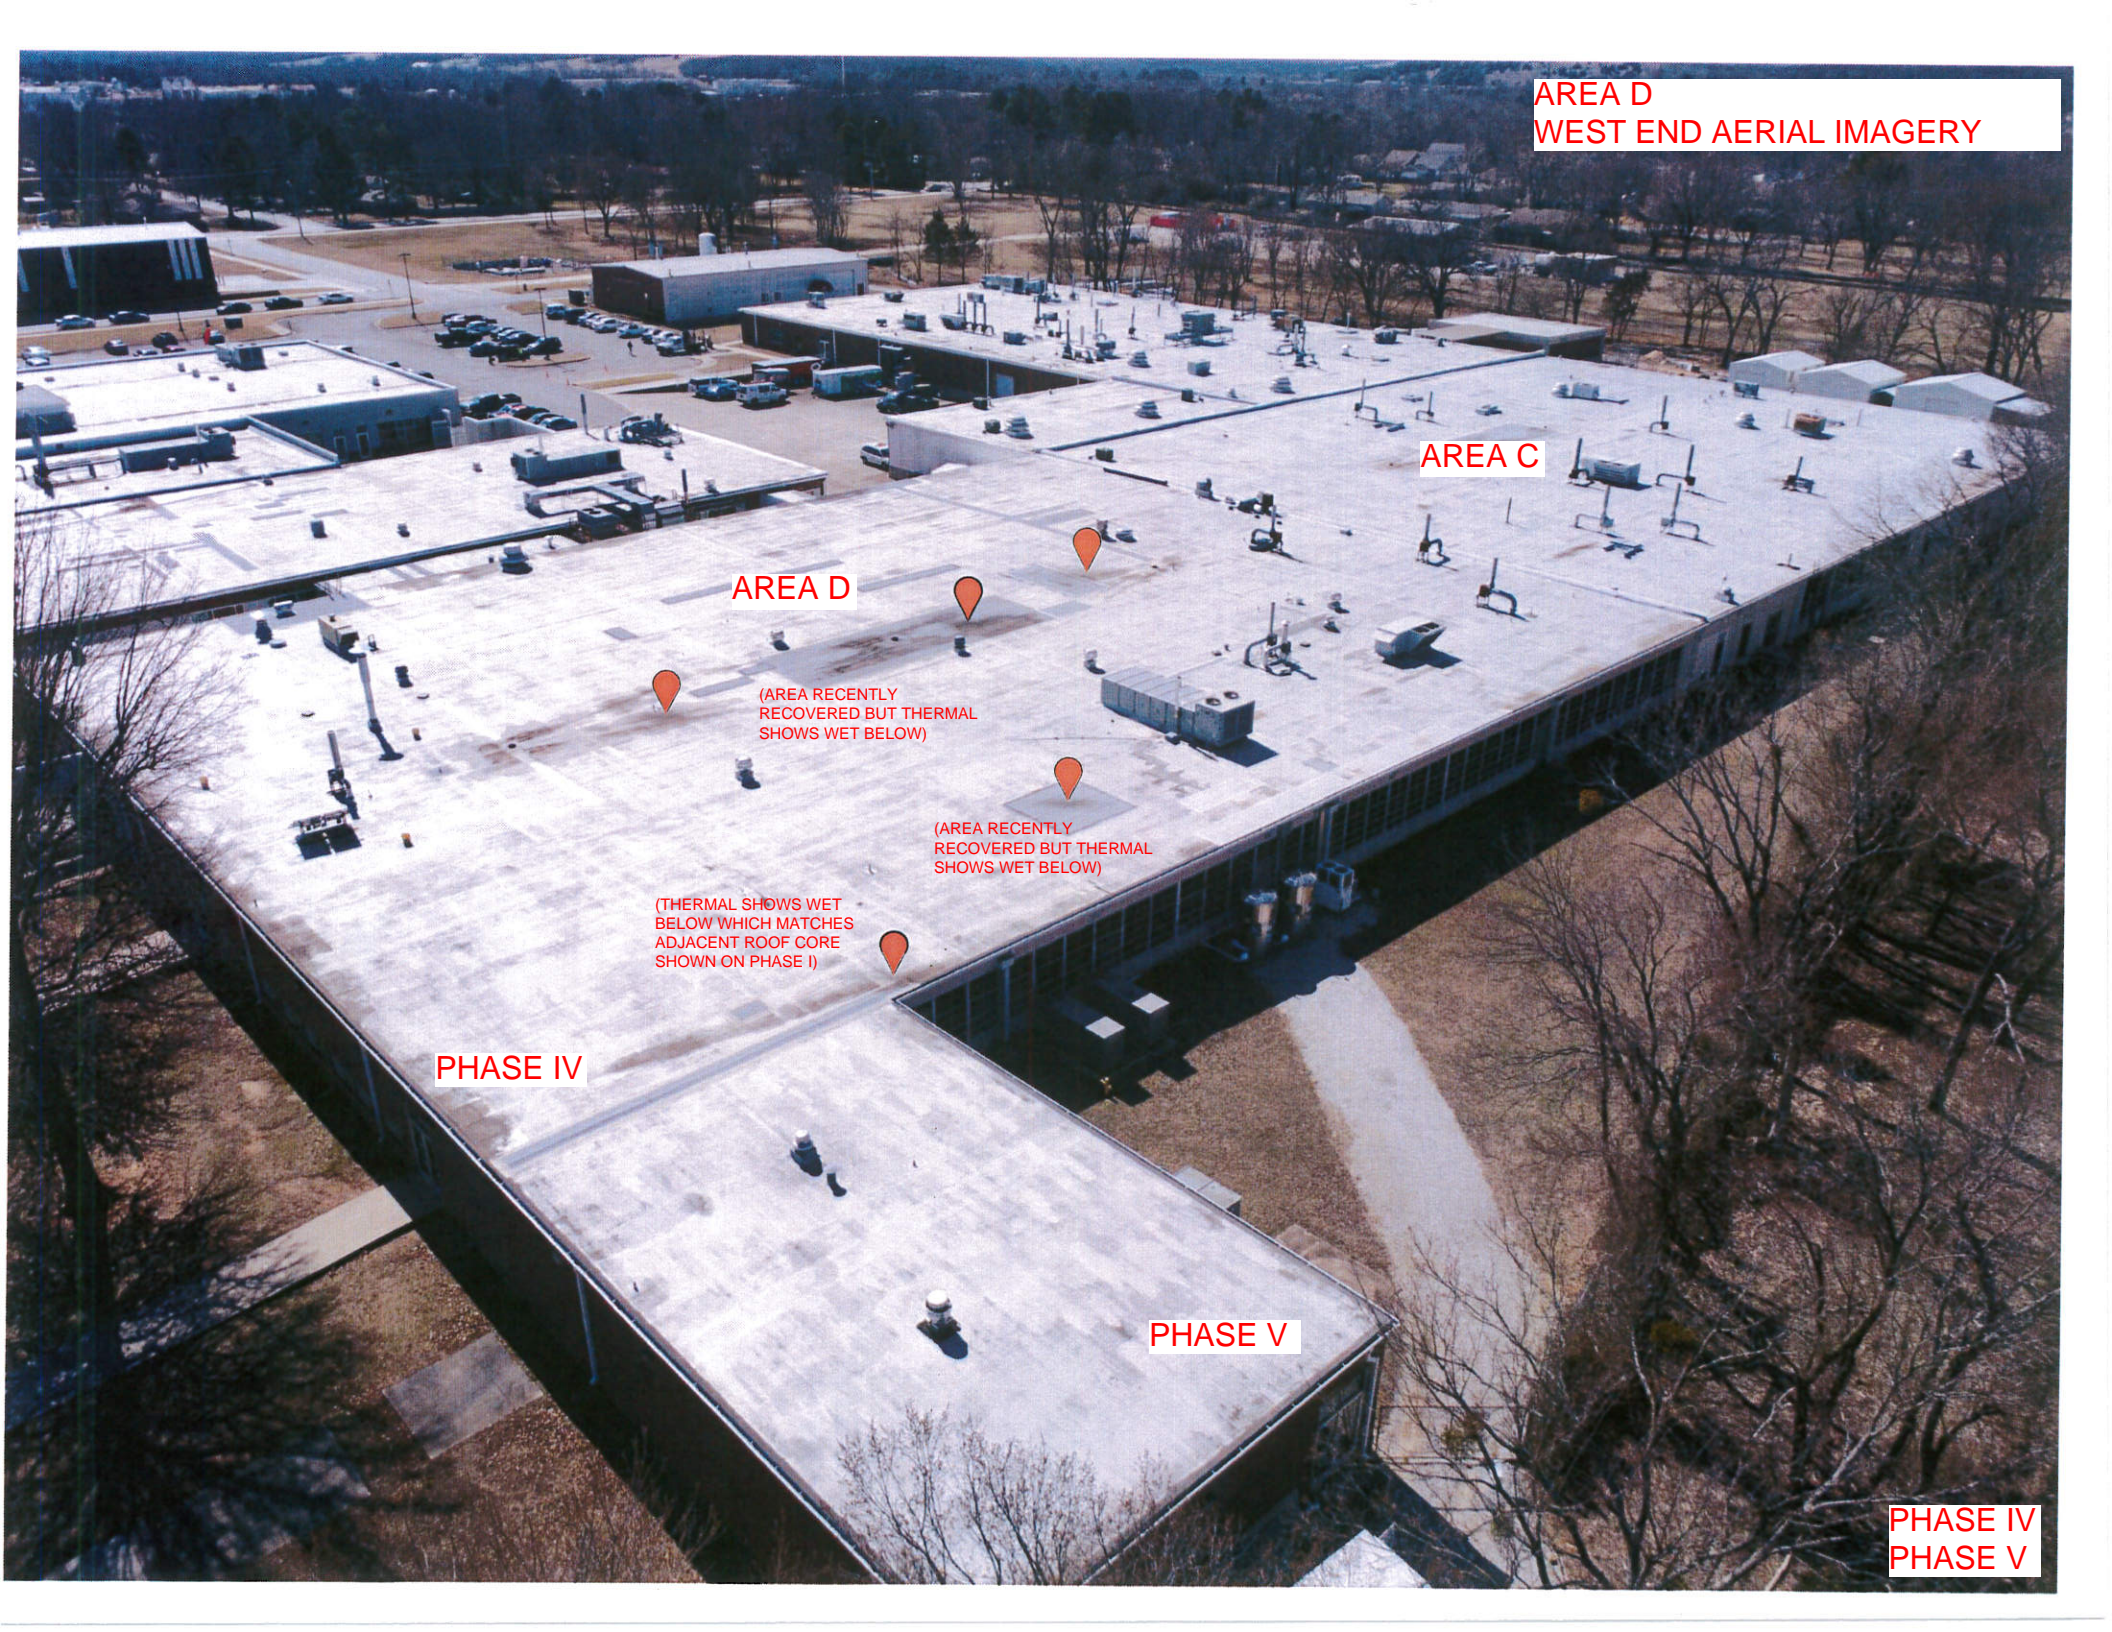
**AREA D
WEST END AERIAL IMAGERY**

(AREA RECENTLY
RECOVERED BUT THERMAL
SHOWS WET BELOW)

(THERMAL SHOWS WET
BELOW WHICH MATCHES
ADJACENT ROOF CORE
SHOWN ON PHASE I)
