UNIVERSITY OF
ARKANSAS

Engineering Research Center (ENRC)

Roof Replacement Plan

UNIVERSITY OF ARKANSAS ENGINEERING RESEARCH CENTER (ENRC) ROOF REPLACEMENT PLAN

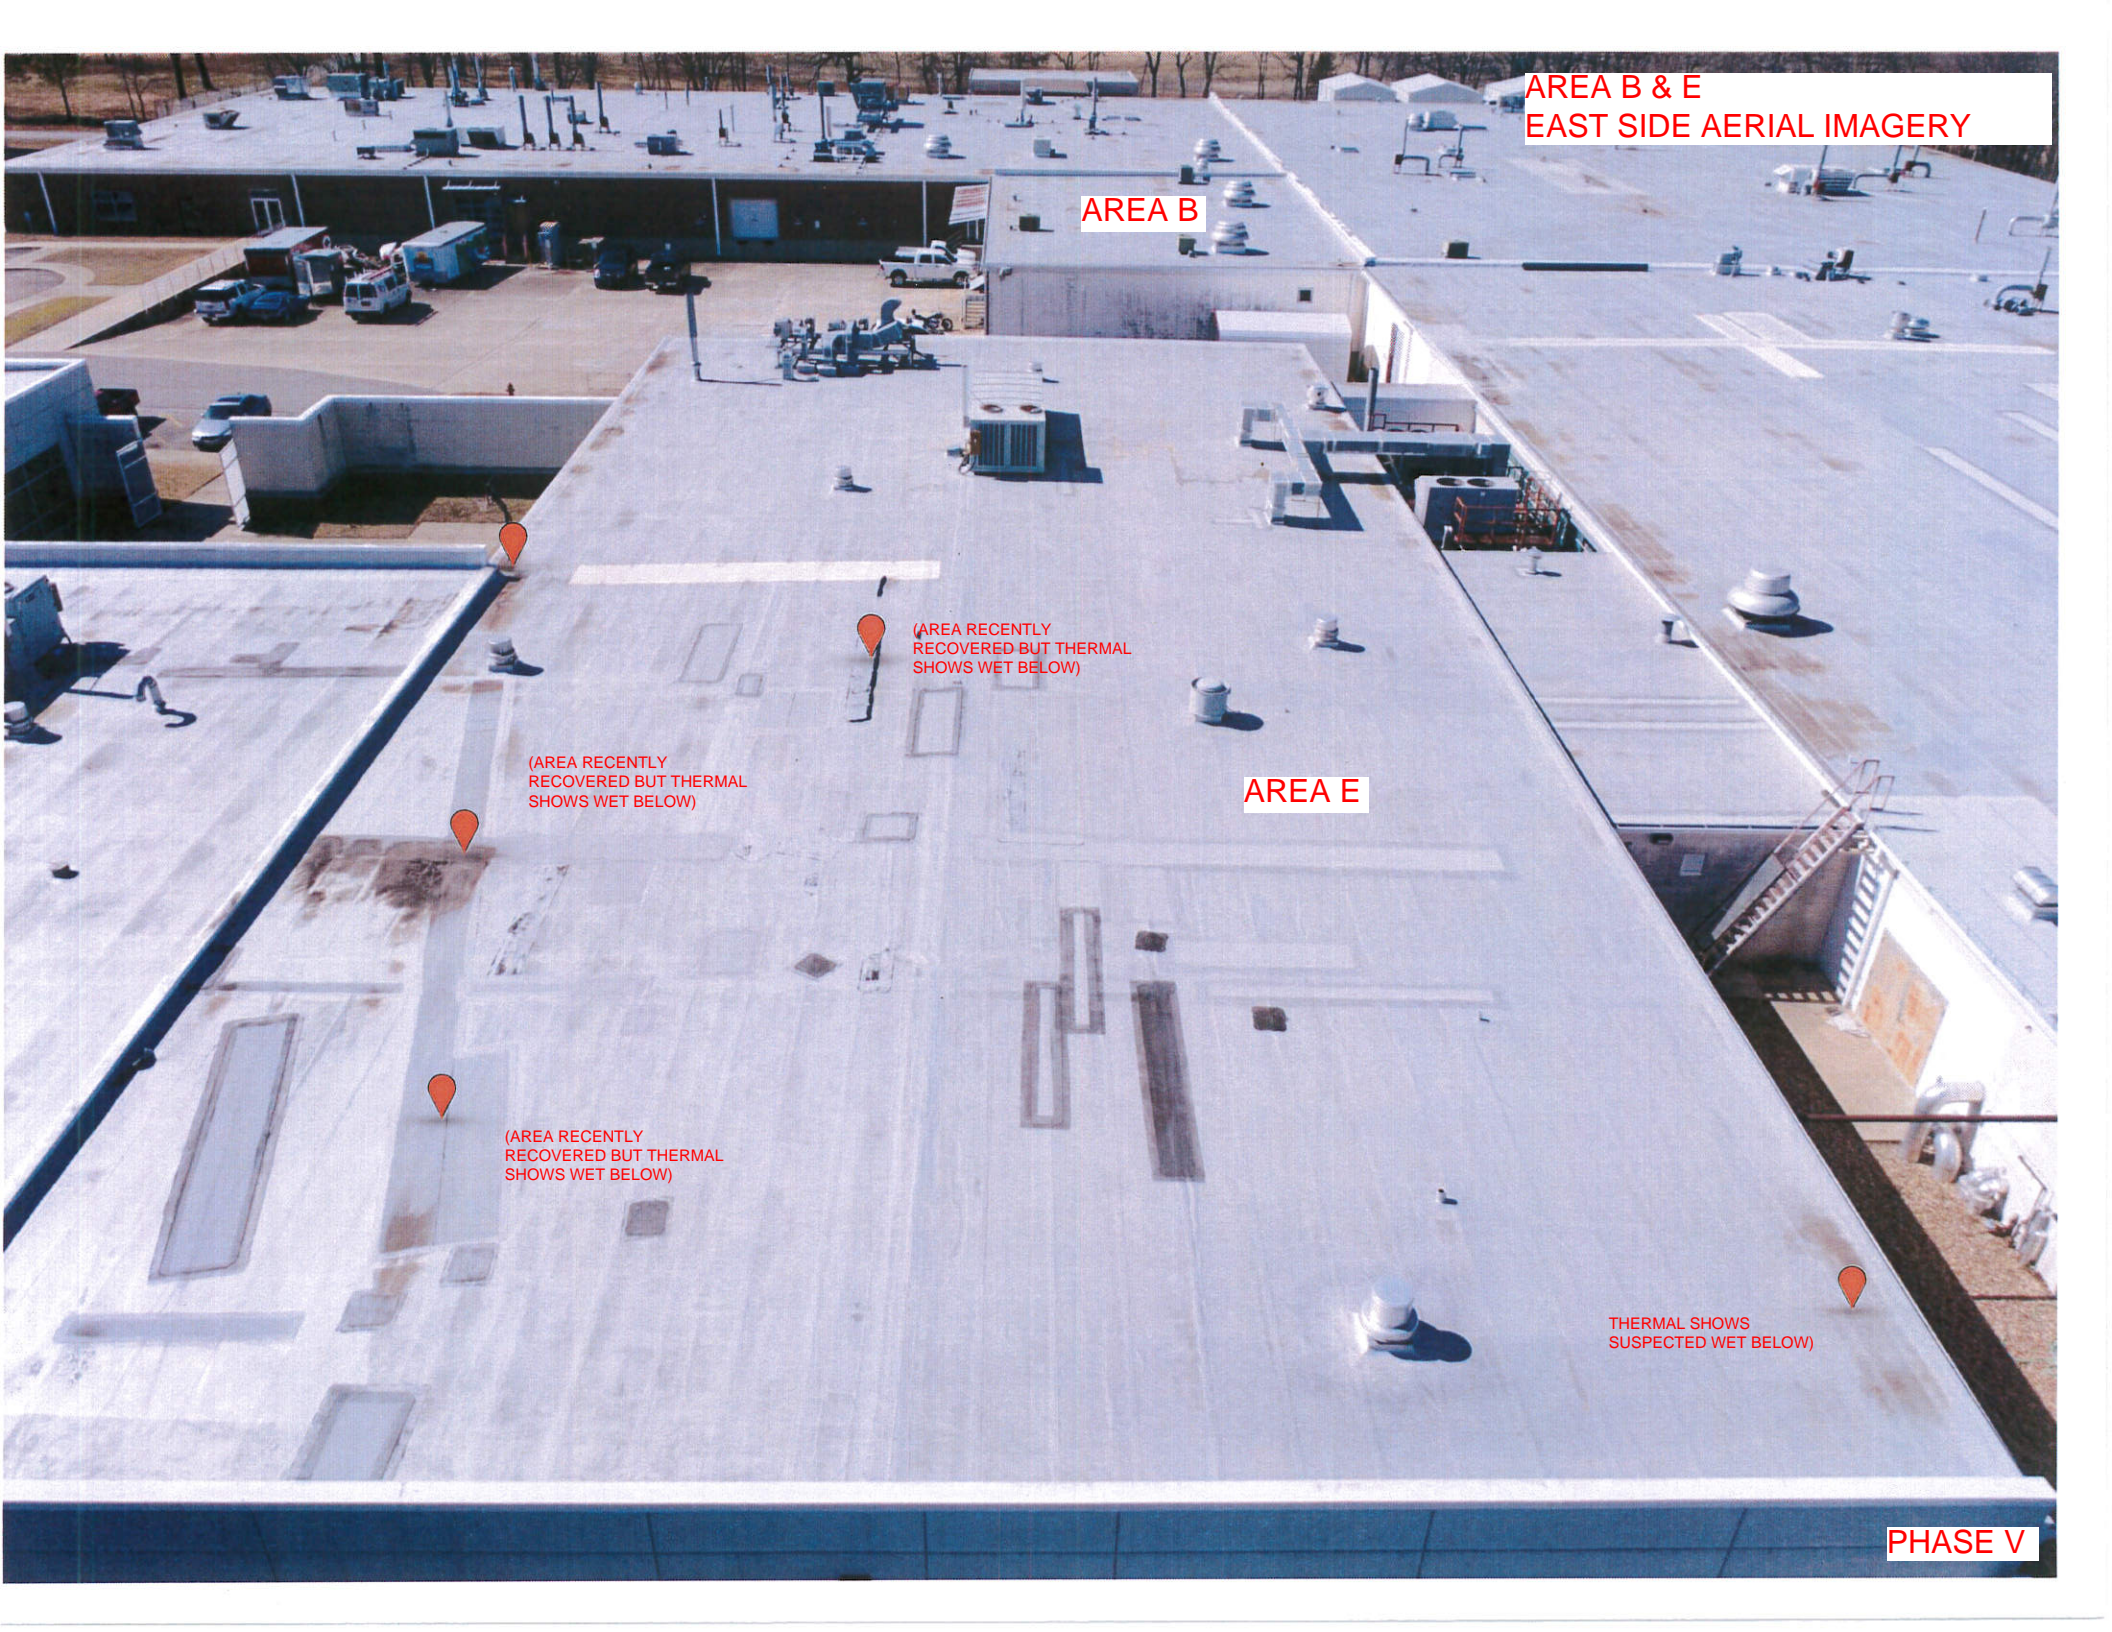
AREA B & E
EAST SIDE AERIAL IMAGERY

(AREA RECENTLY
RECOVERED BUT THERMAL
SHOWS WET BELOW)

THERMAL SHOWS
SUSPECTED WET BELOW)

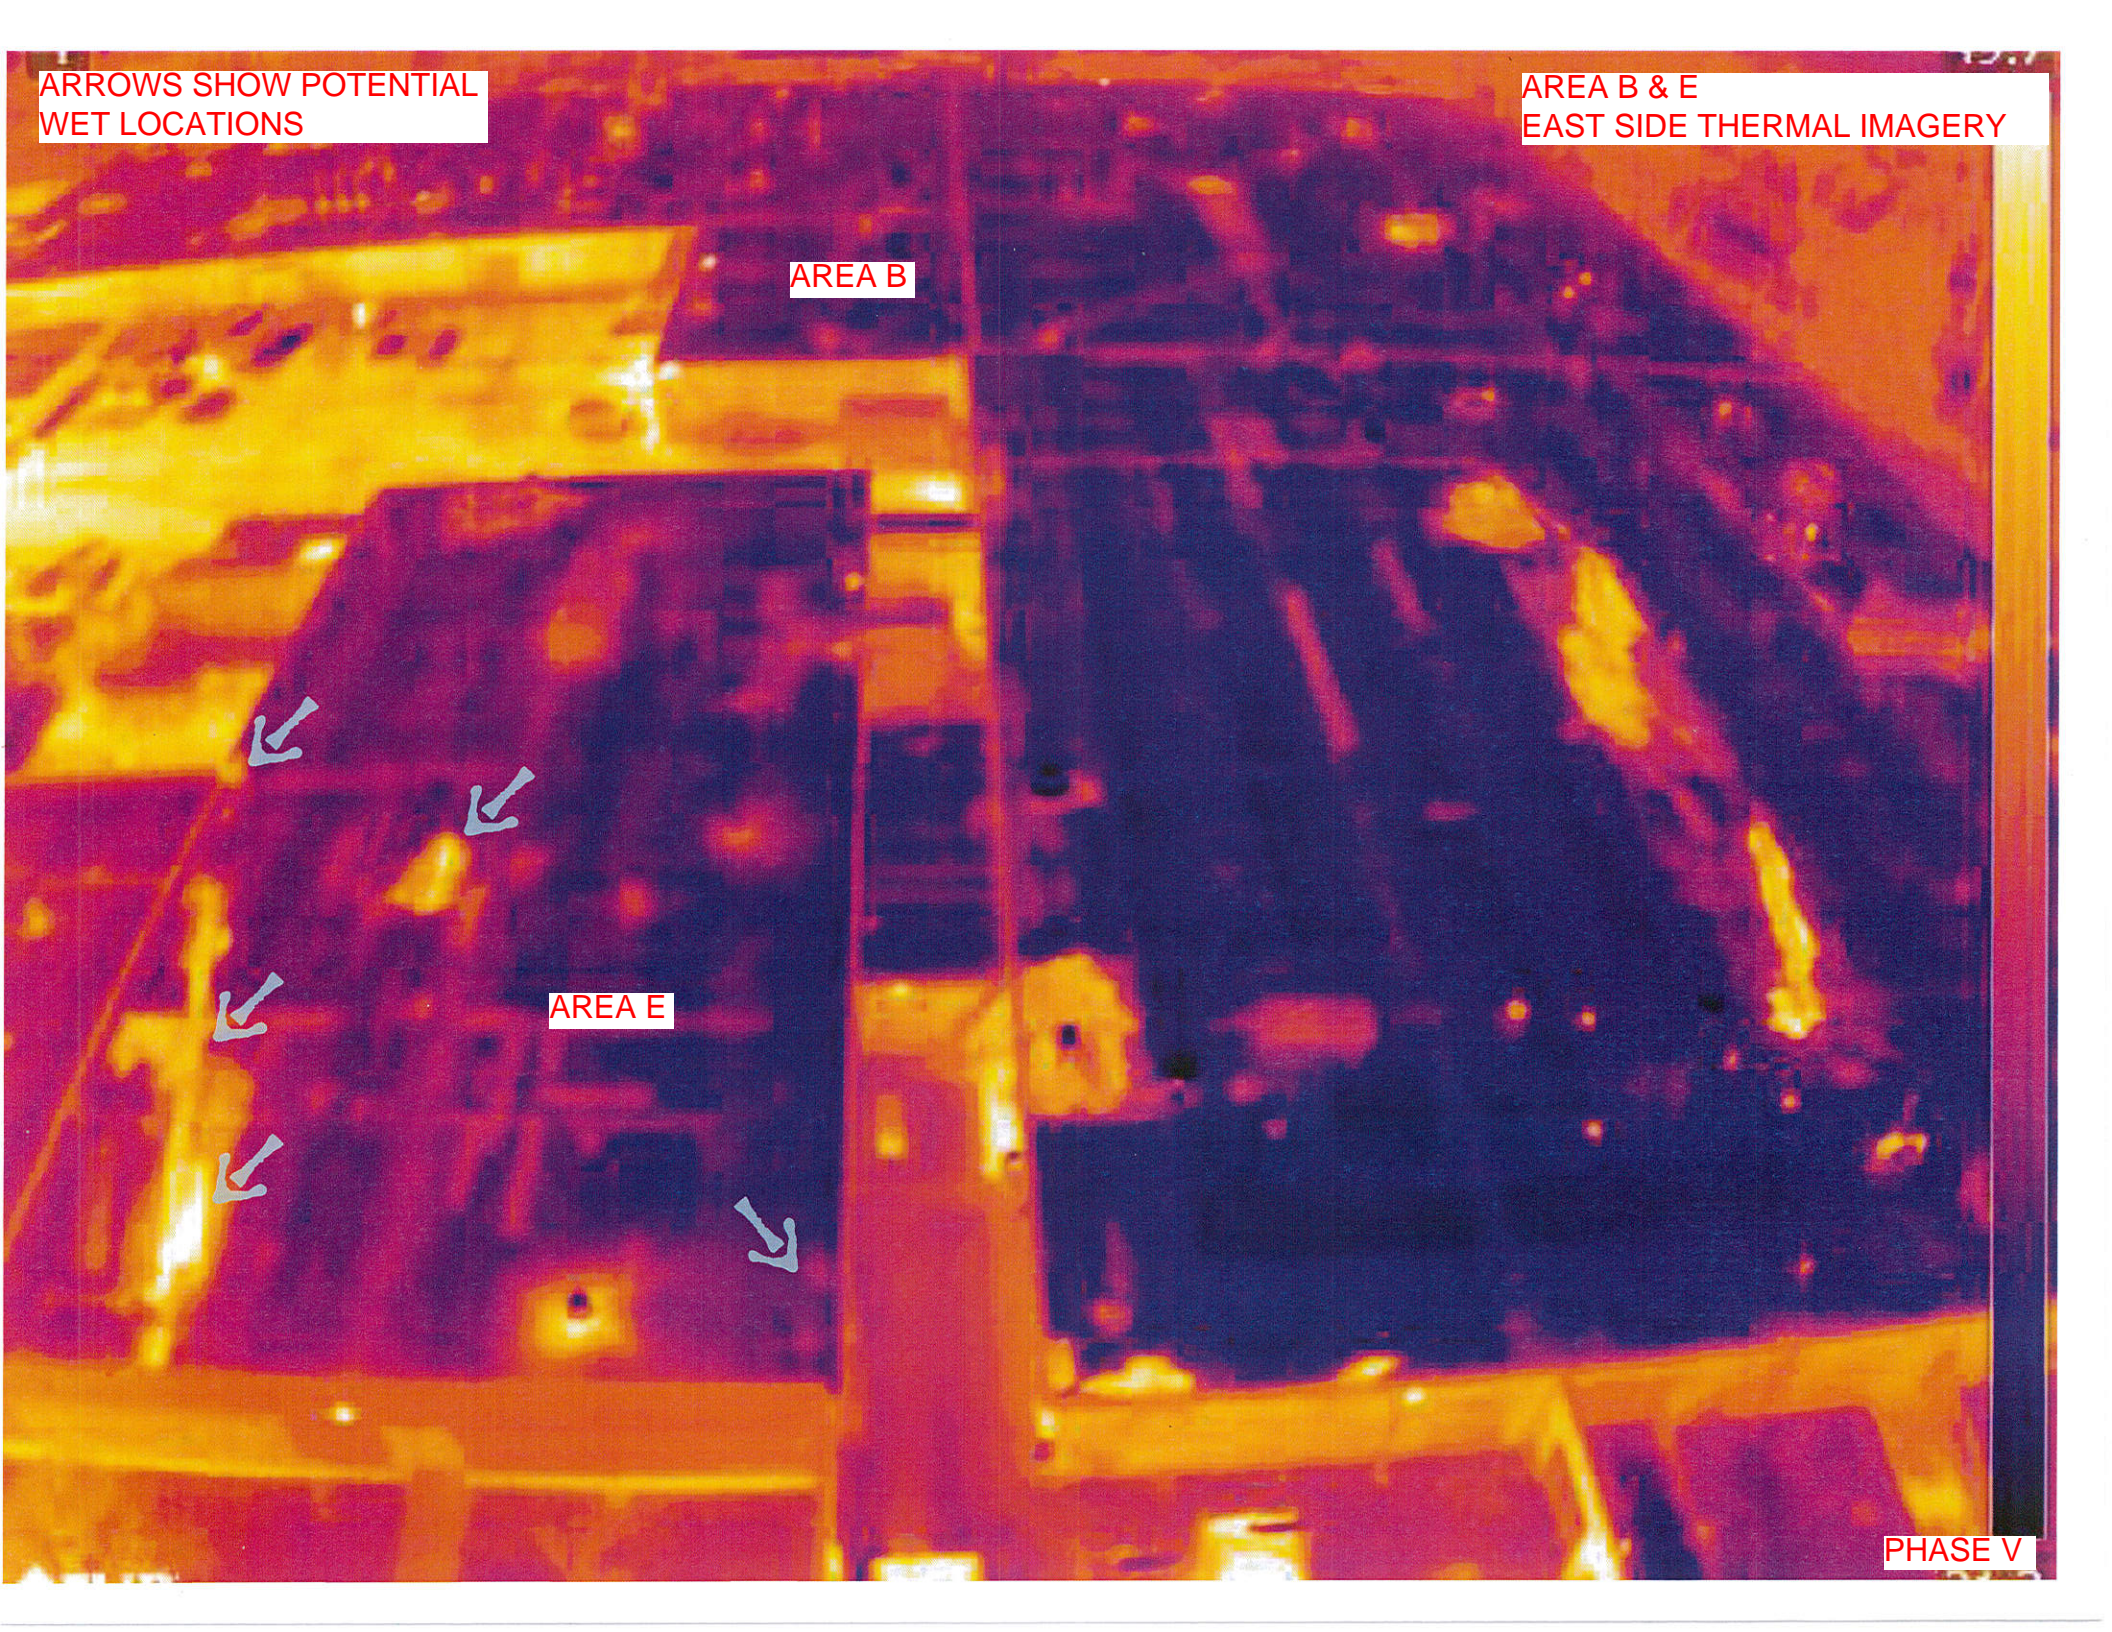
AREA B & E
EAST SIDE THERMAL IMAGERY

ARROWS SHOW POTENTIAL
WET LOCATIONS

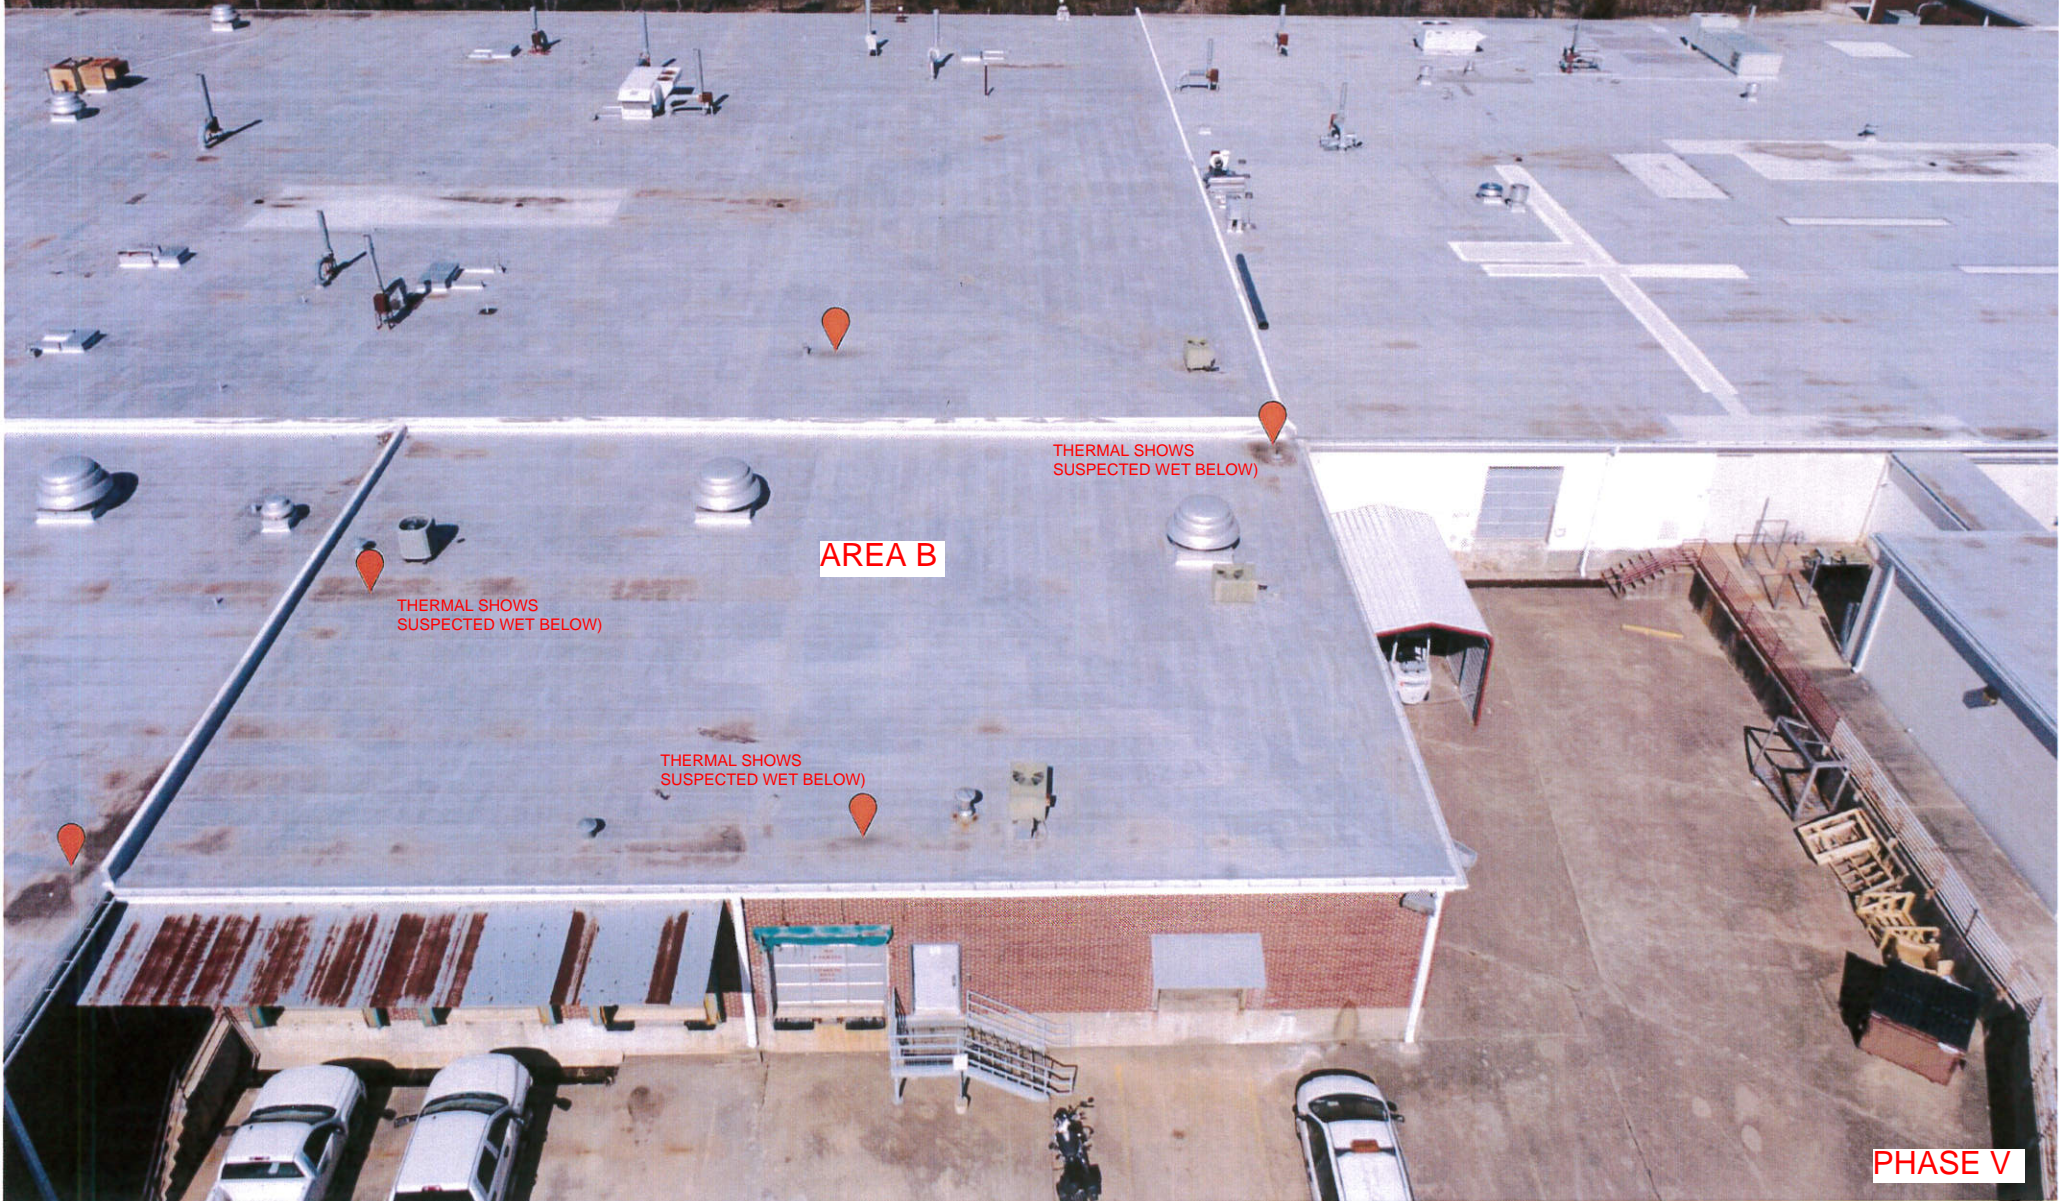
AREA B
SOUTH SIDE AERIAL IMAGERY

THERMAL SHOWS
SUSPECTED WET BELOW)

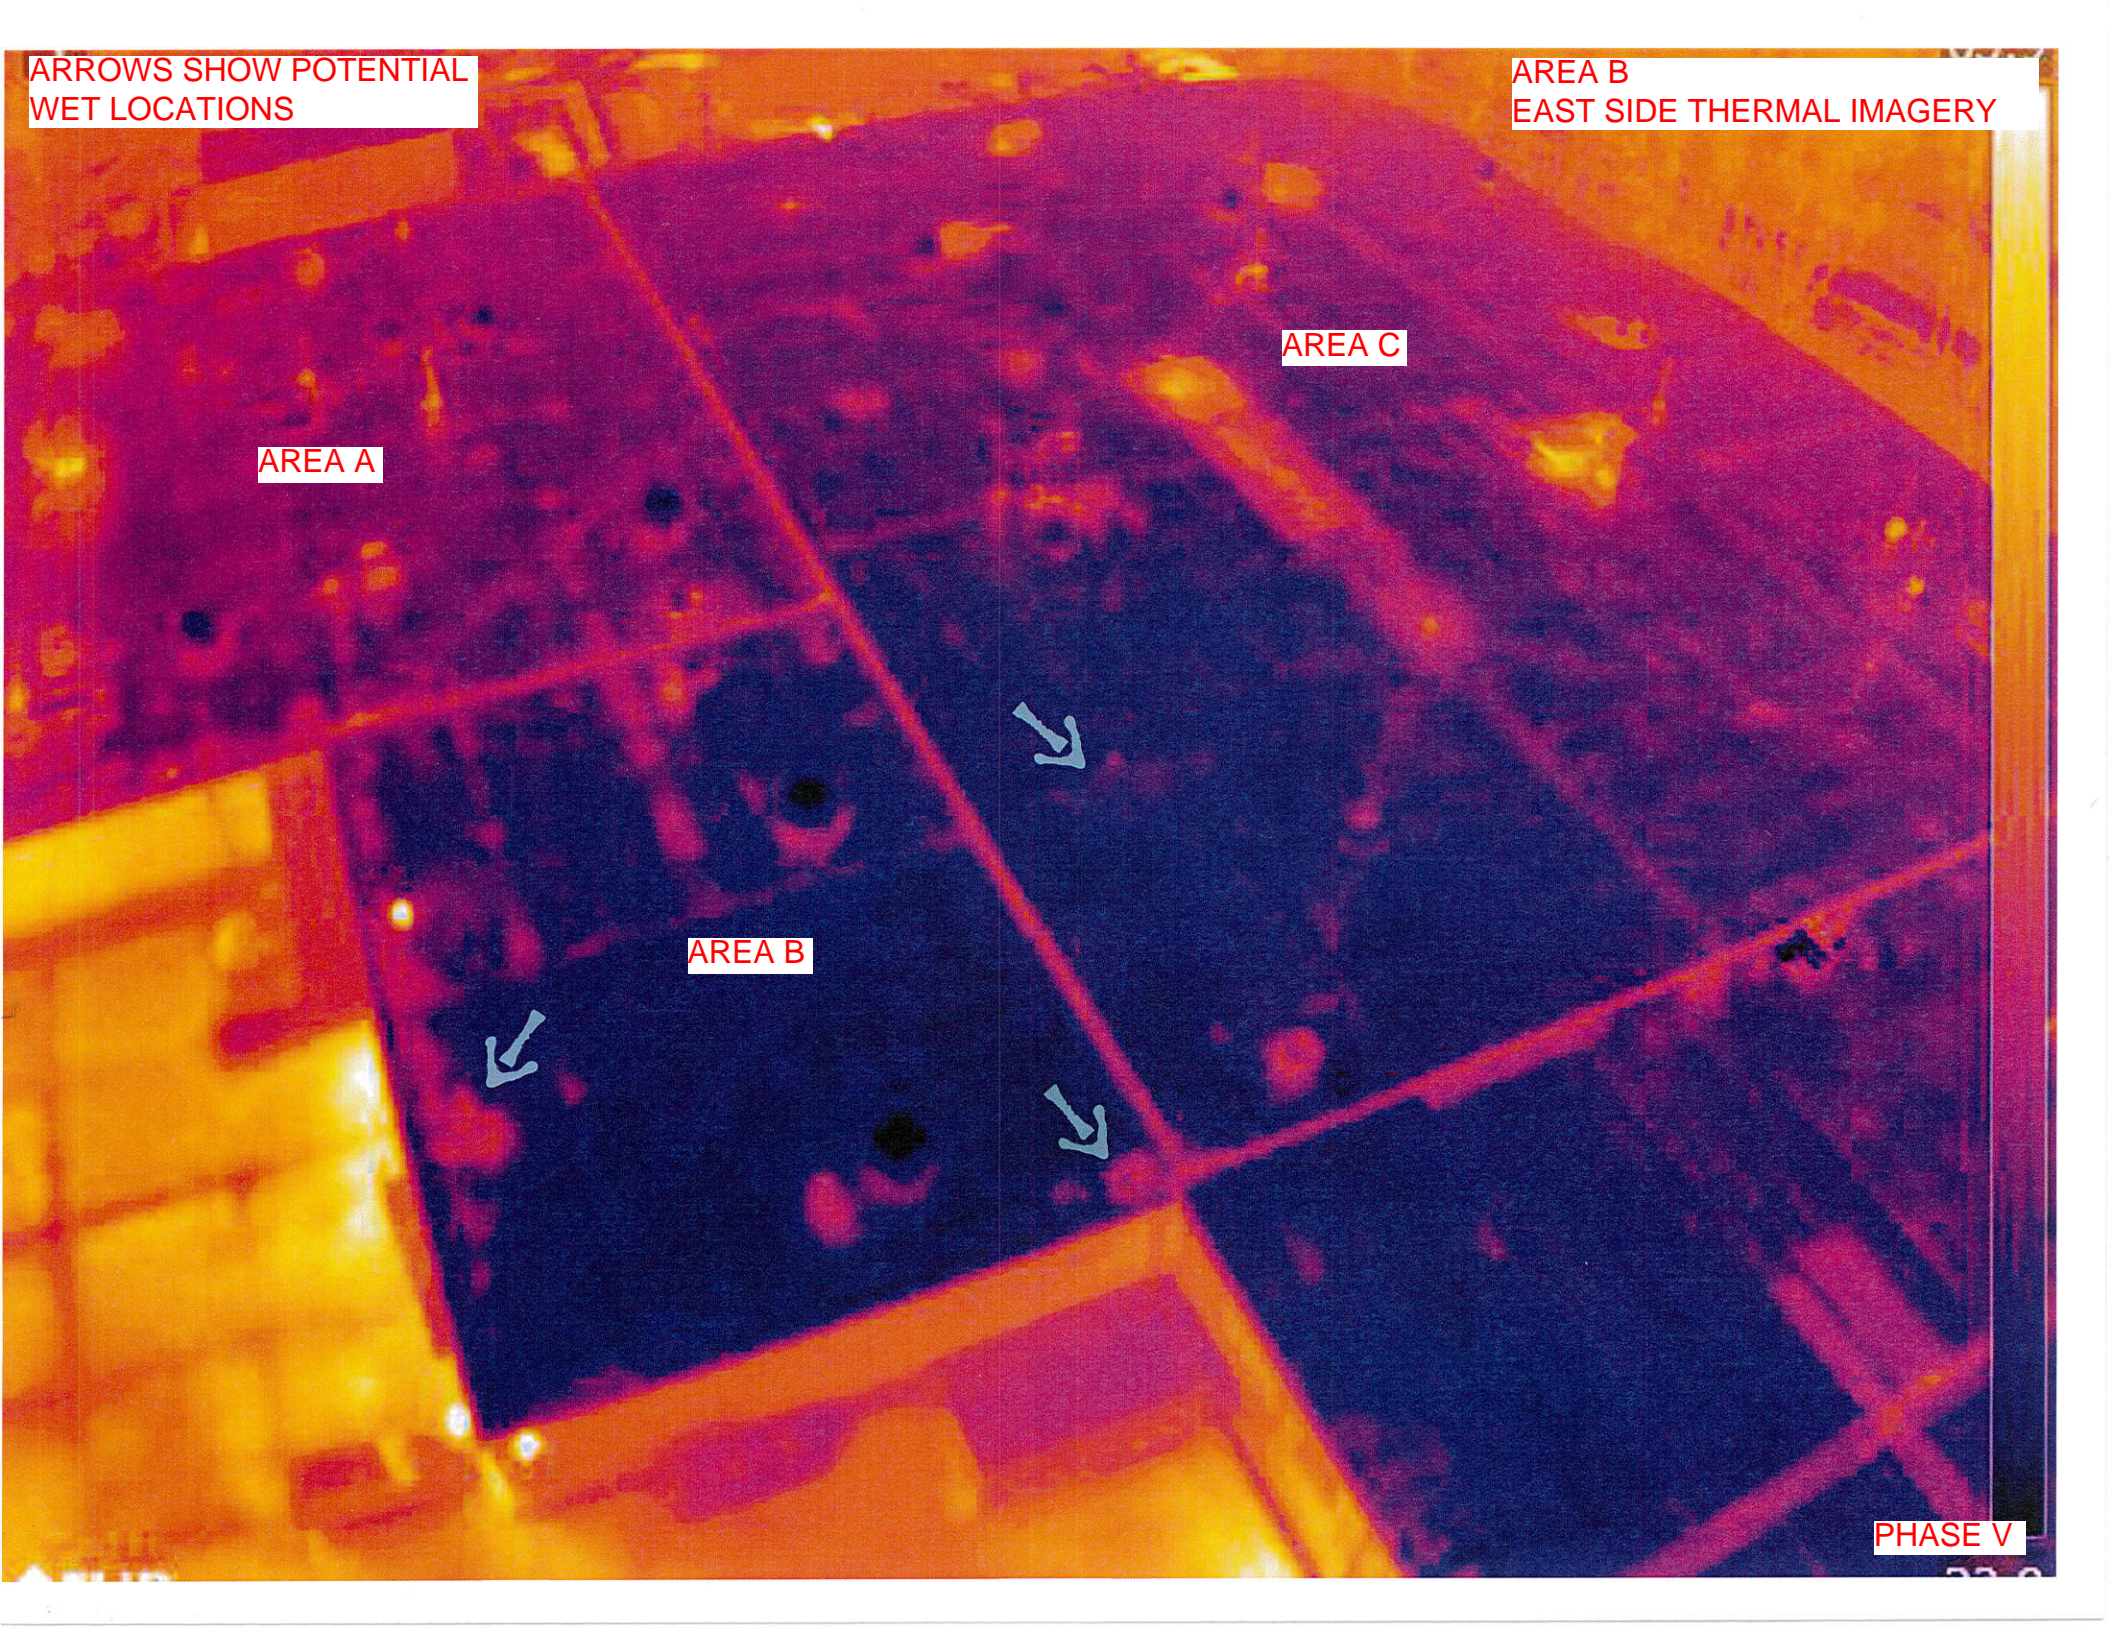
AREA B
EAST SIDE THERMAL IMAGERY

ARROWS SHOW POTENTIAL
WET LOCATIONS
