Arkansas Union

University of Arkansas-Fayetteville

Programming and Concept Design Final Report

February 05, 2010

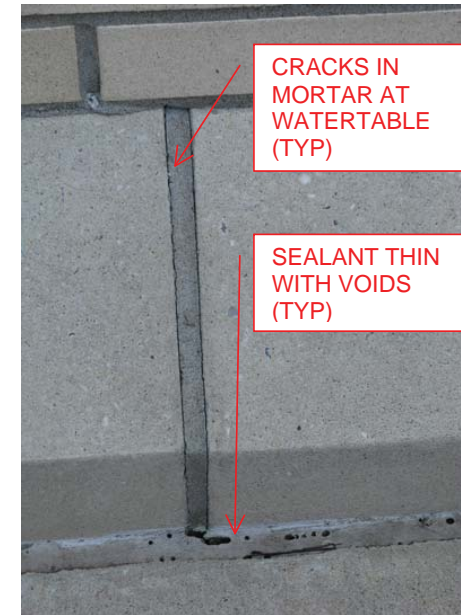
Photo 002

- a. Crack in brick on northwest corner. Probably best to leave it as is now but monitor to see if it gets worse. (Photo 001)
- b. Mortar cracks at water table- typical. Could become problem with water entering and freezing causing damage to precast. Monitor and repoint in future. (Photo 002)

- c. Sealant thin and with many small openings between sidewalk and building-typical. Monitor and replace sealant in future. (Photo 002)
- d. Crack between precast lintel and brick above openings- typical. Monitor and repoint in future. (photo 003)

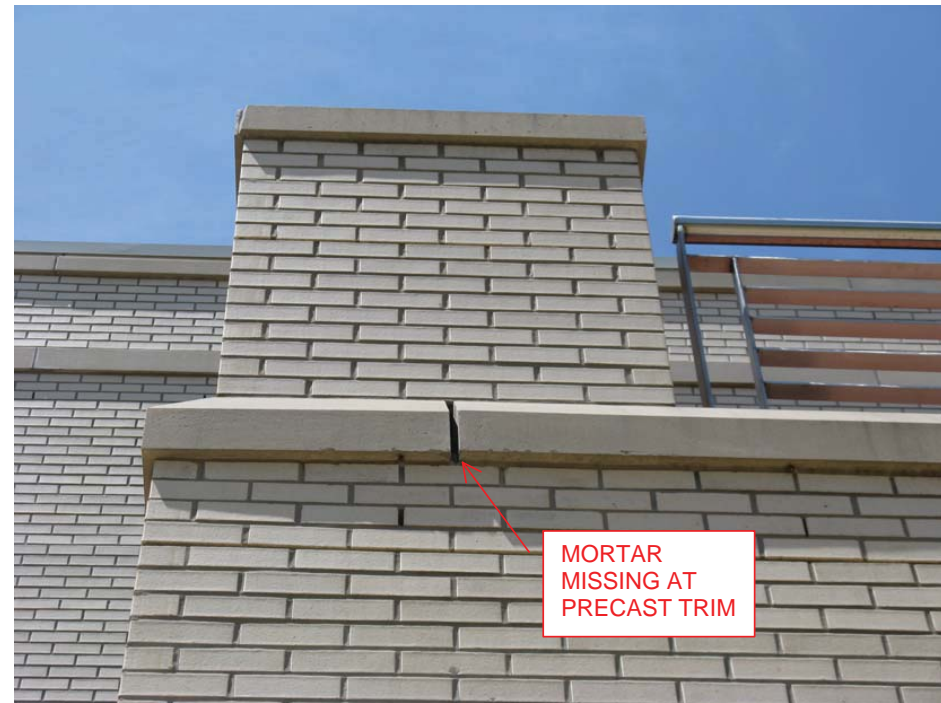
Photo 009

- m. Mortar missing from precast trim at balcony on east side. Repoint in future. (Photo 009)
- n. Sealant joints around arches at entry on east side are deteriorating. Replace sealant in future. (Photo 010)

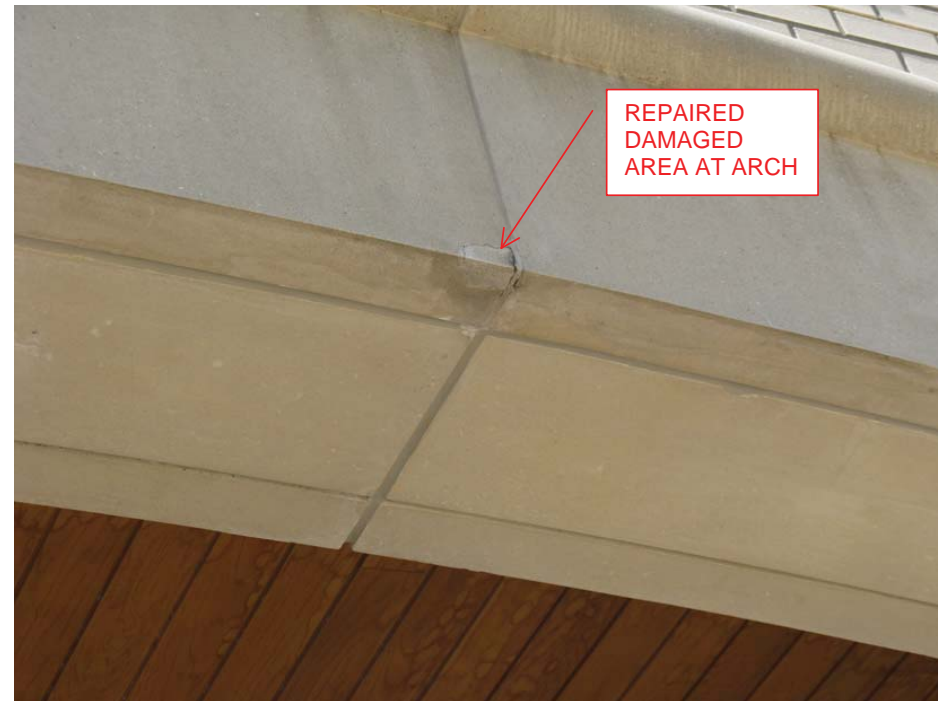
Photo 011

- o. Patched damaged area in arch at entry on west side. Monitor (Photo 011)
- p. Wood soffit finish along east side of building is deteriorating. Possible from lack of seal on end grain. Monitor (Photo 012)

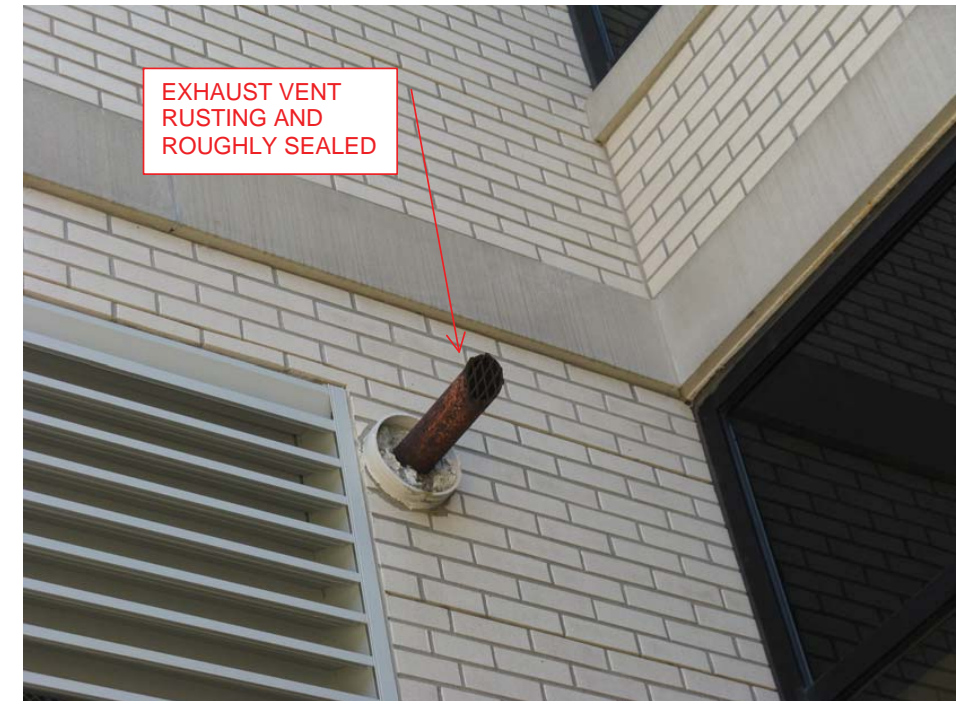
Photo 013

- q. Vent exhaust on north side of building rusting and roughly sealed. Monitor could be replaced with stainless steel piping. (Photo 013)
- r. No mortar in precast joint above window on south side. Repoint in future (Photo 014)

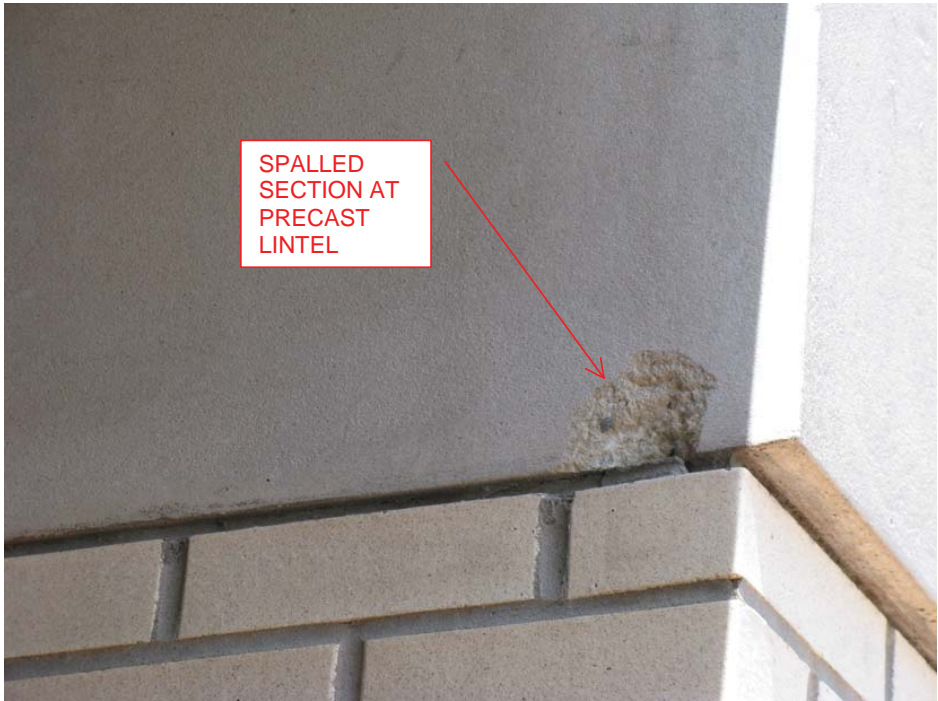
Photo 015

- s. Spalled section at precast lintel at north balcony on east side of building. Monitor (Photo 015)
- t. At balconies on east side above windows sealant between deck and windows has voids. Reseal (Photo 016)
- u. At balconies on east side above windows cracks around guardrail post have developed. Monitor (Photo 017)
- v. At balcony on east side under precast cap crack in brick has developed. Monitor (Photo 018)

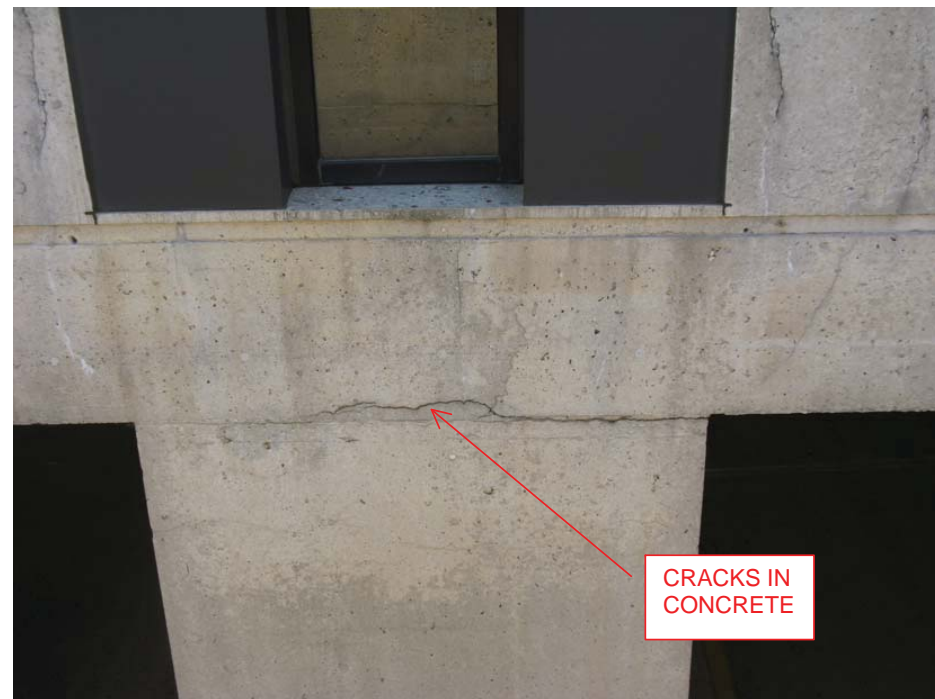
Photo 019

- a. Cracks in bridge guardrail from the original building phase that are incorporated into the enclosed bridge connection. Monitor to verify that it doesn't get worse (Photo 019 & 020)
- b. At double doors on south side of bridge there is no weather seal between doors. Wind blows rain into building. Install seal. (Photo 021)
- c. Soffit that was installed below bridge at enclosed link above has been damaged by traffic. Repair damage and possibly install height indicators on either side of bridge to warn high clearance vehicles (Photo 022, 023, 024, 025, & 026)

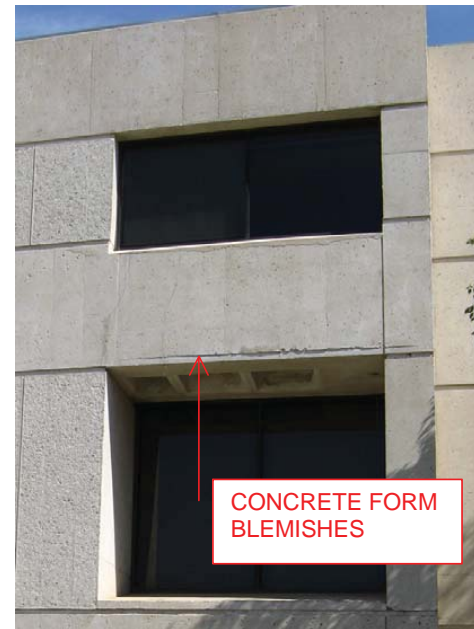
Photo 028

- a. Concrete building has various cracks; rebar rust stains, honeycombs and other various concrete blemishes. None observed seem to be major problems but should be monitored to verify that they aren't getting worse. (Photo 027, 028, 029, 030, 031, 032, 033, & 034)

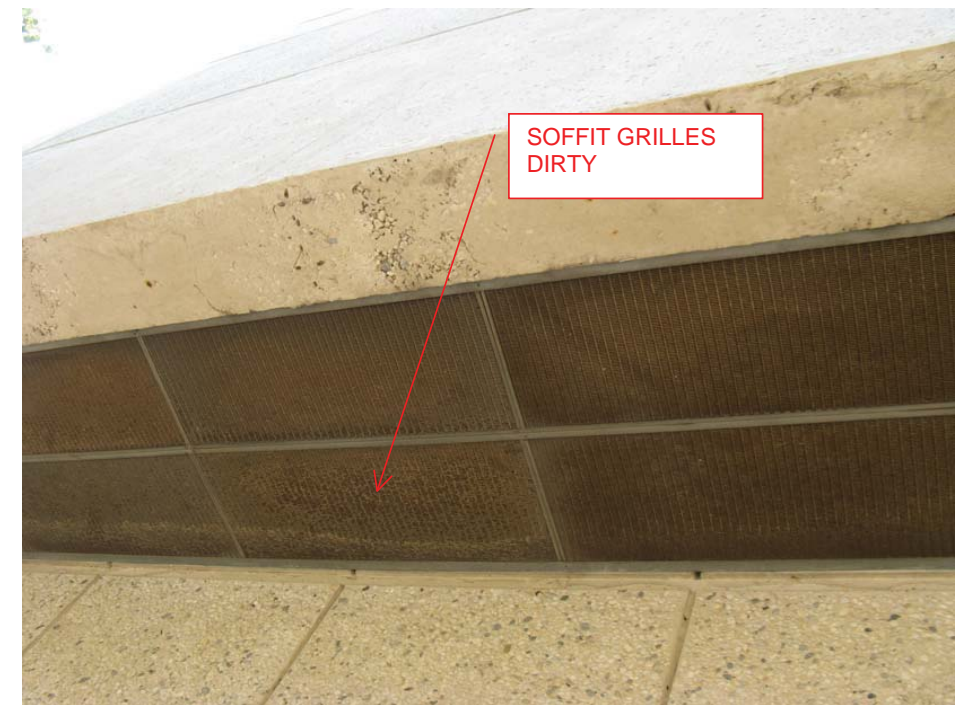
Photo 035

- b. Soffit grilles are dirty and need to be cleaned. May be affecting mechanical performances. (Photo 035)
- c. There is concrete damage to the head of dock opening from trucks. Install protective guards to prevent further damage. (Photo 036 & 037)

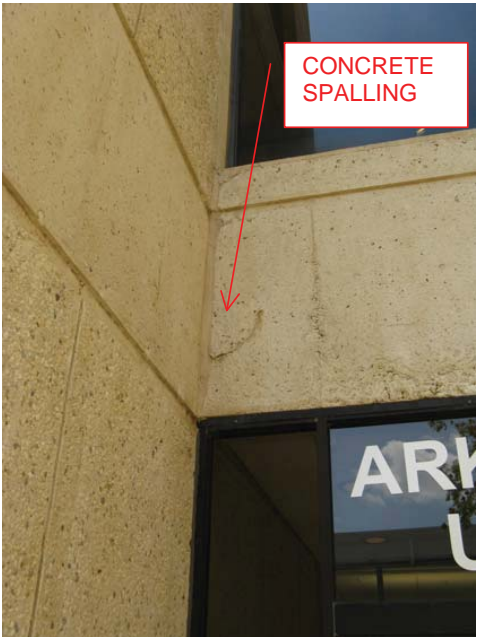
Photo 038

- d. Spalling concrete over recessed south entry should be examined closer to determine if it is stable. If not it should be stabilized to prevent possibility of it falling on someone. (Photo 038)

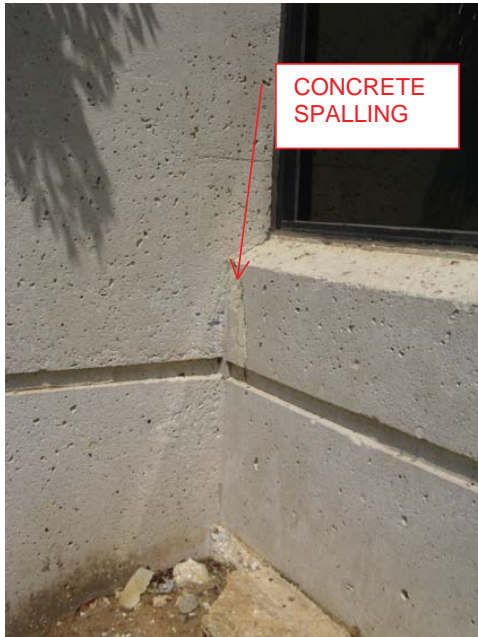
Photo 039

- e. Spalling concrete at inside corner of south wing to west section of building should be monitored over time to verify it is stabilized. (Photo 039)

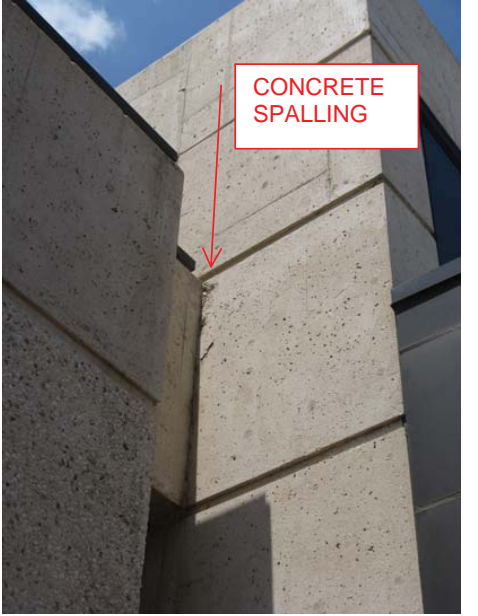
Photo 040

- f. Spalling concrete at south side of link addition to original building should be monitored over time to verify it is stabilized. (Photo 040)
- g. According to staff the windows above the inset entry on the south side leaks in hard wind driven rain. (Photo 041)

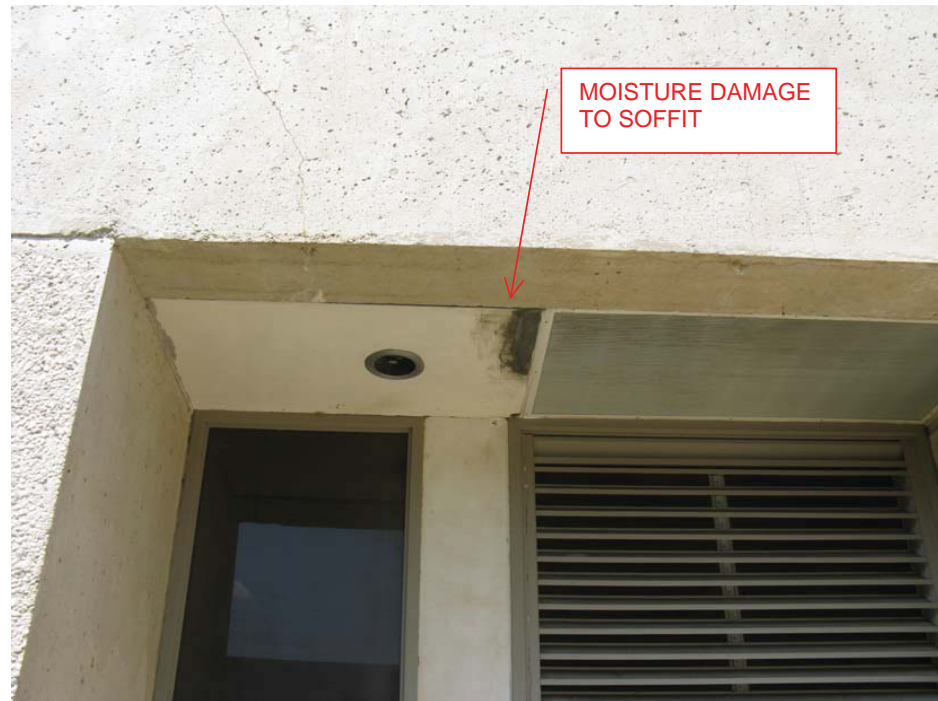
Photo 042

- h. Water damage to soffit area should be repaired. (Photo 042)
- i. Balconies are several inches lower than interior spaces making them not accessible by wheel chair. Wooden ramp at one balcony has been added. (Photo 043)

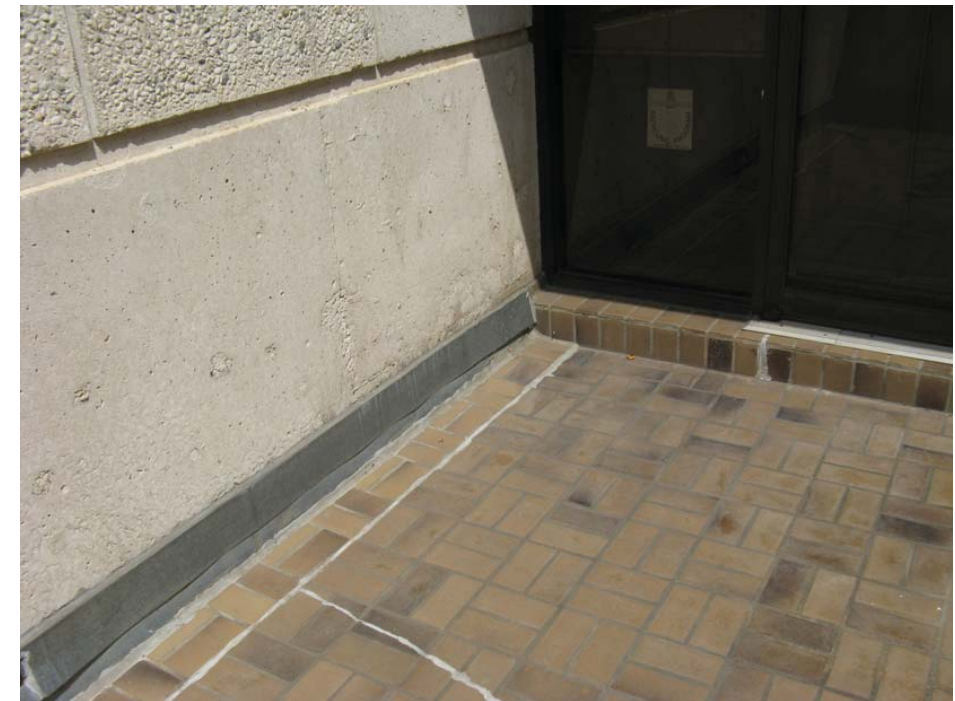
Photo 044

- j. Balcony tiles have cracked and sealant has been added. (Photo 044)

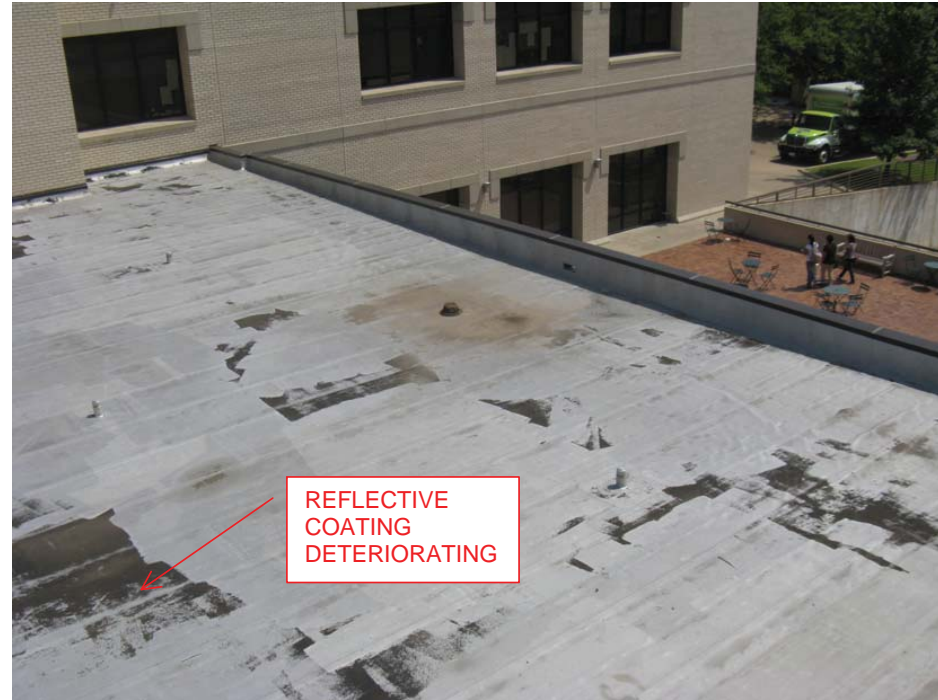
Photo 046

- a. Roofs over the buildings seem in good condition. The reflective coating has deteriorated and should be touched up. (Photo 045 & 046)

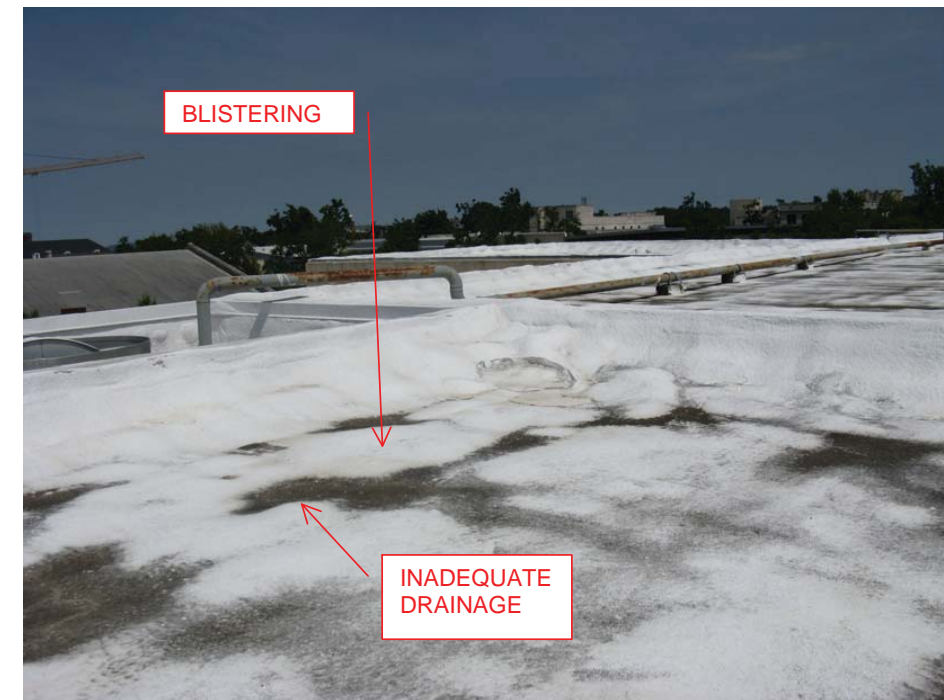
Photo 047

- a. General overall blistering of foam roof. (Photo 047, 048, 049, & 050)
- b. Roof seems to provide inadequate slope to drains. Staining of roof seems to indicate ponding. (Photo 047, 048, 049, & 050)

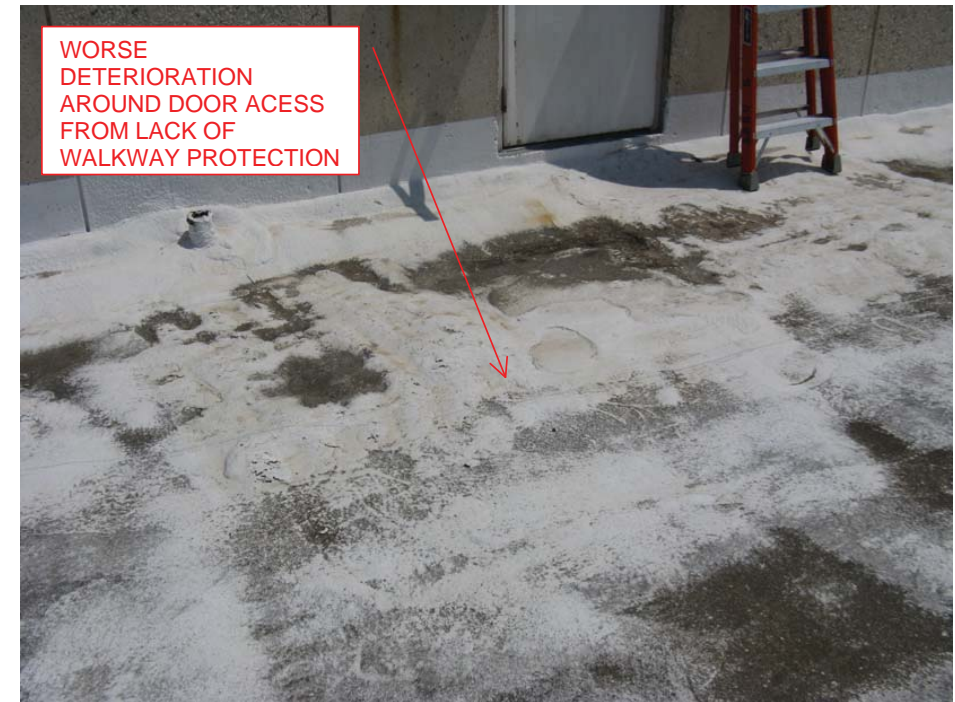
Photo 051

- c. Worse deterioration of the roof occurs at roof access door. There are no protective walkway areas on roof. (Photo 051)
- d. Repairs to roof have been made so that the membrane surface of the repair is lower than the surrounding roof so that it holds water. (Photo 052 & 053)

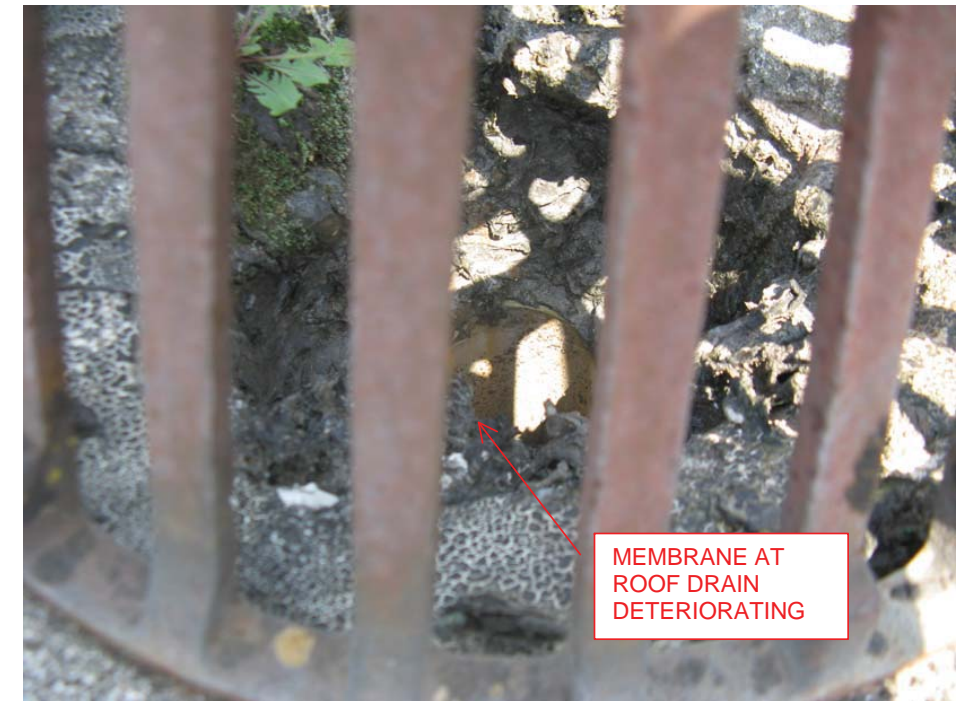
Photo 054

- e. Roof membrane around drains deteriorating. (Photo 054)
- f. Duct insulation is coming apart and needs to be reapplied in a better manner. (Photo 055)

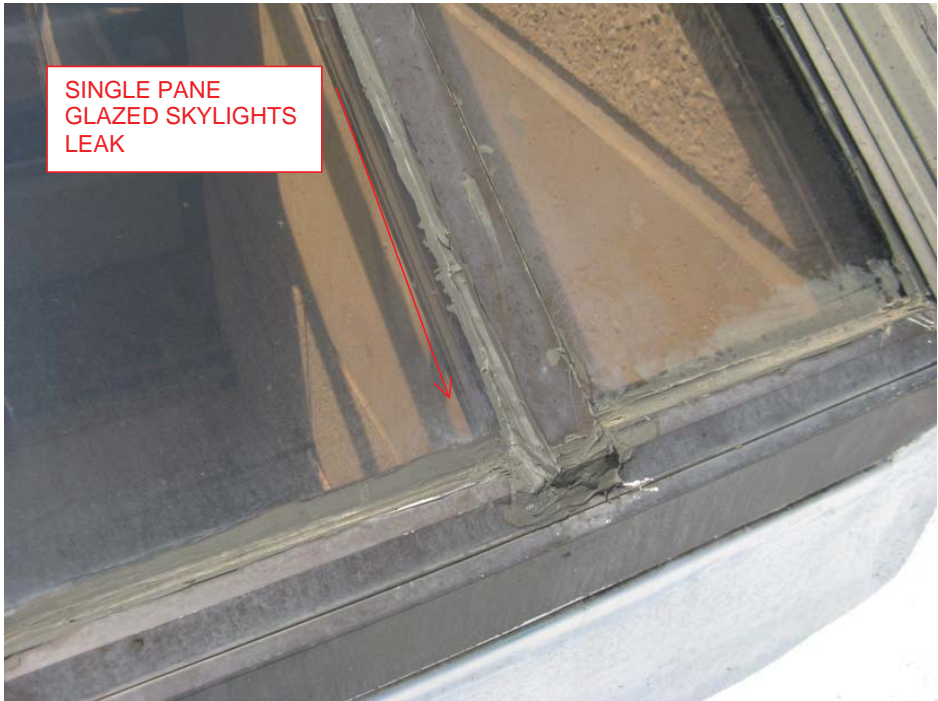
Photo 056

- g. The sloped glazed skylights have single-pane glazing. Staff reports that they are a leak problem that they continually attempt to seal. One persistent leak is on the north sloping skylight. Interior office space near skylight has wet wall surfaces and carpeting. (Photo 056, 057, 058, 059, and 060)

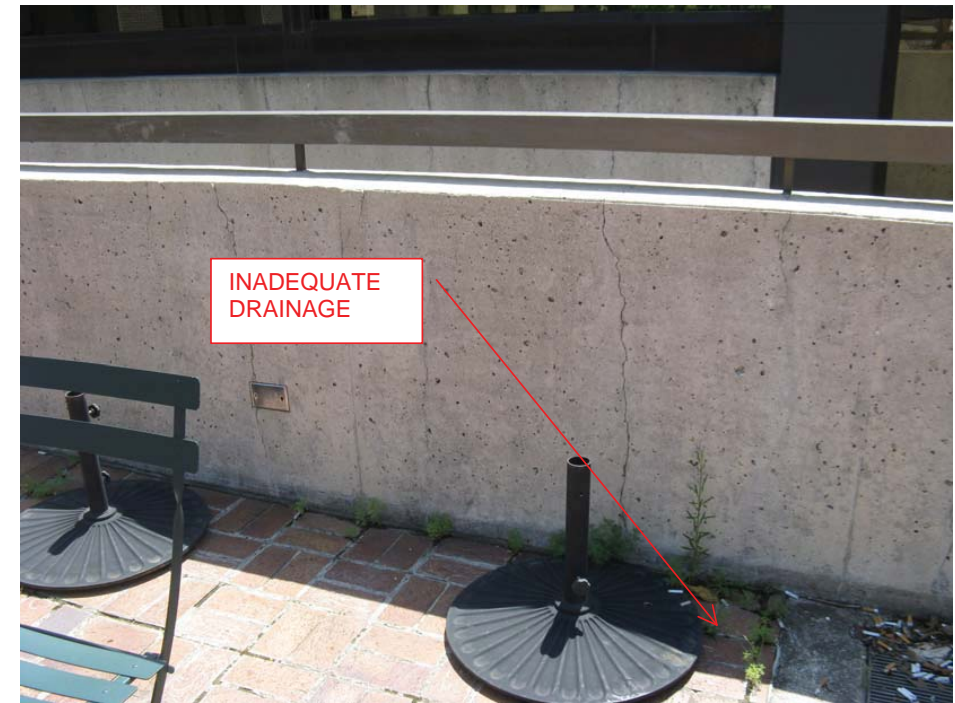
Photo 063

- a. Quarry tile plazas on top of the bridge to the north and south of connecting link are deteriorating. Freezing and thawing has popped up some tiles. (Photo 061). There seems to be inadequate slope to drainage. (Photo 062 & 063) Inadequate water proofing mainly at plaza edges seems to be allowing water to migrate though plaza and form mineral deposits on the concrete structure below. (Photo 064)
- b. Traffic has cause some damage to concrete bridge joists. (Photo 065)
- c. Traffic has caused damage to conduit under bridge that needs repaired. (Photo 066)
- d. Moisture present under plaza deck slabs in some locations indicating possible leakage of membrane above. (Photo 067 & 068)
- e. Guardrail tops at plazas in bad repair. (Photo 069 & 070)
- f. Concrete retaining wall east of drive has staining that could be cleaned and some cracking that should be monitored. (Photo 071 & 072)

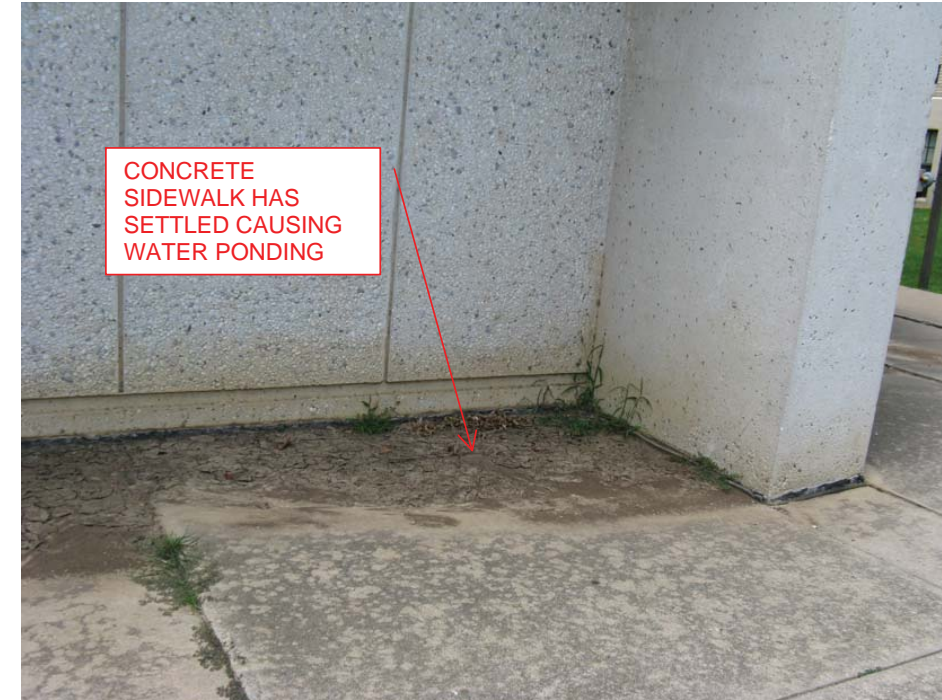
Photo 074

- a. Sidewalks along east side of building at level under bridge have settled several inches. This has caused breakage in the concrete. (Photo 073) It has also cause a place for water ponding along north end of sidewalk. (Photo 074 & 075)
- b. Earth along north side of south wing of building has settled exposing top of footing. This side of building should be regarded. (Photo 076)

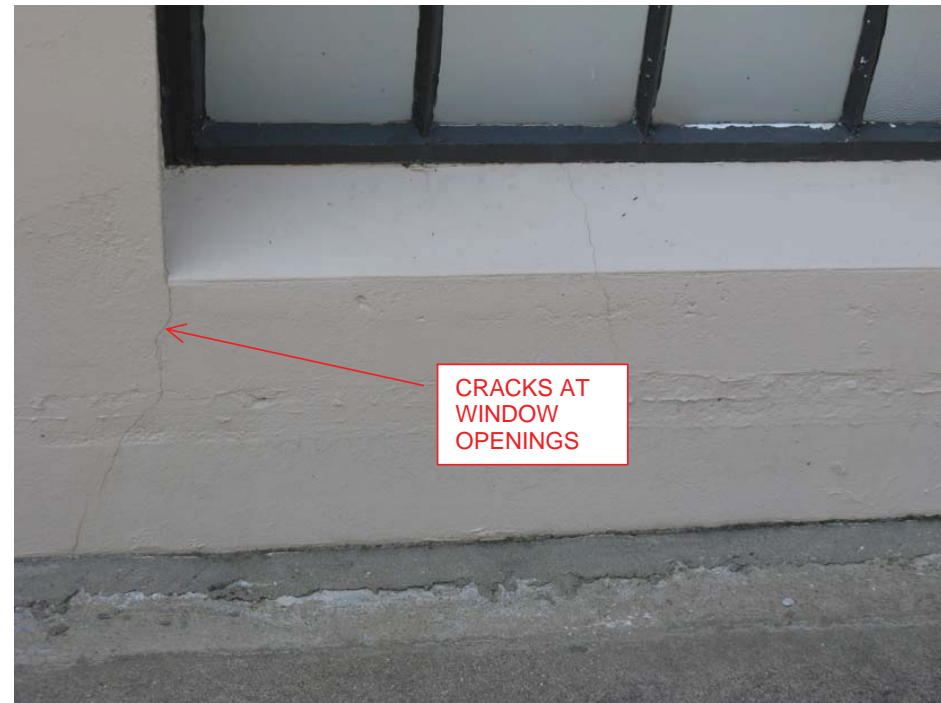
Photo 001

- a. The concrete basement walls are in generally good condition. There is some minor hairline cracking at window openings but cracks seem stable. (photo 001 & 002)

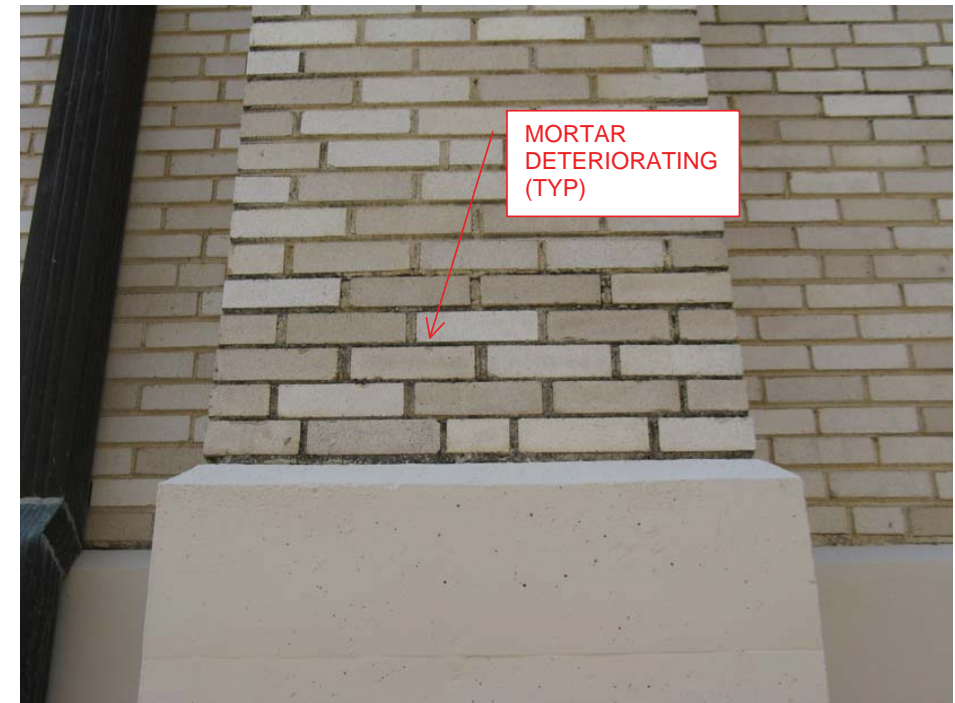
Photo 003

- b. The brick is generally solid and in good condition. Mortar has deteriorated in many locations. Mortar is particularly bad at a bottom water table where brick steps out. At several locations sealant has been applied to joints in apparent attempts to prevent water infiltration. (photo 003, 004, & 005)

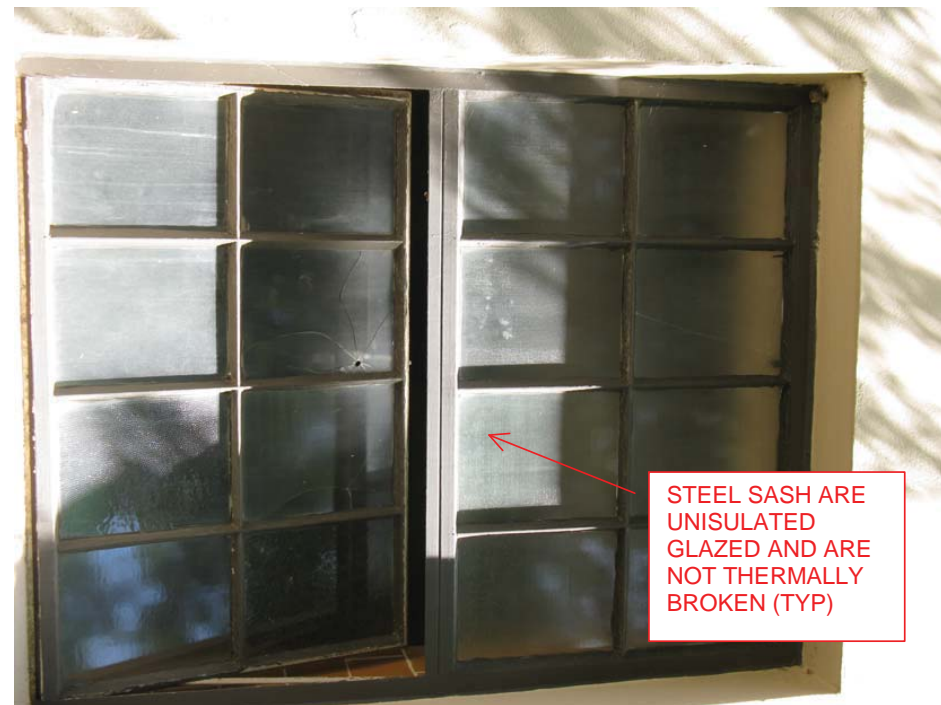
Photo 0010

- e. Steel sash windows have uninsulated glass and are not thermally broken. Numerous openings have been modified to insert window air conditioning units and various piping. (photo 010, 011, & 012)

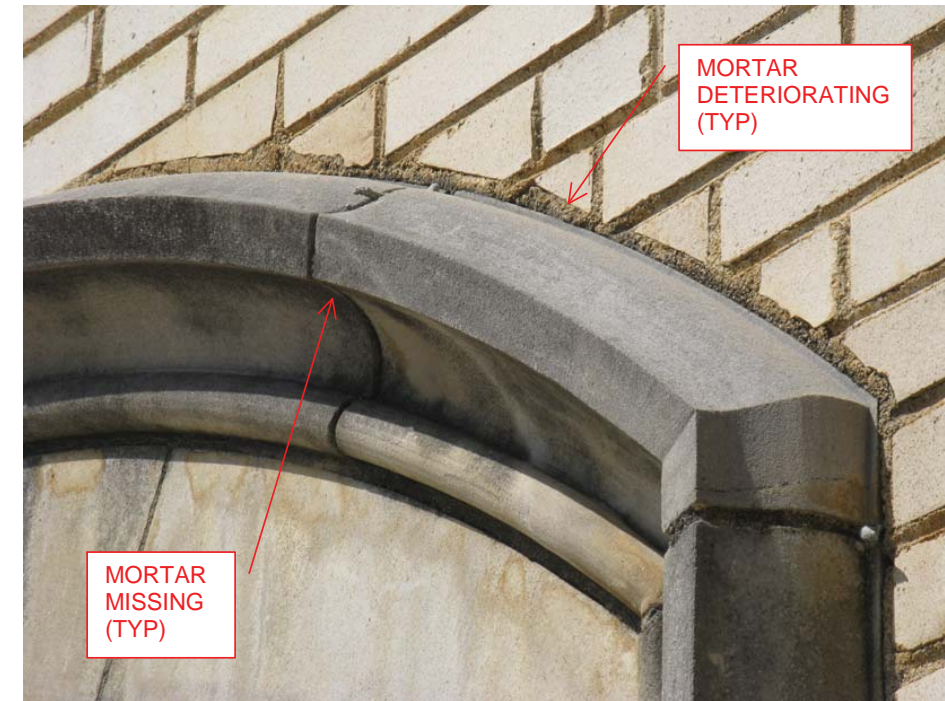
Photo 014

- a. Limestone accents and cornices missing mortar. Should be repointed. (photo 013 & 014)
- b. Steel lintels at ticket booth are rusting and need to be refinished. (photo 015)
- c. Decorative copper cornice at thicket booth is loose. Needs to be reattached. (photo 015)
- d. Staining on brick below decorative louvers in gable. Should be removed in general overall cleaning of brick. (photo 016)
- e. There are a few spalled face bricks above low roof that should be replaced with matching brick. (photo 017)

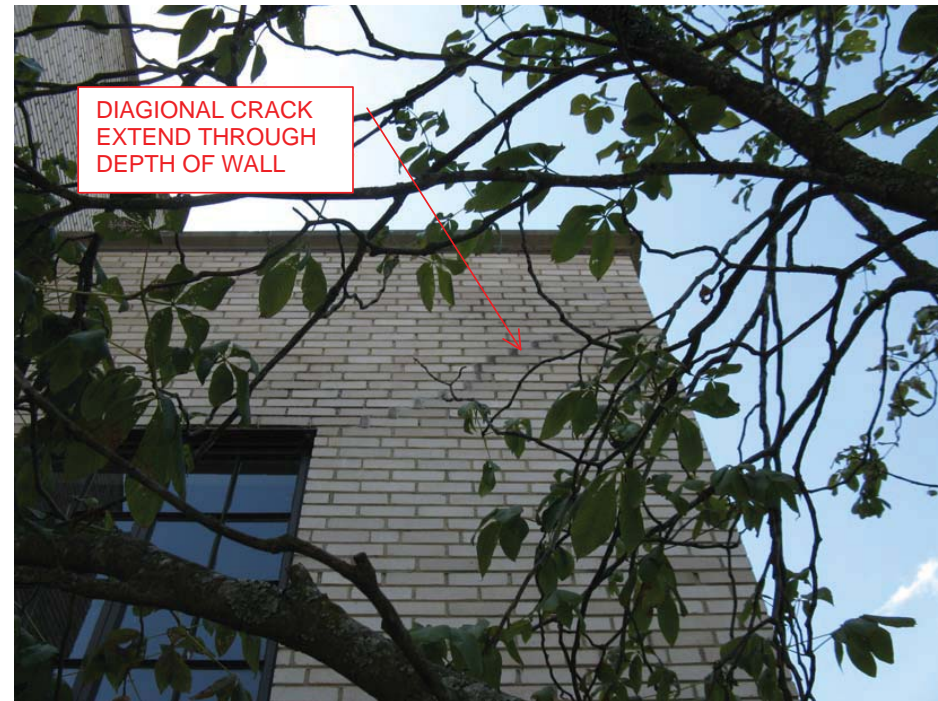
Photo 019

- a. Some spalling and brick breakage at stepped out brick cornice. These should be replaced with matching brick. (photo 008)
- b. At lower section of building on the west end of the building is a significant diagonal crack that extends through the depth of the wall. Reason for crack as determined by structural engineer should be corrected and wall should be taken down as necessary and relaid. (photo 018 & 019)

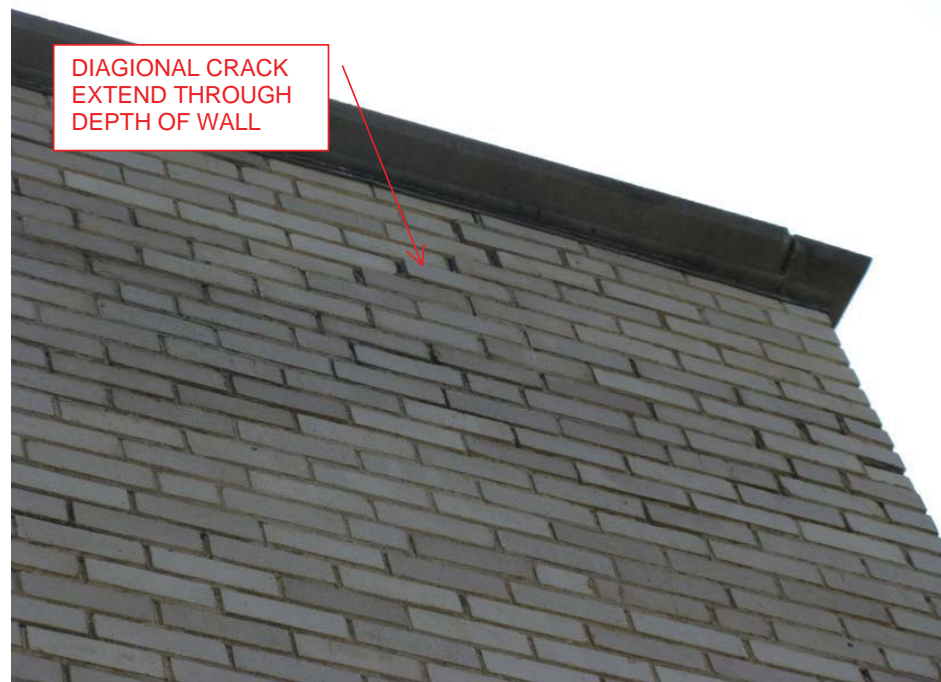
Photo 021

- a. Diagonal cracking continues at lower section of building, both ends of building. See previous corrective suggestion (photo 020 & 021)
- b. Open joint at brick pilaster needs filled. (photo 022)
- c. While copper downspouts are generally in good overall condition, some joints have been sloppily repaired with contrasting sealant. These should be cleaned and repaired in more sympathetic manner. (photo 023)
- d. Wood canopies over doors and door frames have deteriorated. Some wood trim needs replaced and entire canopy repainted. (photo 024 & 025)

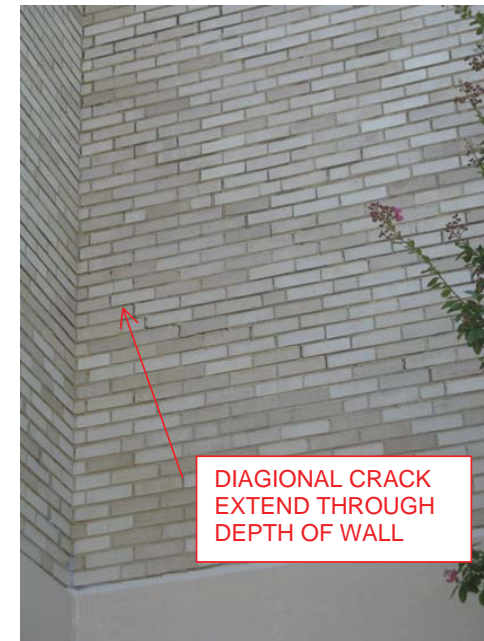
Photo 027

- a. At lower section of building on the west end of the building is a significant diagonal crack that extends through the depth of the wall. Reason for crack as determined by structural engineer should be corrected and wall should be taken down as necessary and relaid. (photo 026 & 027)
- b. Spalled concrete at intersection of lower west section of building to higher gymnasium section. Wall should be patched and repainted (photo 028)
- c. Concrete window head spalled off. Wall should be patched and repainted. (photo 012)
- d. Some spalled brick at pilaster. Brick should be replaced. (photo 029)
- e. Wood canopies over doors and door frames have deteriorated. Some wood trim needs replaced and entire canopy repainted. (Similar photo 024 & 025)

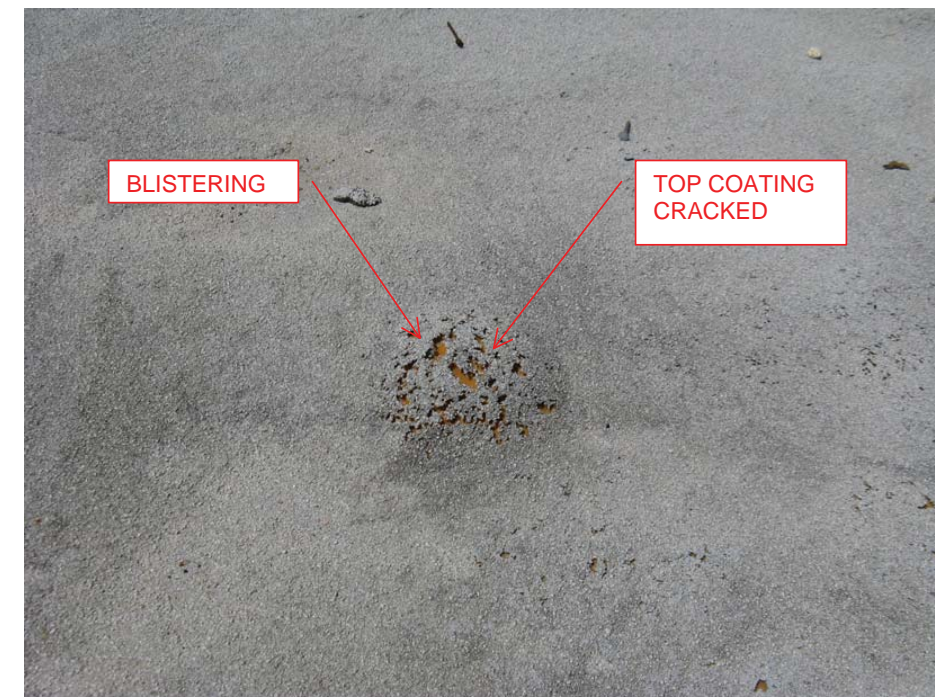
Photo 030

- a. There are numerous blisters in the sprayed foamed overlay. Many have compromised the membrane topping. (photo 030, 031, & 032)
- b. It looks like the roof allows ponding of water and doesn't provide continuous drainage to drain. (photo 033)
- c. Sprayed foam insulation has greatly reduced the opening of vent piping. (photo 034 & 035)
- d. Flashing around pipe penetration looks like it will allow blowing rain to go into old chimney. (photo 036)

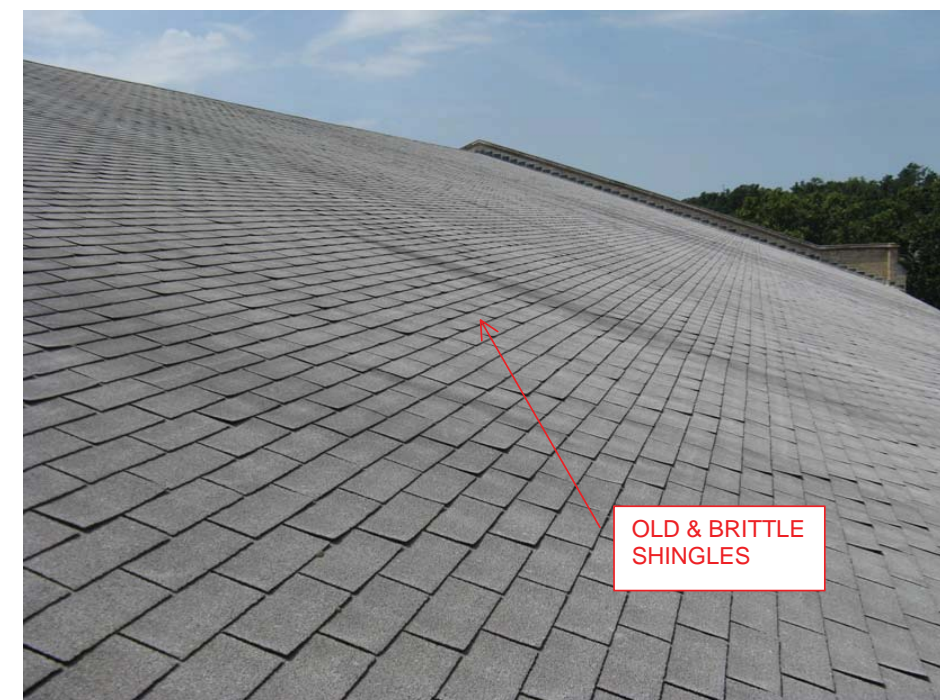
Photo 037

- Shingle roof is in terrible condition. Shingles are old and brittle. Many have broken. Roof on south side is worse than the north. Several repairs have been with newer shingles. (photo 037 & 038)
- Stepped counter flashing along edge of roof is loose and coming away from wall. Sealant has been applied apparently to prevent leakage. (photo 039 & 040)
- Parapet caps are missing mortar and sound probably be taken off and reset to make them sound. (photo 041 & 042)
- Copper guttering and downspouts are generally in good shape. They should be went over and straighten in some locations and made sure they are secured. Snow guard may be advised. (photo 043)

All roofs should be replaced with appropriate new roofing materials.

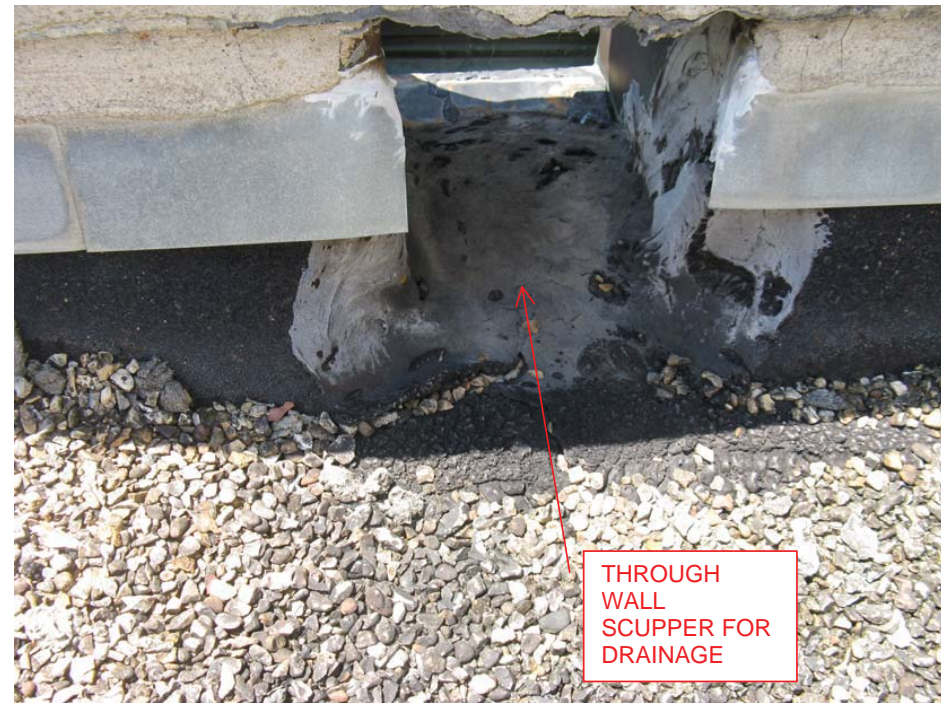
Photo 45

- a. Roof seems to be a built-up type roof with pea gravel that has been patched for installation of new equipment. (photo 044) Roof shows generally to be sound but showing age. (photo 045 & 046)
- b. Flashing around vent penetration damaged. (photo 047)

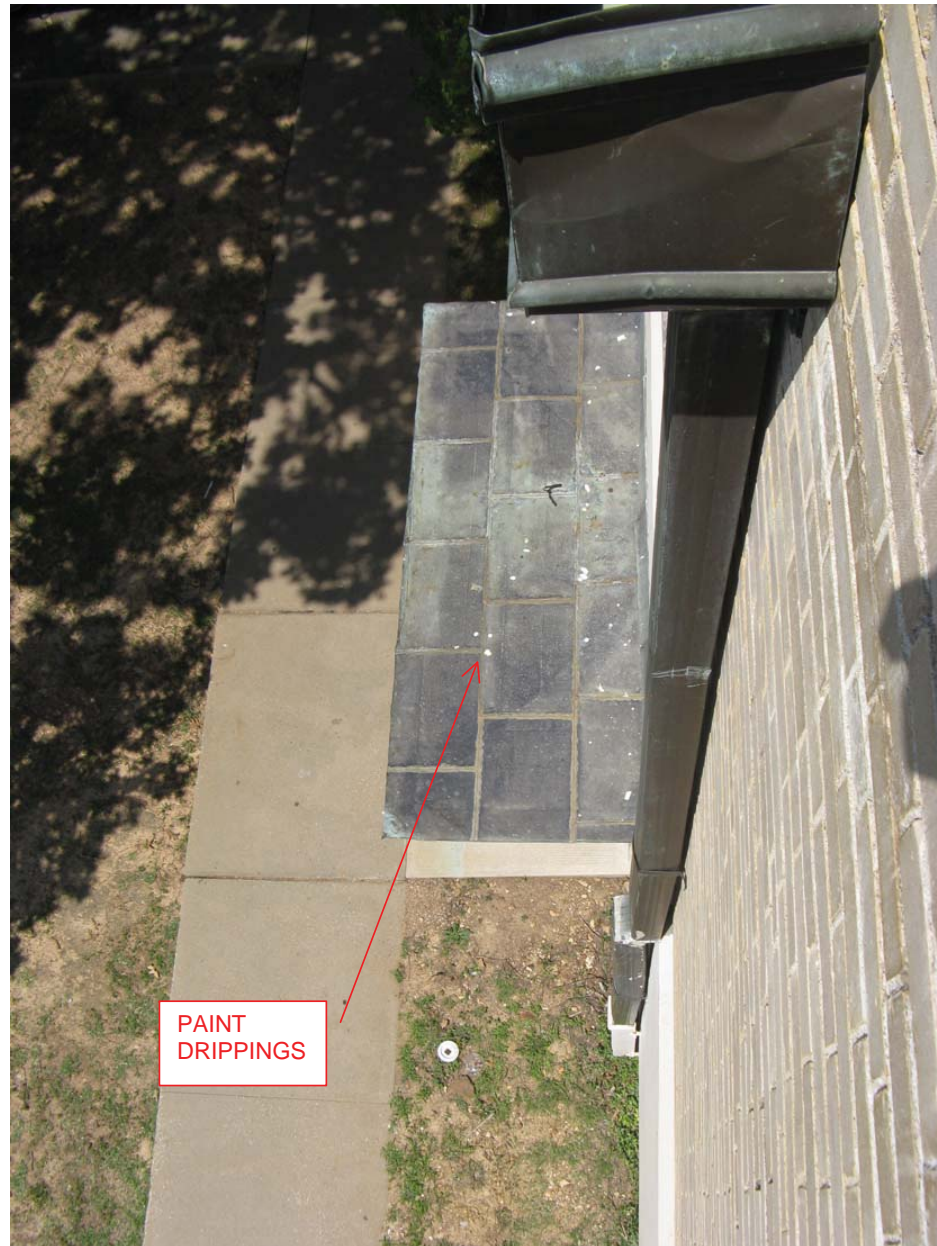
Photo 048

- a. Flat copper roofing over canopies seems generally in good shape in locations where it was visible. Closer inspection of seams and clean of some locations would be advisable. (photo 048)

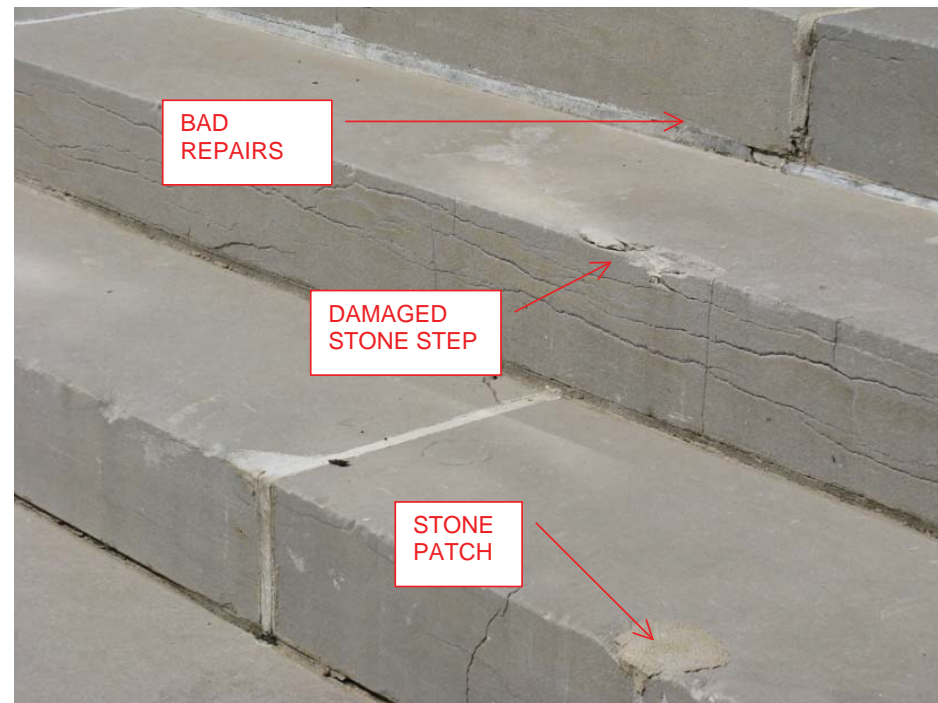
Photo 051

- a. Several of the stone steps have been damaged. Attempts to patch some have been made. Movement has occurred in some. (Photo 050 & 051)
- b. Stones in the ashlar terrace have moved over time and the mortar has deteriorated. (Photo 052)
- c. Concrete sidewalk in front of step platform at entry is broken and uneven. (Photo 053)
- d. A concrete ramp provides wheel chair accessibility to main front entry. (Photo 054)
