Arkansas Union

University of Arkansas-Fayetteville

Programming and Concept Design Final Report

February 05, 2010

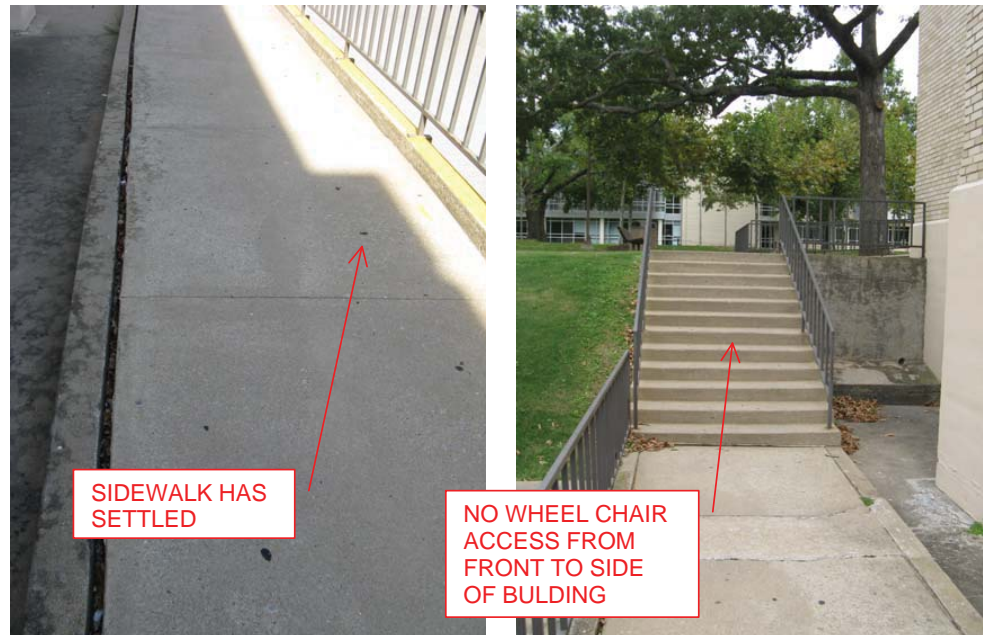
- a. Sidewalk along north side of the building has settled. (Photo 055)
- b. Steps should be replaced with wheelchair accessible access if possible from front of building to side. (photo 056)
- c. Joint between concrete gutter and face of building has been patched in what looks like an attempt to prevent water from coming into building. (Photo 057)

SIDEWALK HAS
SETTLED
